WIPP Underground Fire Accident Investigation Summary February 5, 2014

Ted Wyka
Chairman, Accident Investigation Board
March 2014

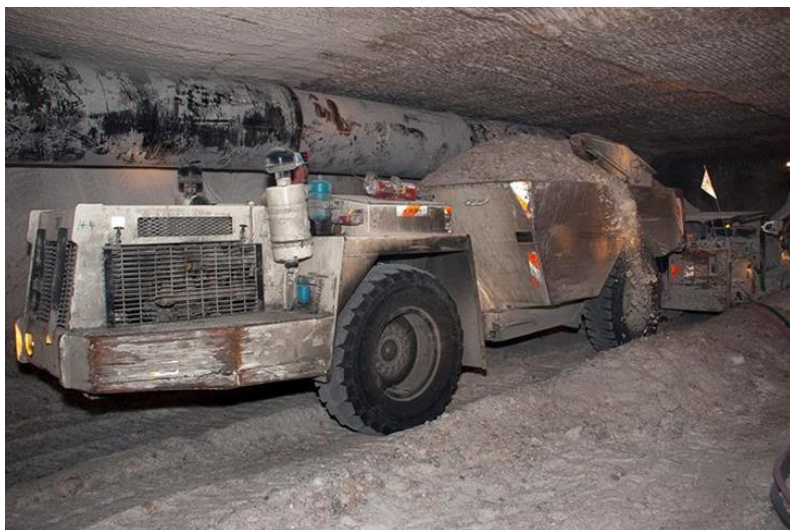
The EIMCO Model 985, 15 ton haul truck is a diesel powered vehicle used to haul salt from the mine. This is an aged piece of equipment, approximately 29 years old.

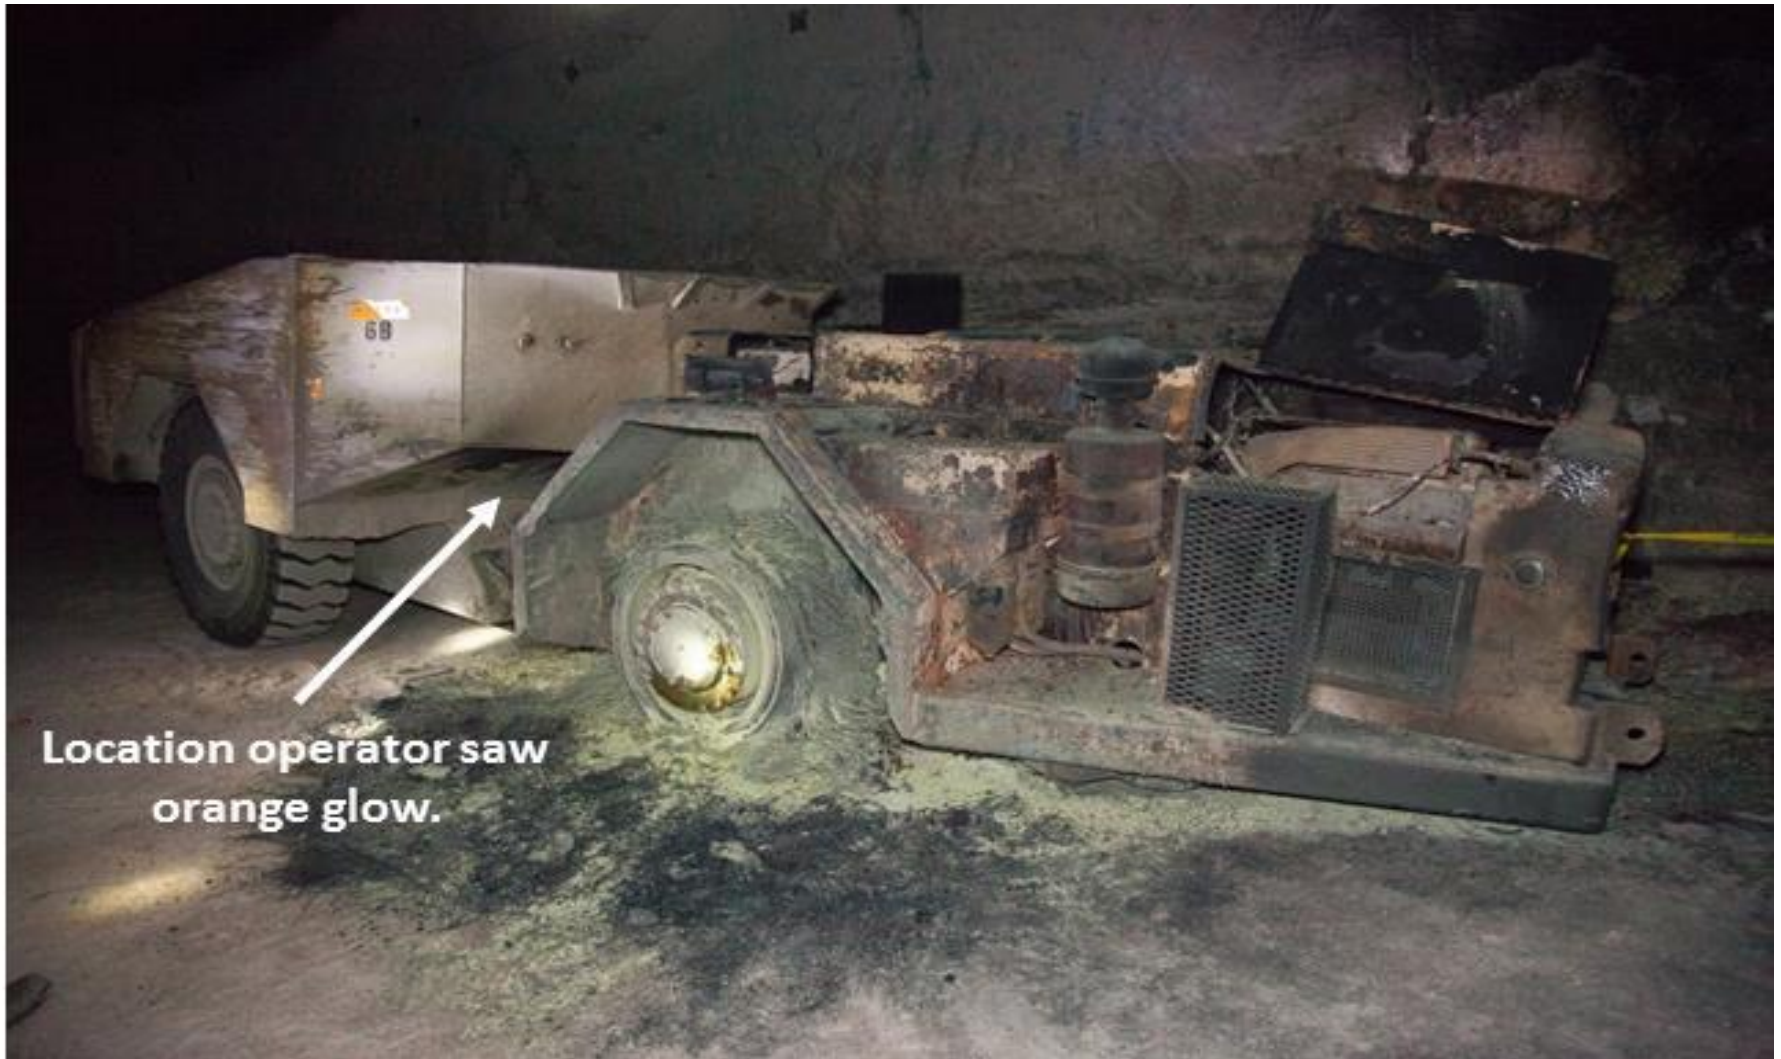
Salt Haul Truck

Location operator saw
orange glow.

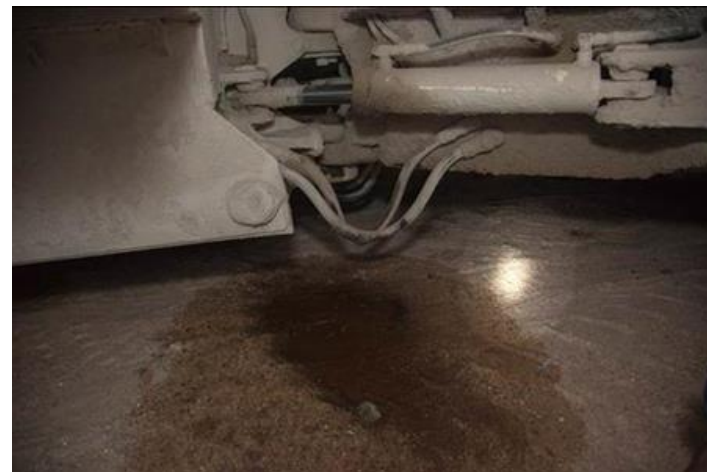
Hydraulic Leak under Sister Vehicle

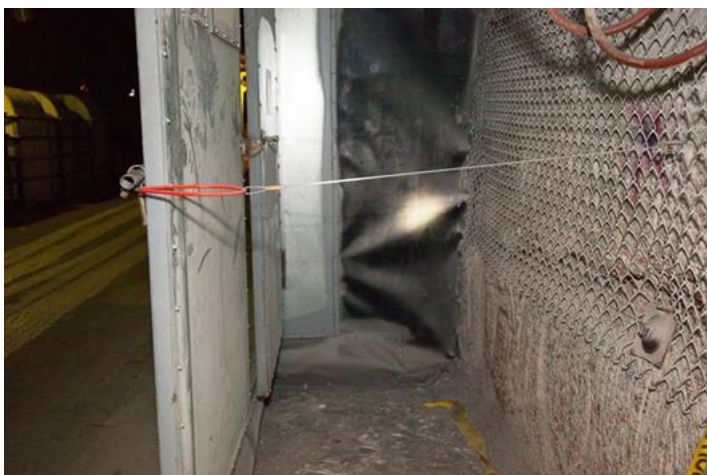
Air Lock Doors Wired Open

- **Operability and recognition of impaired critical safety equipment,** e.g., salt haul truck combustible build up; discontinued use of the vehicle wash station; chaining open of ventilation doors impairing remote operation; inoperable ventilation fans; out-of-service regulator/damper; inoperable mine phones ; emergency lights in the Waste Handling Facility; obscured evacuation reflectors; decision and analysis to disable the automatic fire detection and suppression system, etc. No method to readily understand status and impact of impaired mine safety related equipment.

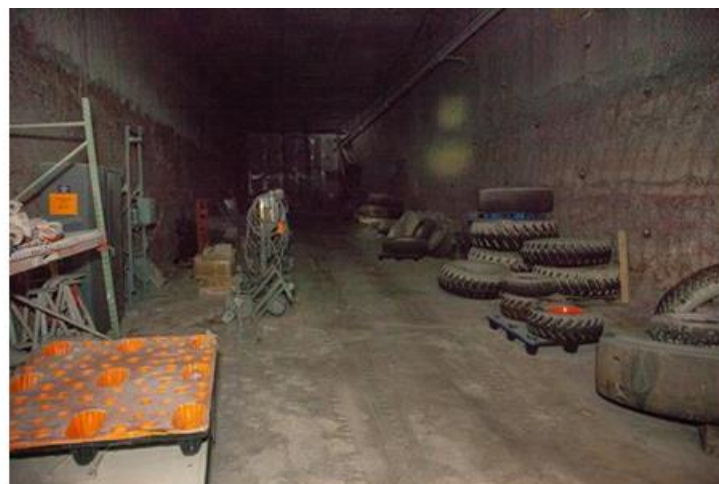
Combustible Loading in the Mine

- **Inadequate combustible loading program in the underground.**
- **Inadequate Fire hazard Analysis** (i.e. analysis of a fire near a shaft)
- **Maintenance, Emergency Management/Preparedness programs and NWP contractor assurance system (CAS) and CBFO oversight** were evaluated as **ineffective.**

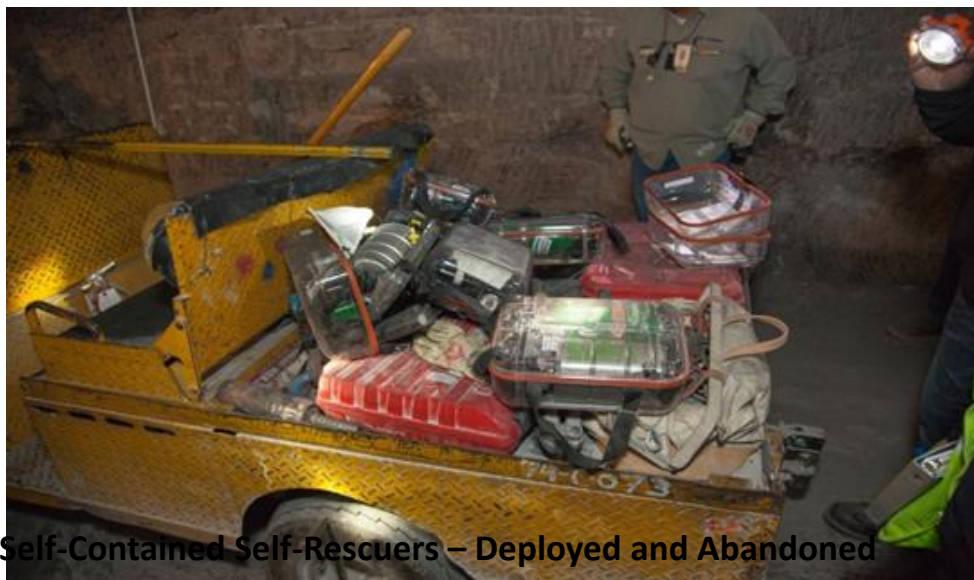
Self-Contained Self-Rescuers – Deployed and Abandoned

- **Ineffective training and drilling**
 - No unannounced drills.
 - No donning of self-rescuers or SCSRs during training or drills, or hands on training with portable fire extinguishers.

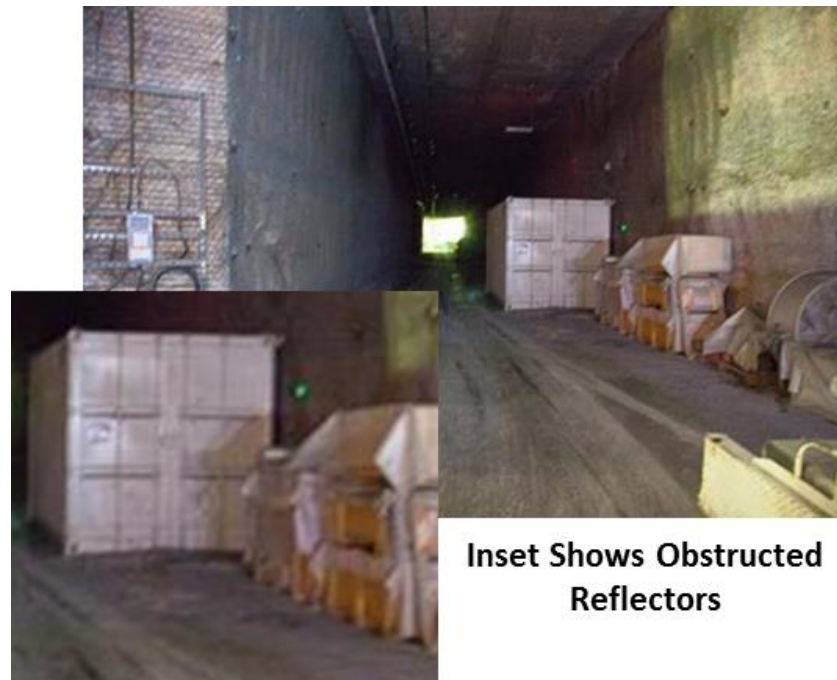
Inset Shows Obstructed Reflectors
