WIPP Underground Fire Accident Investigation Summary February 5, 2014

Ted Wyka
Chairman, Accident Investigation Board
March 2014

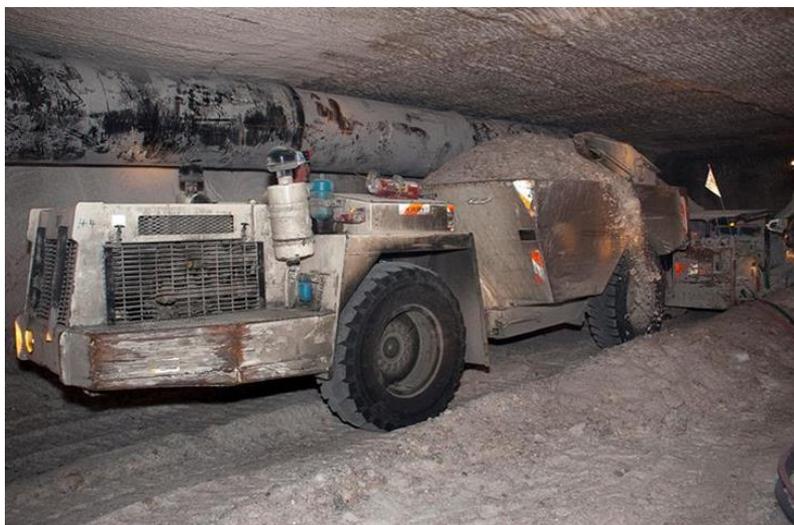
The EIMCO Model 985, 15 ton haul truck is a diesel powered vehicle used to haul salt from the mine. This is an aged piece of equipment, approximately 29 years old.

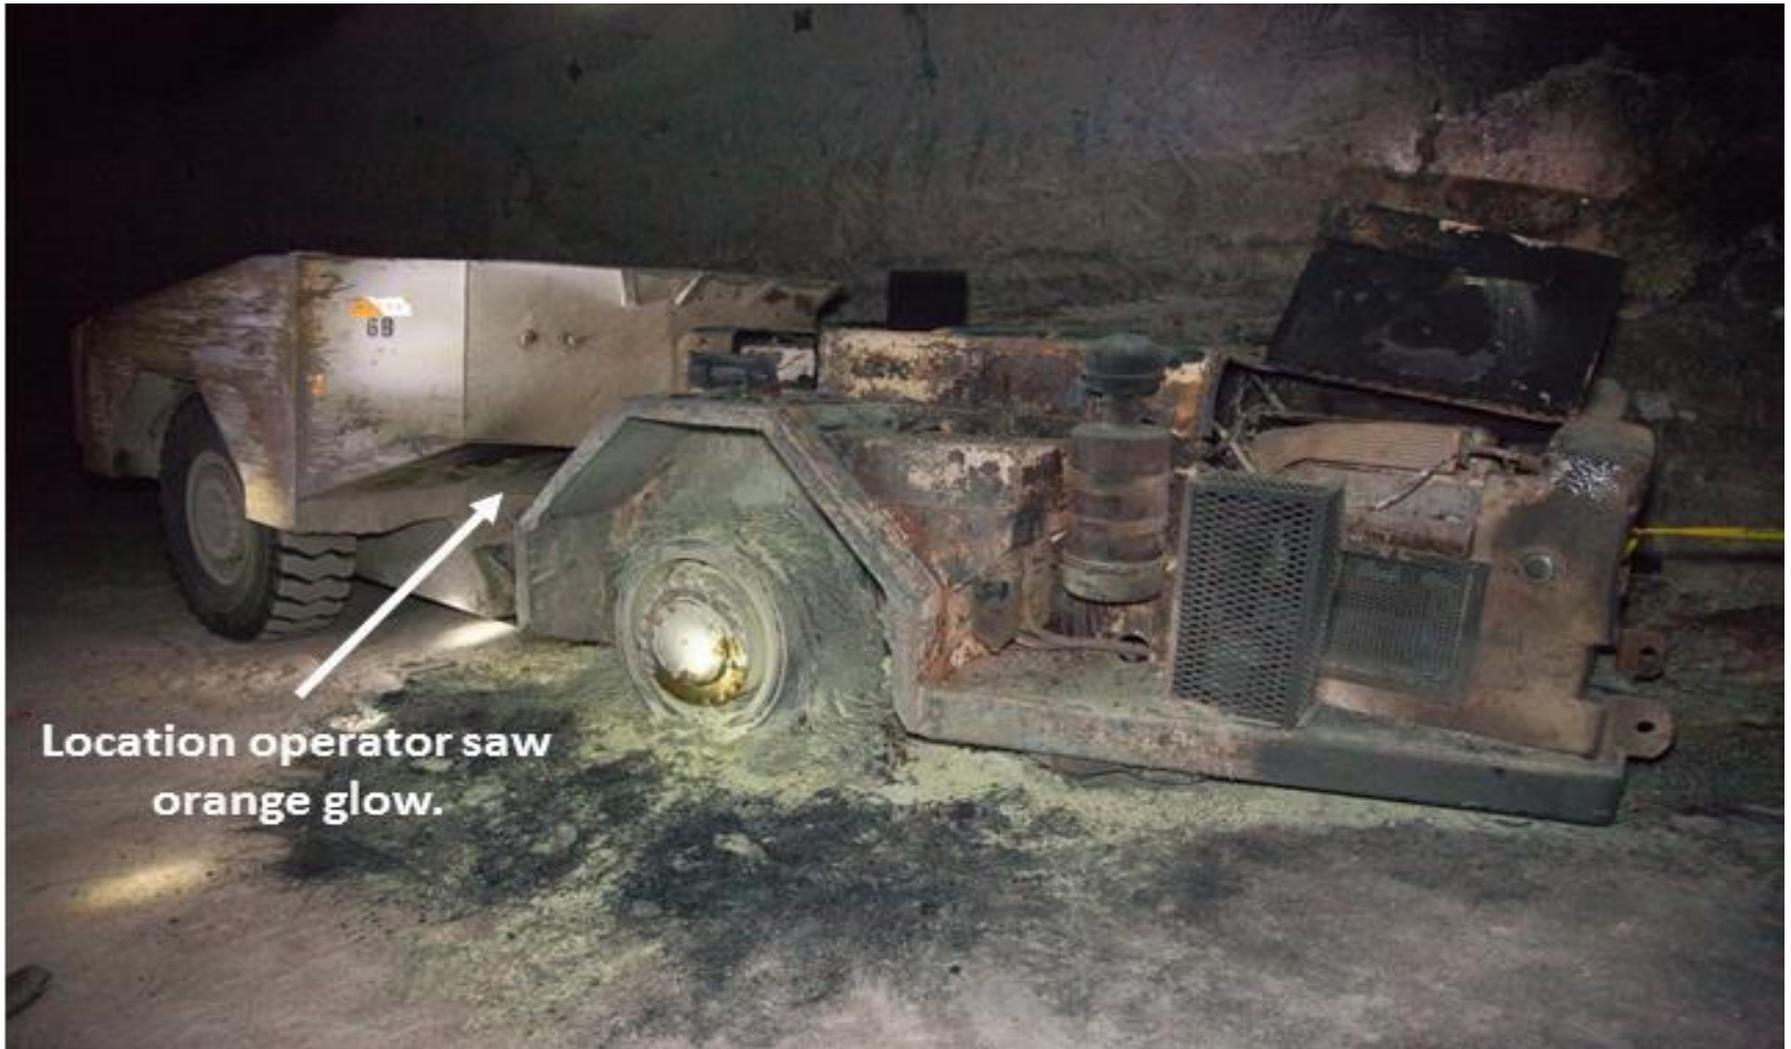
Salt Haul Truck

Location operator saw
orange glow.

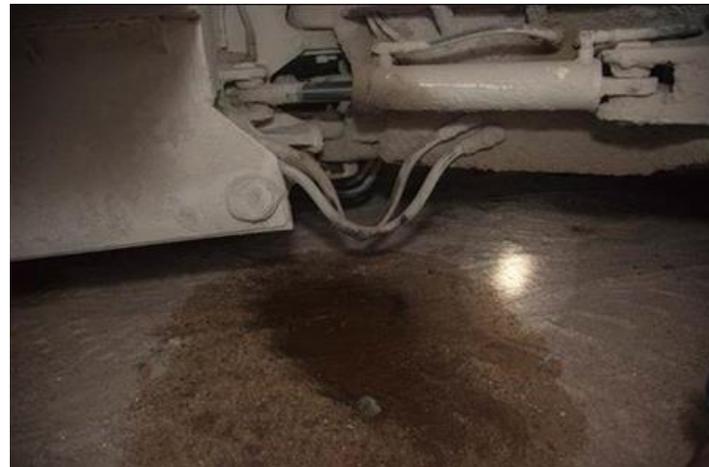
Hydraulic Leak under Sister Vehicle

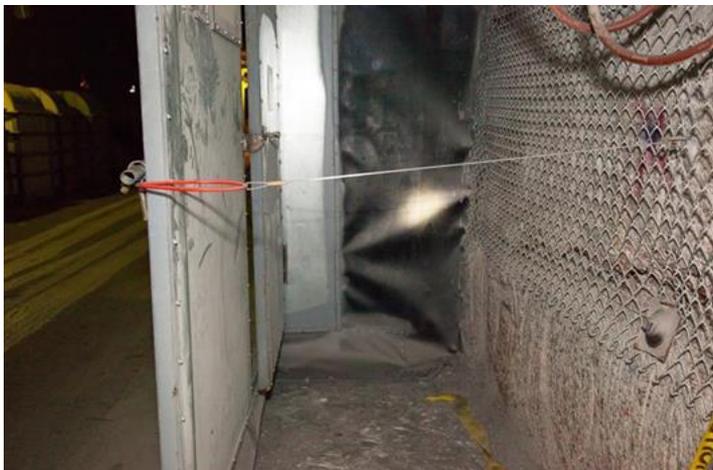
Air Lock Doors Wired Open

- **Operability and recognition of impaired critical safety equipment,** e.g., salt haul truck combustible build up; discontinued use of the vehicle wash station; chaining open of ventilation doors impairing remote operation; inoperable ventilation fans; out-of-service regulator/damper; inoperable mine phones ; emergency lights in the Waste Handling Facility; obscured evacuation reflectors; decision and analysis to disable the automatic fire detection and suppression system, etc. No method to readily understand status and impact of impaired mine safety related equipment.

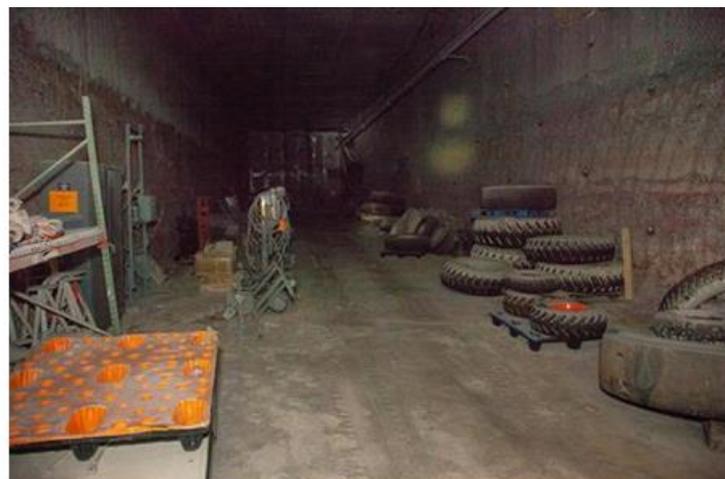
Combustible Loading in the Mine

- **Inadequate combustible loading program in the underground.**
- **Inadequate Fire hazard Analysis** (i.e. analysis of a fire near a shaft)
- **Maintenance, Emergency Management/Preparedness programs and NWP contractor assurance system (CAS) and CBFO oversight** were evaluated as **ineffective.**

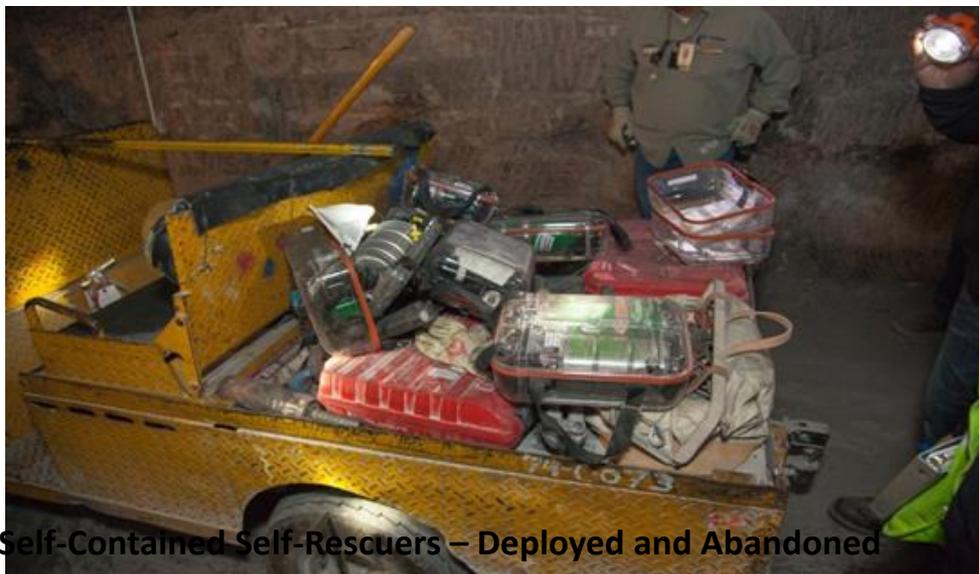
Self-Contained Self-Rescuers – Deployed and Abandoned

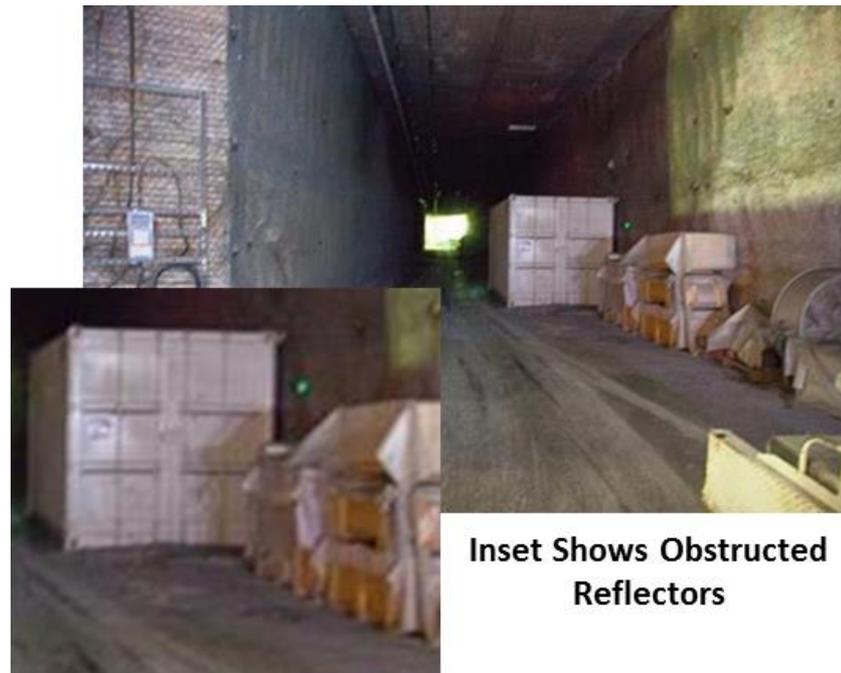
Inset Shows Obstructed Reflectors
