Accident Investigation Report

Underground Salt Haul Truck Fire at the Waste Isolation Pilot Plant February 5, 2014

March 2014

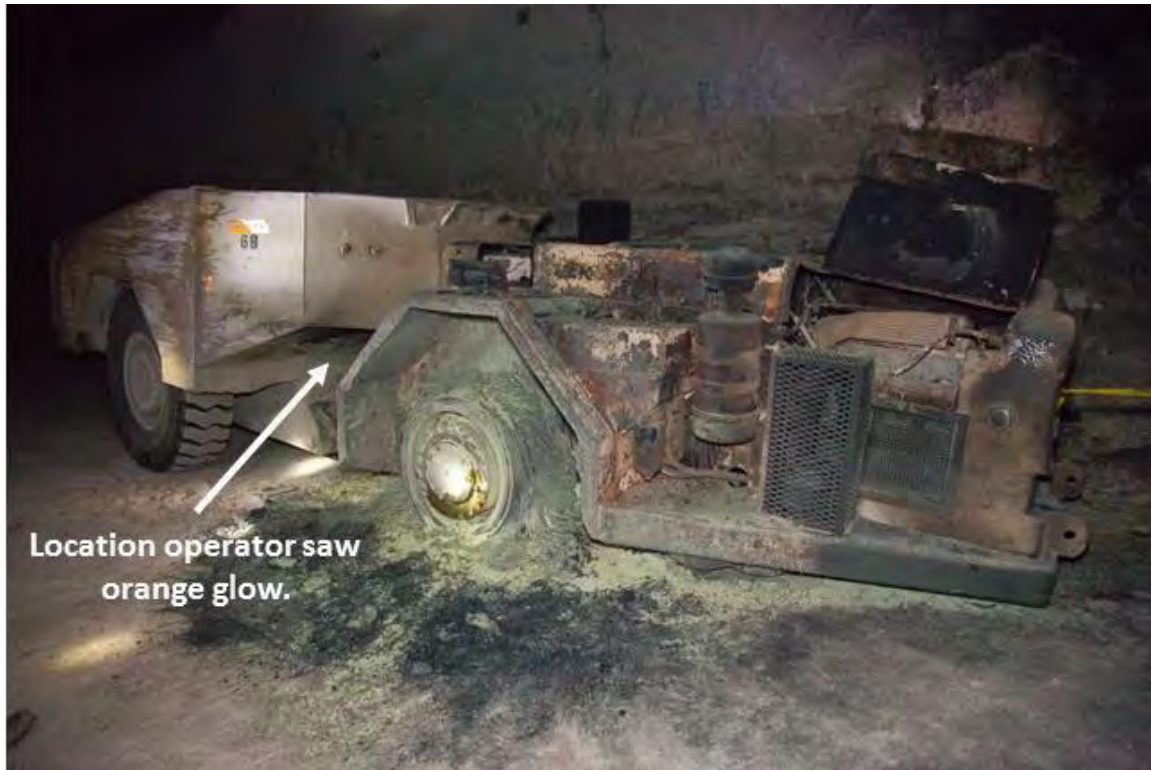
Figure ES-1: EIMCO Haul Truck 74-U-006B after Fire

The Board identified the direct cause of this accident to be contact between flammable fluids (either hydraulic fluid or diesel fuel) and hot surfaces (most likely the catalytic converter) on the salt haul truck, which resulted in a fire that consumed the engine compartment and two front tires.

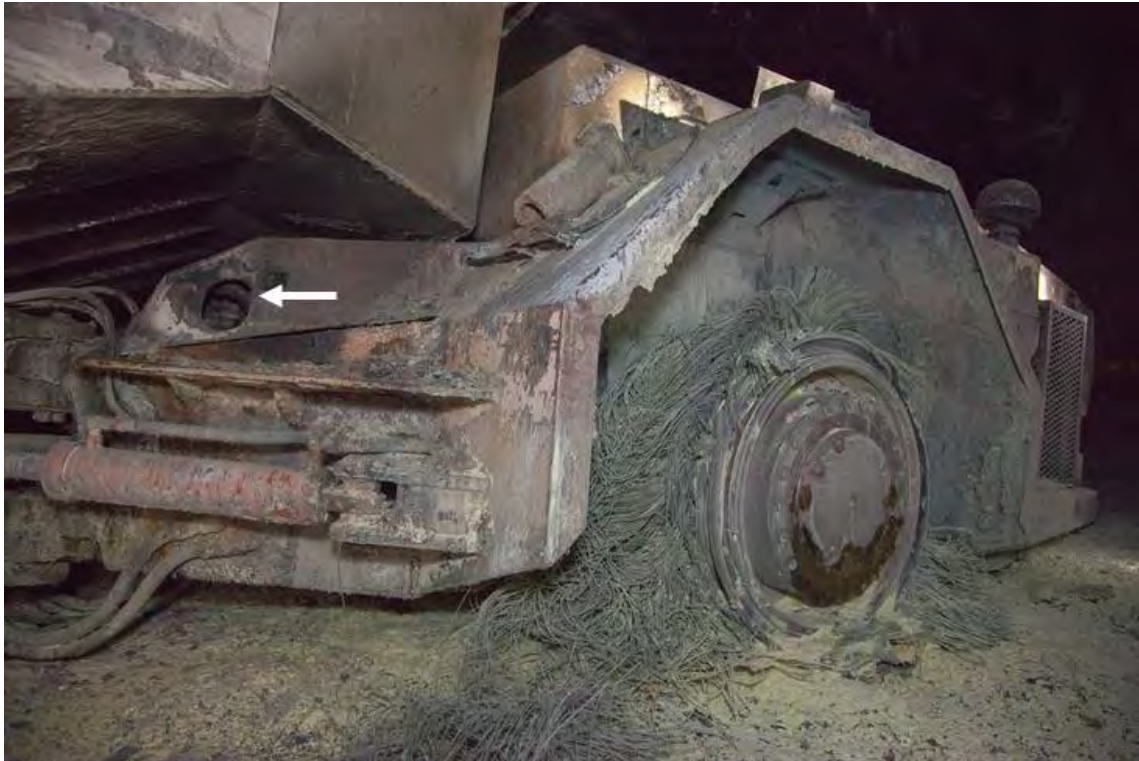
Upon noticing the fire, the Operator stopped the truck, shut off the engine, set the brake, and exited the vehicle, taking a portable fire extinguisher which was mounted on the left front fender. The Operator proceeded to the opposite side of the vehicle, near the articulation joint and attempted to extinguish the fire by discharging the fire extinguisher into the area where the Operator had observed the fire (Figure 9).

Figure 9: Photo Showing the Area on the Salt Haul Truck where the Fire Extinguisher was Discharged

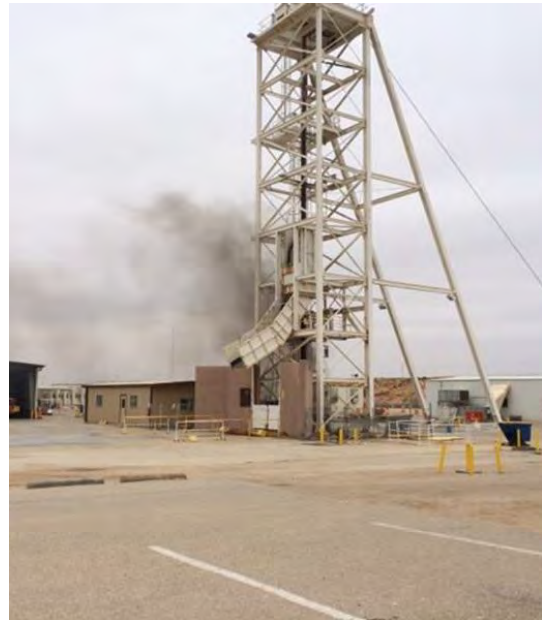
Figure 10: Smoke Visible Exiting through the Salt Shaft

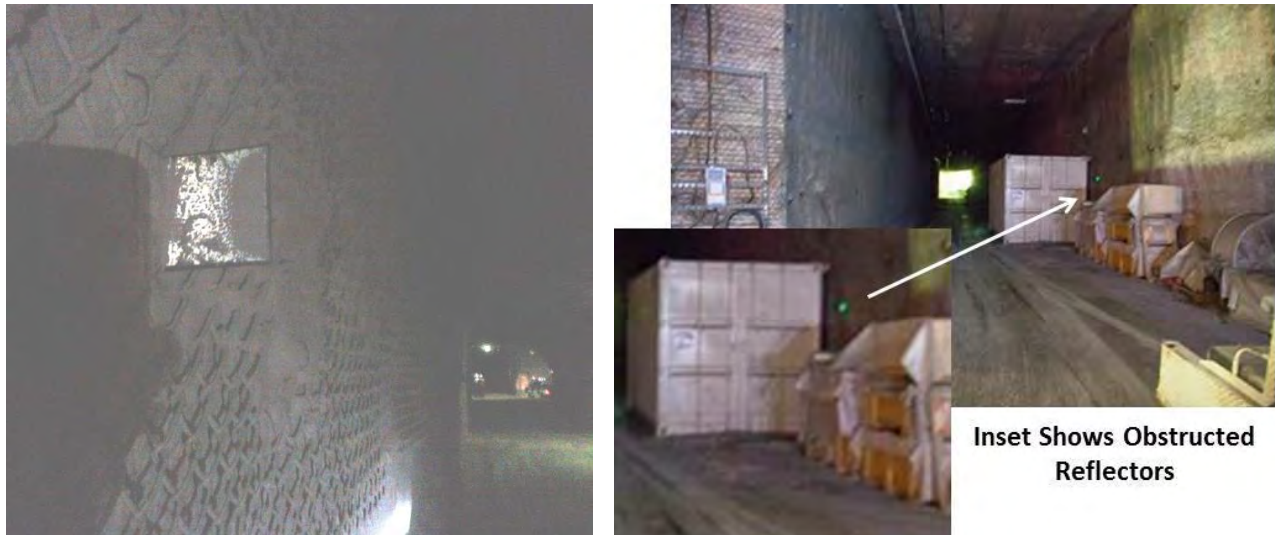
Large quantities of material were staged haphazardly throughout the mine. The contents of the maintenance shop lined both sides of the drift. Additionally, the U/G green and red reflectors that provide an indication of where to proceed during an evacuation were not effective. Some were obscured by being placed under the mesh fence along the ribs, while others were hidden from sight by other material stored in the mine. The Board also identified that these reflectors were covered in soot from the fire, and were located at irregular spacing (Figure 12).

Figure 12: Obscured Reflectors

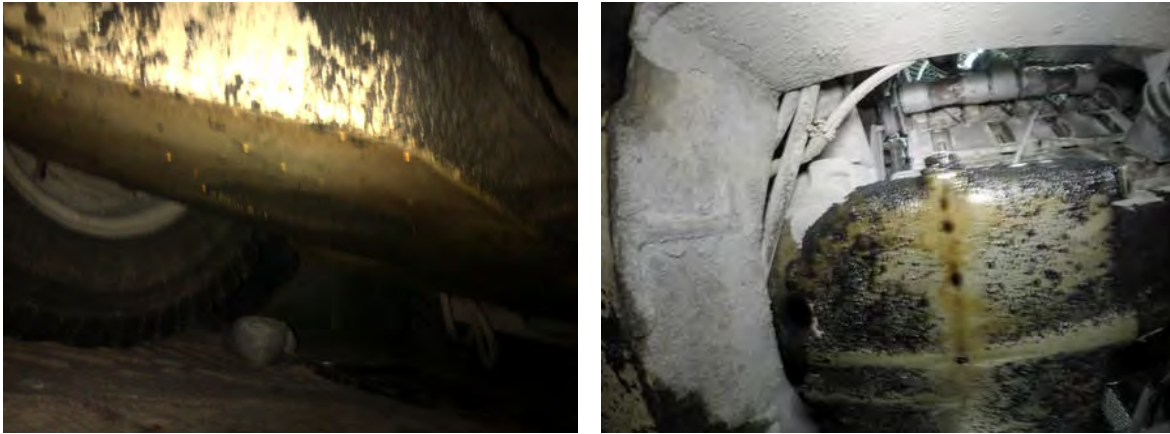
- There was significant buildup of engine and hydraulic oil on other mining equipment including Salt Haul Truck 74U006A. (Figure 13)

Figure 13: Buildup of Engine Fluids on the Underside of Vehicles in the Mine

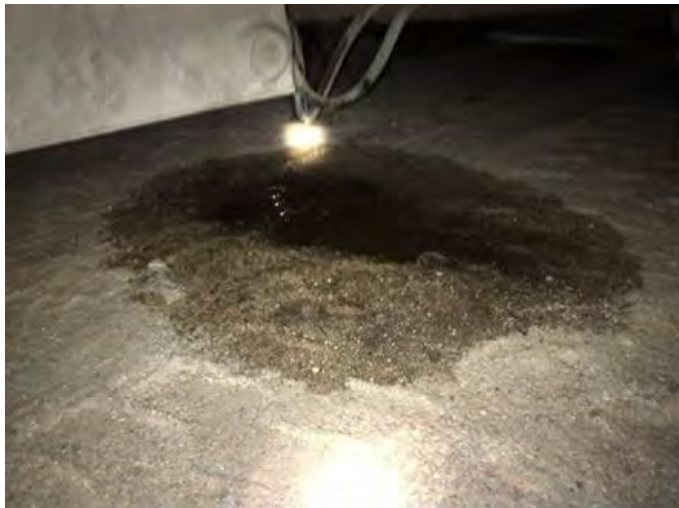
- There was a three-foot diameter puddle of hydraulic fluid underneath Salt Haul Truck 74U006A. (Figure 14)
- The daily Operator's Checklist was completed on February 5, 2014, for Salt Haul Truck 74U006A with no deficiencies indicated.
- There was an Out of Service tag on Salt Haul Truck 74U006A indicating that a lighting deficiency existed.
- Several mine phones were found to be inoperable (run to battery failure). Twelve of 40 phones tested were non-functional.
- Numerous components of the mine ventilation system were out of

Figure 14: Hydraulic Fluid under Truck 74U006A

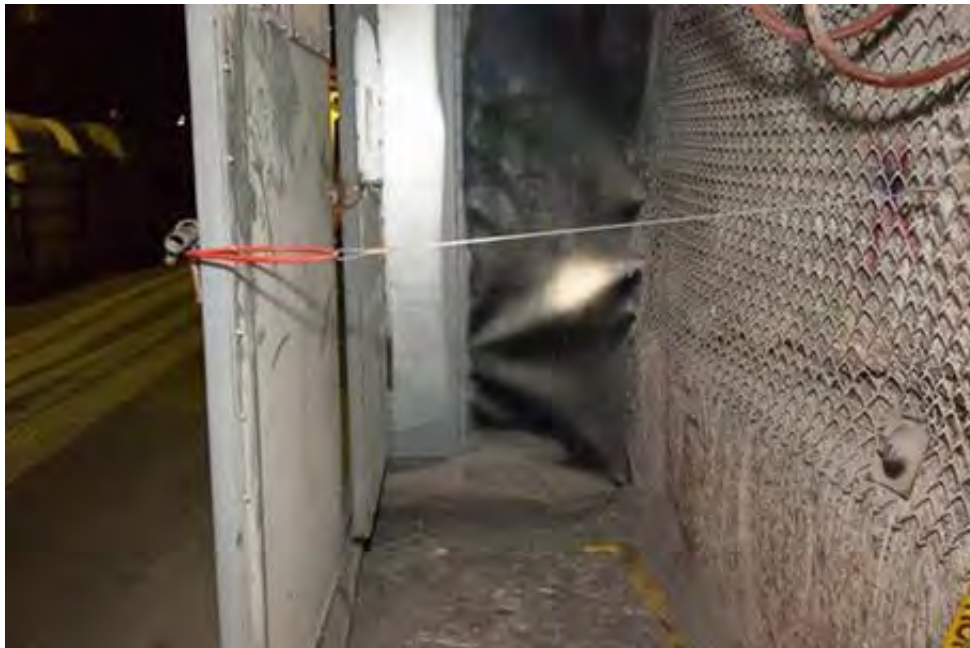
- 308 bulkhead regulator cannot be remotely operated from the CMR due to the regulator being out of service or impaired. This bulkhead is located between the Waste Shaft and the exhaust shaft.

Figure 15: One of Chained Bulkhead Doors

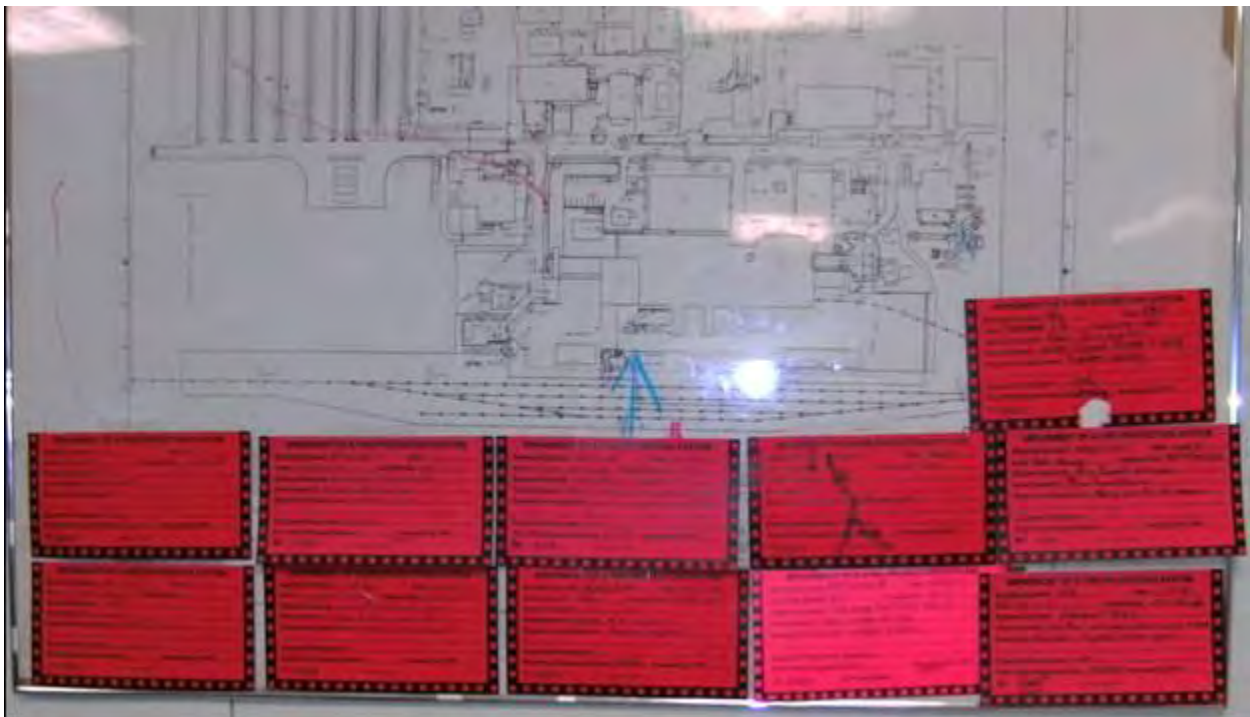
The Board reviewed the equipment status and condition in the CMR and the U/G. The condition of critical pieces of equipment, such as the 700 exhaust fans, indicates that management has not taken prompt action to resolve longstanding deficiencies. Many items have been out of service or in a reduced status for more than six months. It was not clear that NWP had a clear approach to prioritizing maintenance activities in regard to critical equipment or that there is an effective formal process to identify compensatory measures other than a fire watch for impaired safety-related equipment. Additionally, the equipment and components that affect normal operation of the mine ventilation system did not appear to have been effectively evaluated and dispositioned regarding their impact on system operation. (Figure 16)

Figure 16: Fire Protection System Impairment (Out-of-Service Tags) in the CMR

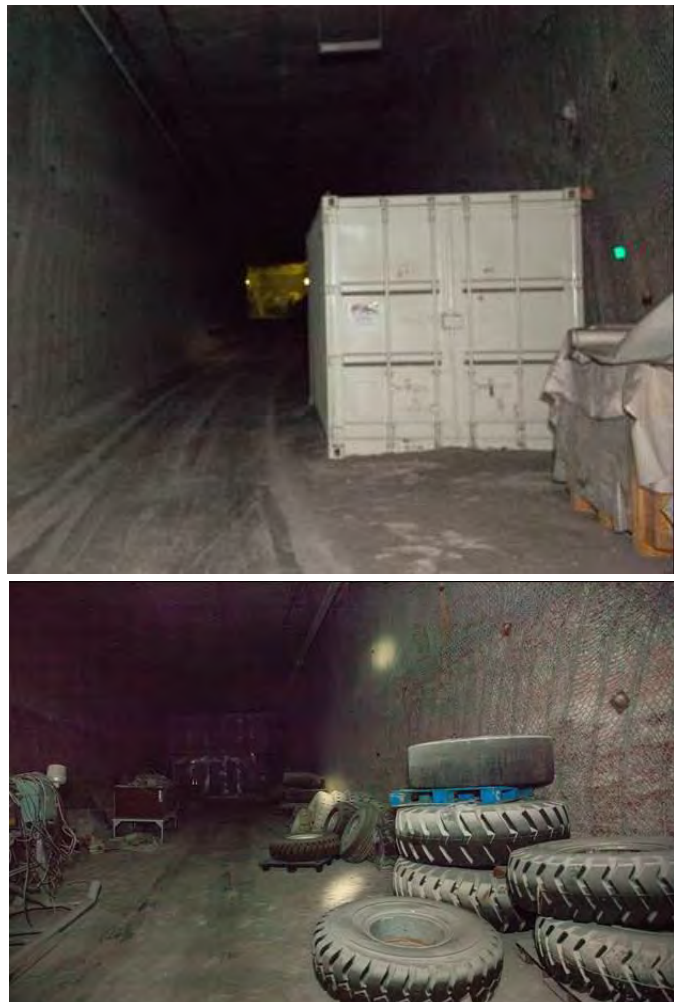
While these fire protection reviews addressed only the control of combustible materials, material storage and staging is really the issue. Salt movement requires periodic touchup to the ribs and back (walls and ceiling) to maintain the non-waste work areas, and the floors throughout the mine, in good repair. As a result, equipment and materials are moved out of an area and staged in the drifts. Although this staging is temporary storage, the condition can last several months. The Board observed materials

Figure 17: Combustible Loading in the Mine

stored on either side of the drifts, materials that obscured reflectors, and stored combustibles exceeding the 5 megawatt (MW) limit. Personnel group interviews indicated storage on only one side of drift could have made navigation in drift easier.

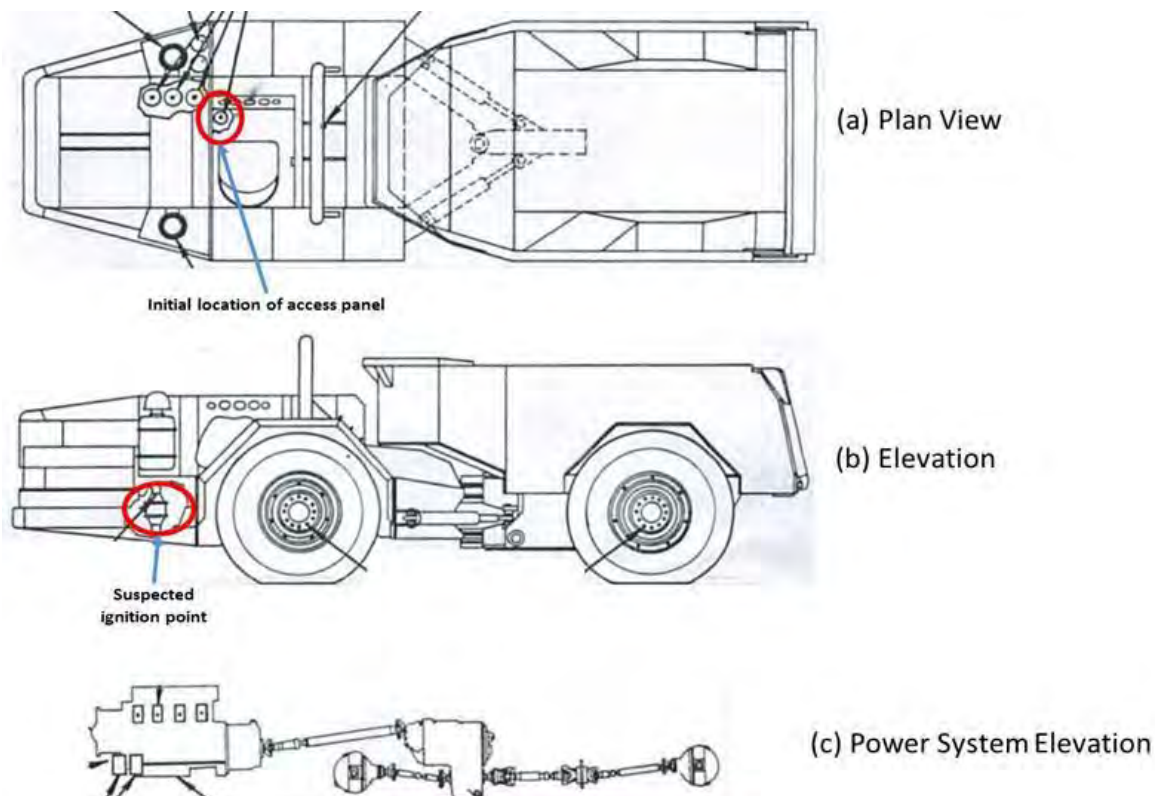
Fire ignition is presumed to have occurred near the exhaust system piping on the lower left side of the haul truck forward of the front wheel (see Figure 18). This area is enclosed by steel construction, making early visual detection difficult. The initial material ignited was a combustible liquid leaking onto the exhaust system. The liquid could have been free flowing or an accumulation on exposed surfaces. The flashpoint temperatures for haul truck fluids are listed in Table 2. The operating temperature of a typical catalytic converter will range from 300 to 500° C; however, this may exceed 500° C during abnormal engine operation (NFPA 921-2014, *Fire and Explosion Investigations*). All of these values exceed the flashpoints shown in Table 2.

Figure 18: Salt Haul Truck

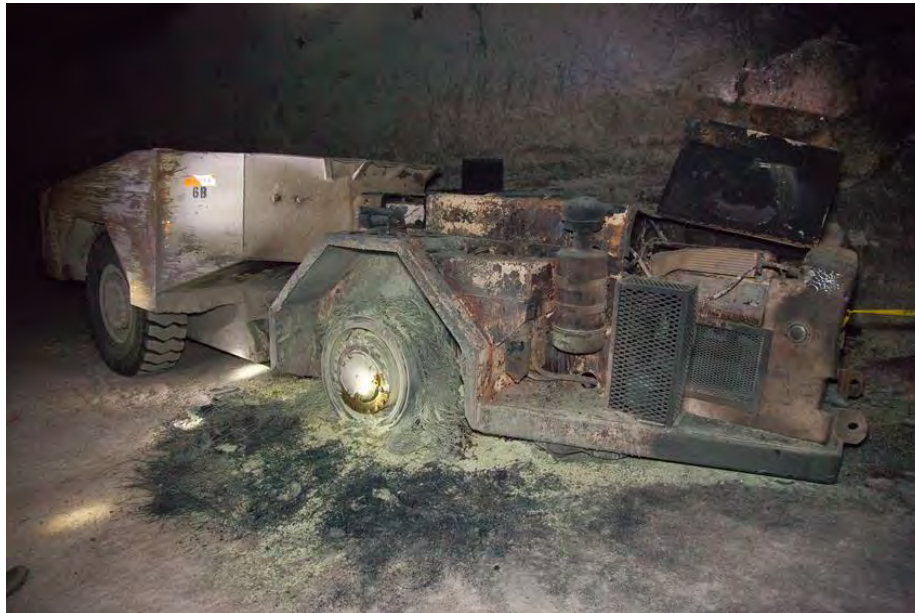
Ignition of the front tires likely occurred within 10 minutes of fire ignition (see Figure 21). Involvement of the tires produced heavy black smoke at the Salt Handling Shaft station before 1053 (1051 plus two minutes for the Salt Handling Shaft Bottom Lander to move to the station).

Figure 21: Salt Haul Truck Damage
(Engine Cowling Was Opened Post-Fire)

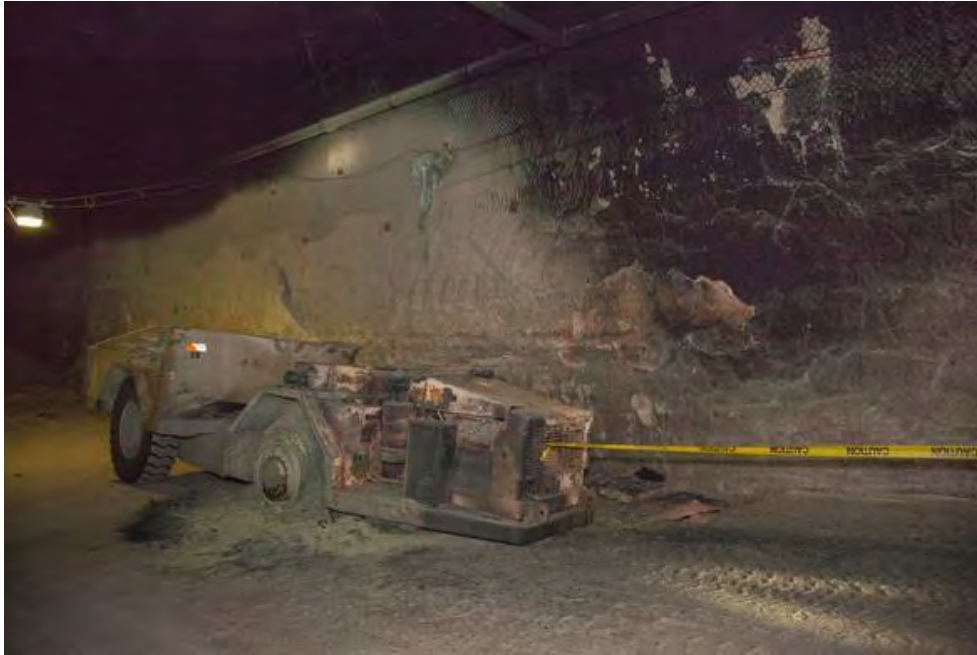
Figure 22: Haul Truck and Rib Spalling

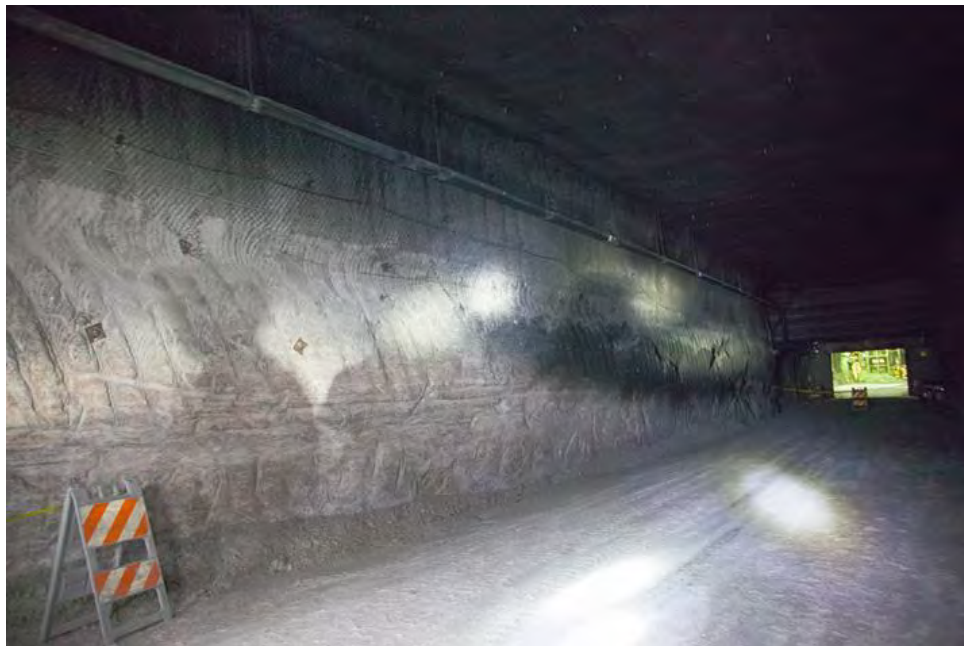
Figure 23: Smoke Signature on Rib (Looking South)

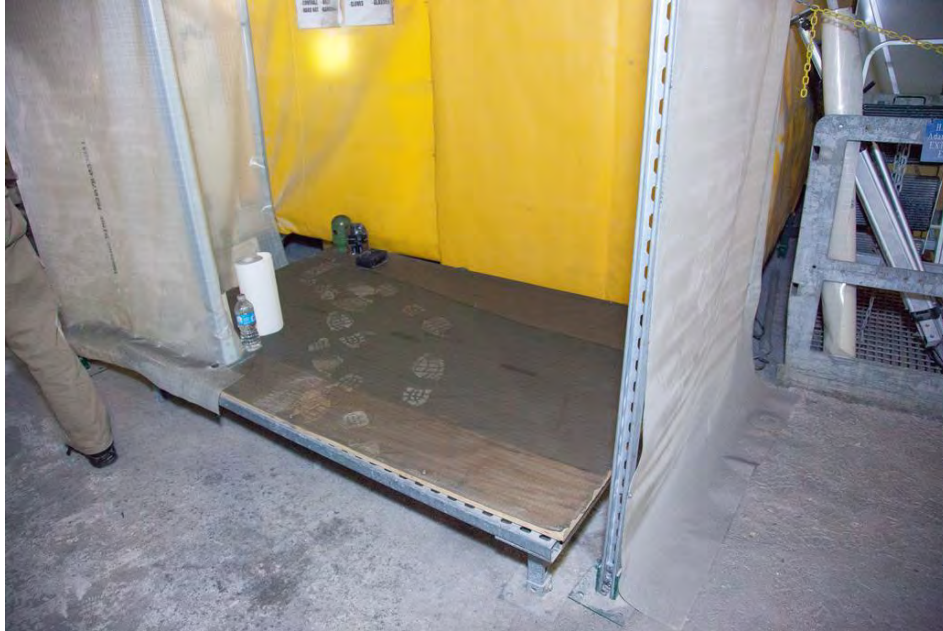
A portion of the airflow entering the underground traveled through the North Air Handling Circuit. The salt haul truck fire created a smoke layer in this circuit. This layer was approximately two feet deep, and traveled to the partially opened rollup door in E140. This arrangement trapped the upper smoke layer since the lower layer moved through the door.

Figure 24: Soot Deposits in North Ventilation Circuit

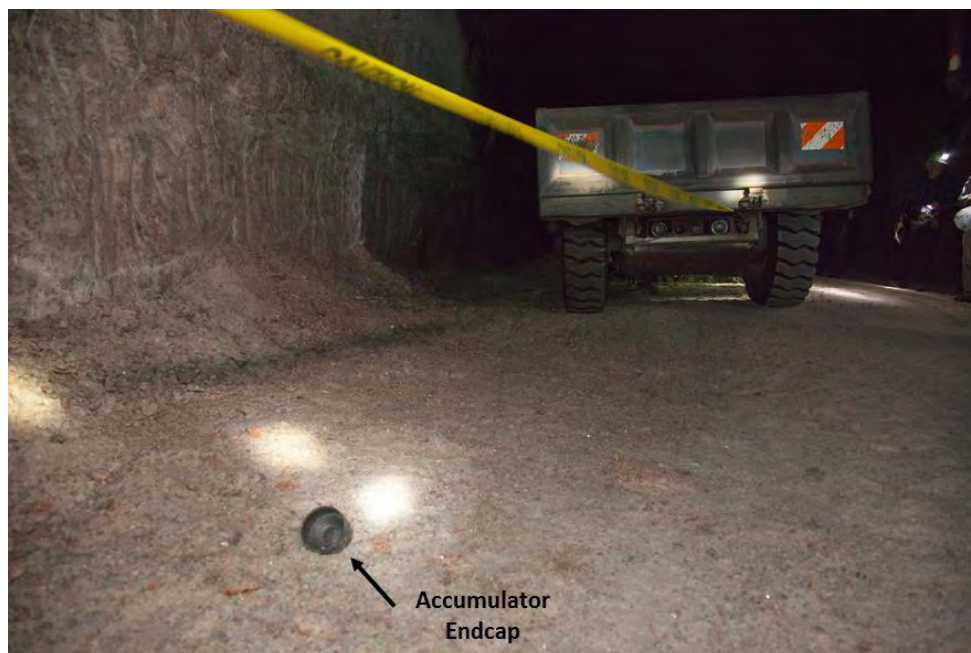
Sometime during the intense burning period an accumulator within the engine compartment burst. This ejected an end-cap which ruptured an access plate and went through the hauler operator compartment. The end-cap traveled approximately 10 feet beyond the back of the haul truck (see Figure 25). The access plate was severely deformed and traveled approximately 20 feet beyond the end of the haul truck (see Figure 26).

Figure 25: Accumulator Endcap (MG 3591)

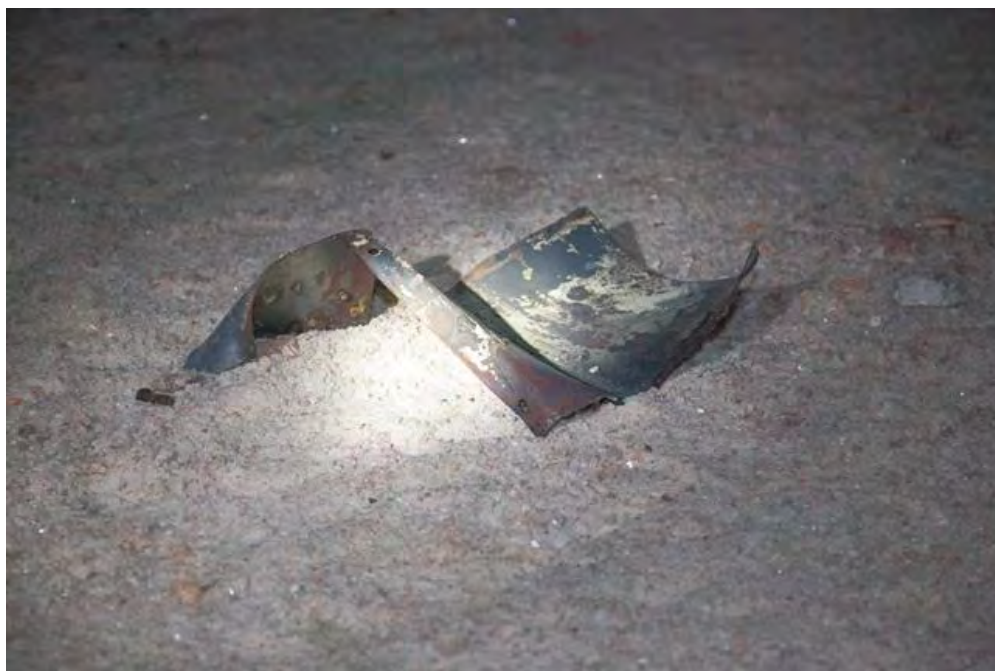
Figure 26: Damaged Access Plate
