SUBJECT:

Field Investigation at the U.S. Department of Energy's Waste Isolation Pilot Plant (WIPP), ID No. 29-01857, Carlsbad, New Mexico (RCD Control Number 17AA01)

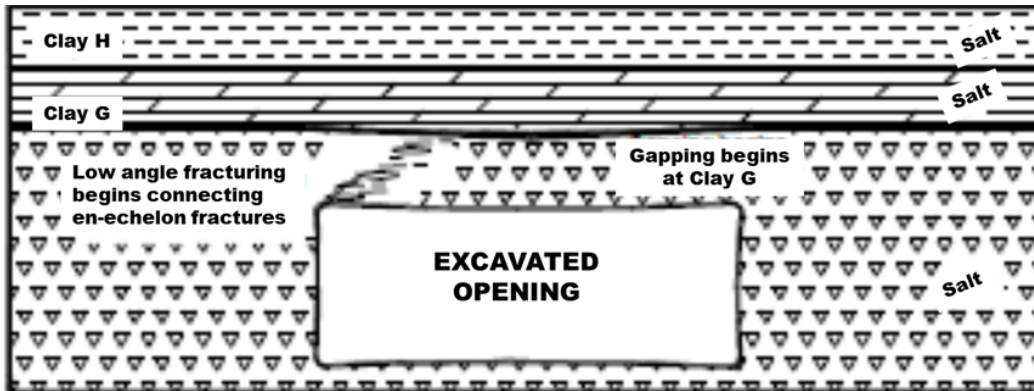
The continuing creep causes “low-angle fractures” to develop in the roof beam (see Figures 3 and 4). These fractures generally begin at the roof line near the ribs and terminate at the clay seam. Eventually the low-angle fractures will coalesce on one side or the other, creating a cantilevered roof beam with a relatively sharp “point” on one end. Once the fractures have coalesced, the beam is free to slide along the clay layer, and the displacement rates accelerate. As the free end of the beam is forced downwards, tensile fractures develop at the top of the beam at its other end, and large gaps develop between the beam and the overlying salt. Unless controlled by heavy roof support, gravity will take over and a roof collapse will ensue. If the beam is supported, it will continue to compress laterally and become severely deformed. Roof bellies of 4 feet or more can develop, accompanied by extensive fracturing and separations (Figure 5).

FIGURE 3.—Formation of a low-angle fracture due to creep in a typical drift at WIPP.

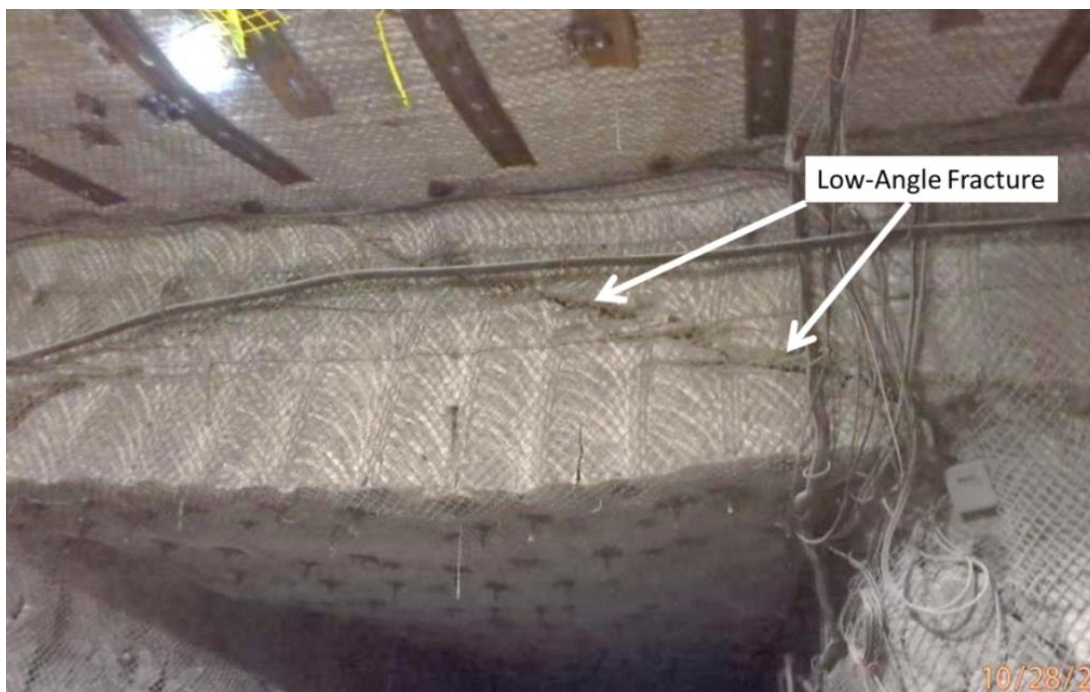
FIGURE 4.—Photograph showing a low-angle fracture exposed in a roof brow.

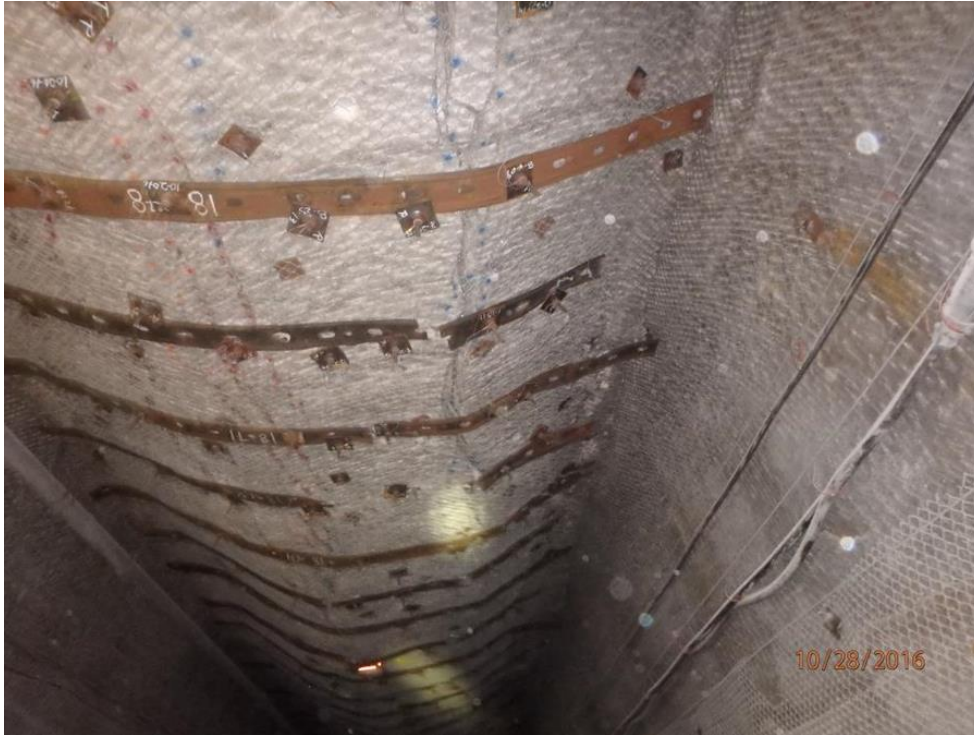
FIGURE 5.—Severe roof bellying in a WIPP drift supported by long tendons, short bolts, straps, and mesh.

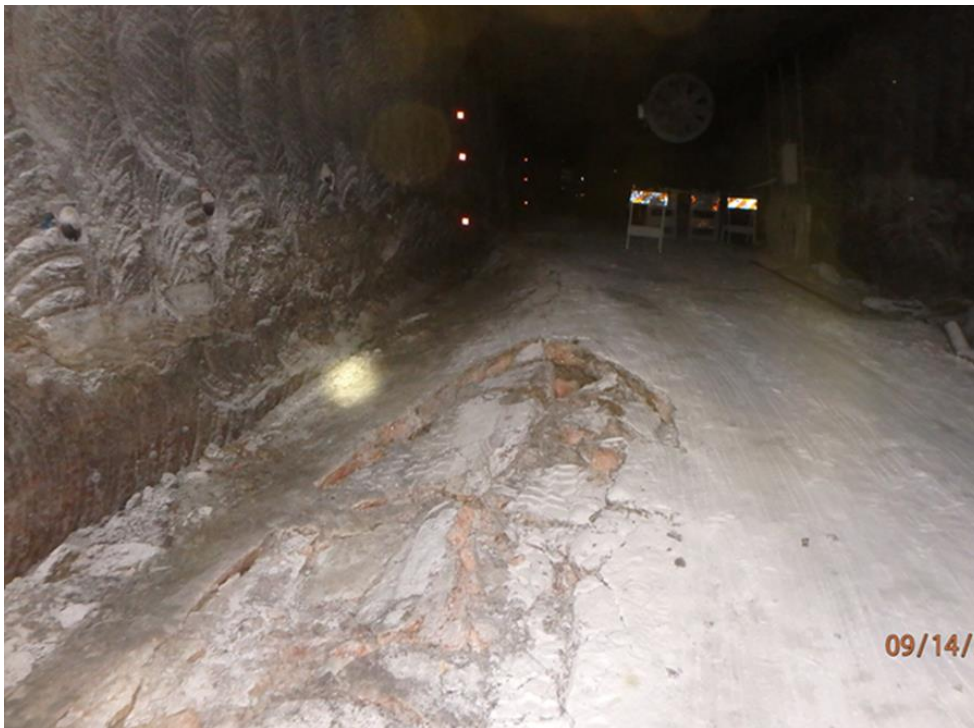
Floor heave, which has more impact on equipment travel than it does on safety, can follow a process that is analogous to roof failure (Figure 6). A floor beam can develop with extensive uplift into the opening. Pillar creep can also cause extensive fracturing in the ribs (Figure 7).

FIGURE 6.—Floor heave in WIPP drift.

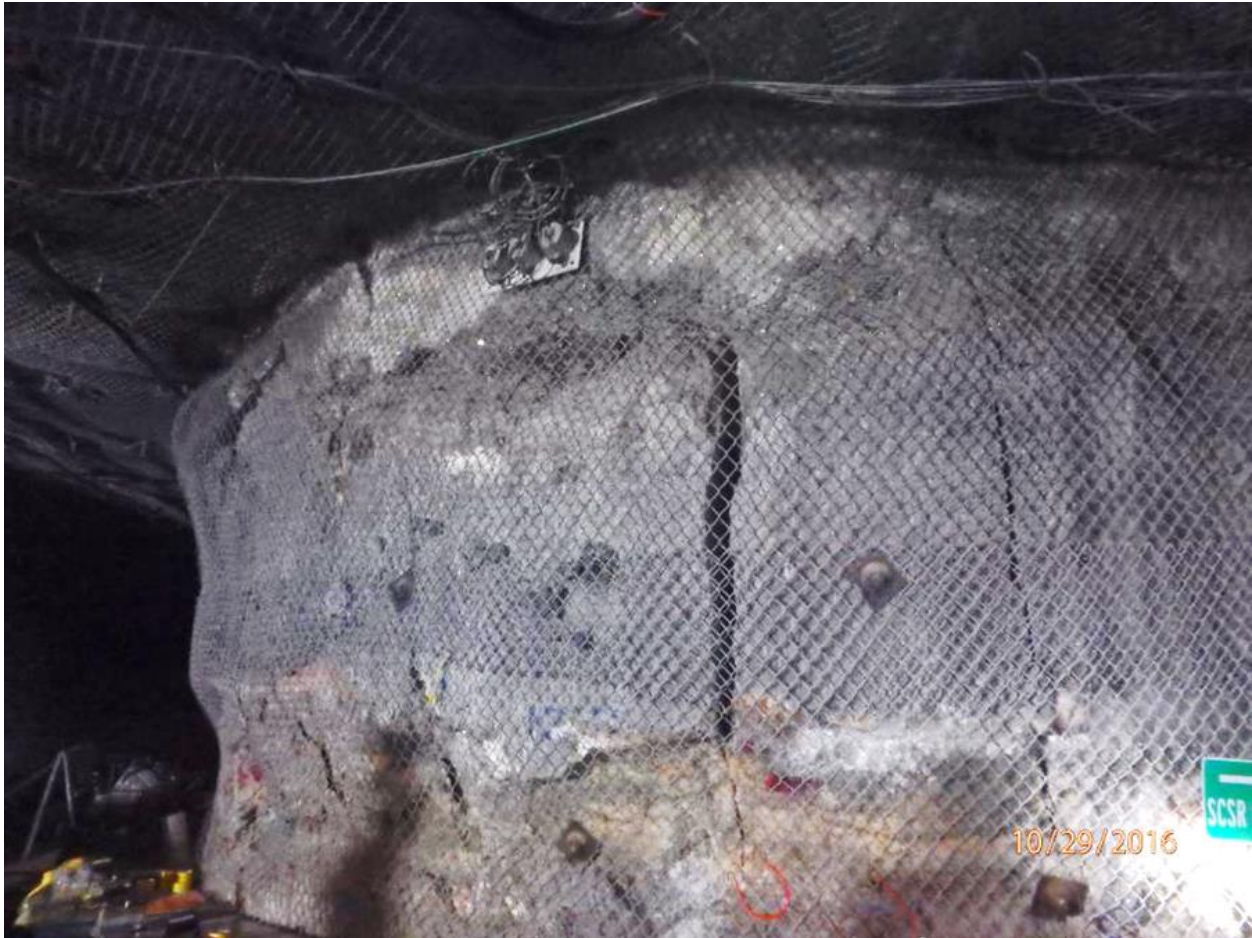
FIGURE 7.—Rib fractures contained by short bolts and mesh.

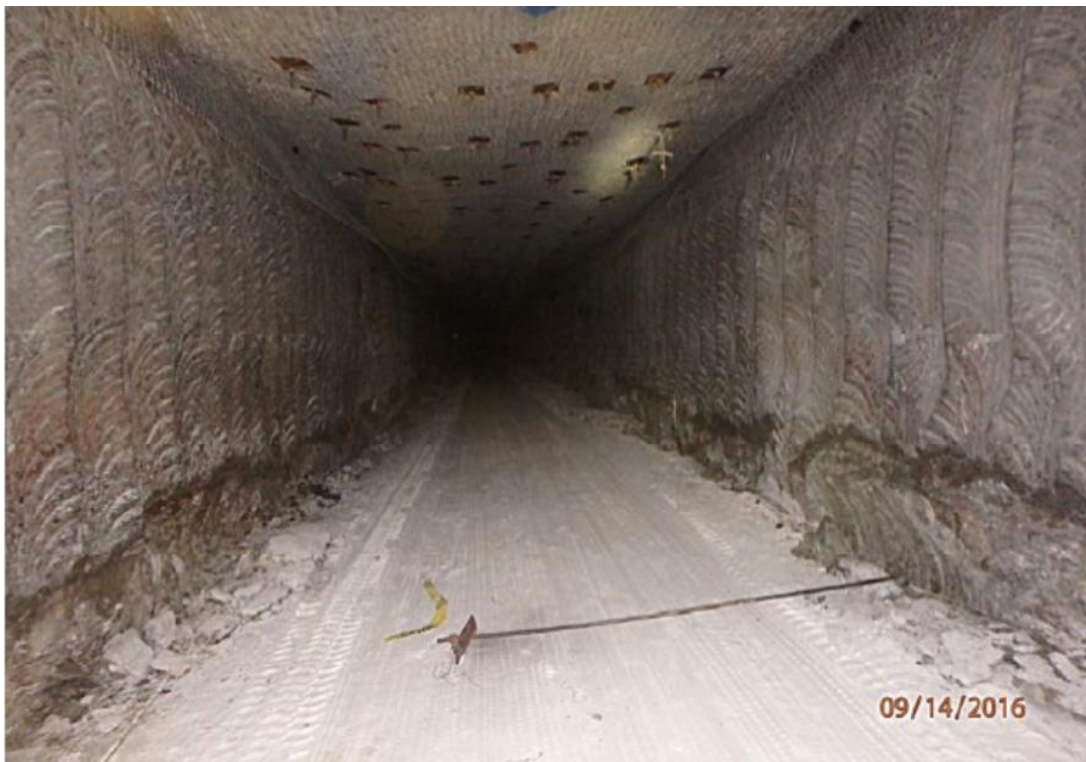
As ground control maintenance operations fell behind, roof conditions deteriorated throughout the facility. MSHA resumed regular inspections of WIPP in September 2014 and ground conditions have been cited 34 times since then.⁴ Six of these citations have addressed hazardous roof conditions, and three more addressed rib conditions. The other 25 citations have been for broken, hanging, and unsecured roof bolts and plates that could fall and injure personnel (see Figure 9). In the past, a man lift was routinely used to secure bolts and remove broken ones, but the recent ventilation restrictions have reportedly precluded its use.

FIGURE 9.—A broken roof bolt that has fallen to floor.
