U.S. Department of Energy  
Carlsbad Field Office  
Waste Isolation Pilot Plant  
P.O. Box 3090  
Carlsbad, New Mexico 88221

## WIPP UPDATE: January 21, 2015 Roof Separation Highlights Bolting Priority

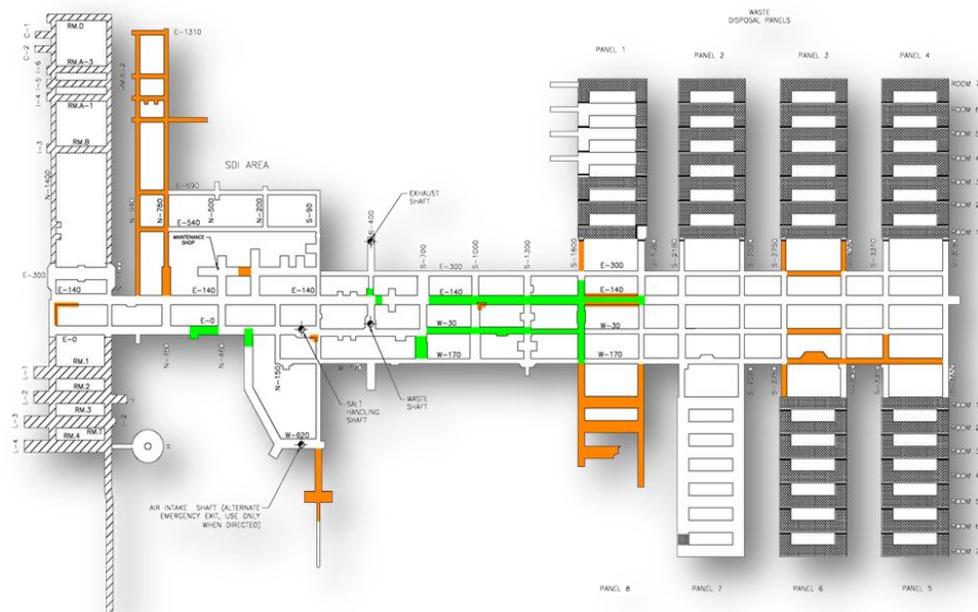
Roof bolting resumed in mid-November of 2014, and ground control engineers have indicated that the area where the roof fall occurred can be re-bolted and recovered. The map to the right identifies the areas where progress has been made to catch up on the backlog of ground control and maintenance activities, as well as areas where access is restricted until bolting activities can be completed.

Access restricted areas needing ground control

Performed bolting activities
