Department of Energy  
Carlsbad Area Office  
P. O. Box 3090  
Carlsbad, New Mexico 88221

[PLANS TO RAISE THE REPOSITORY HORIZON] Aug 2/6/04

# **Investigation of the Advantages of Removing Highly Fractured Roof Beams**

**Waste Isolation Pilot Plant**

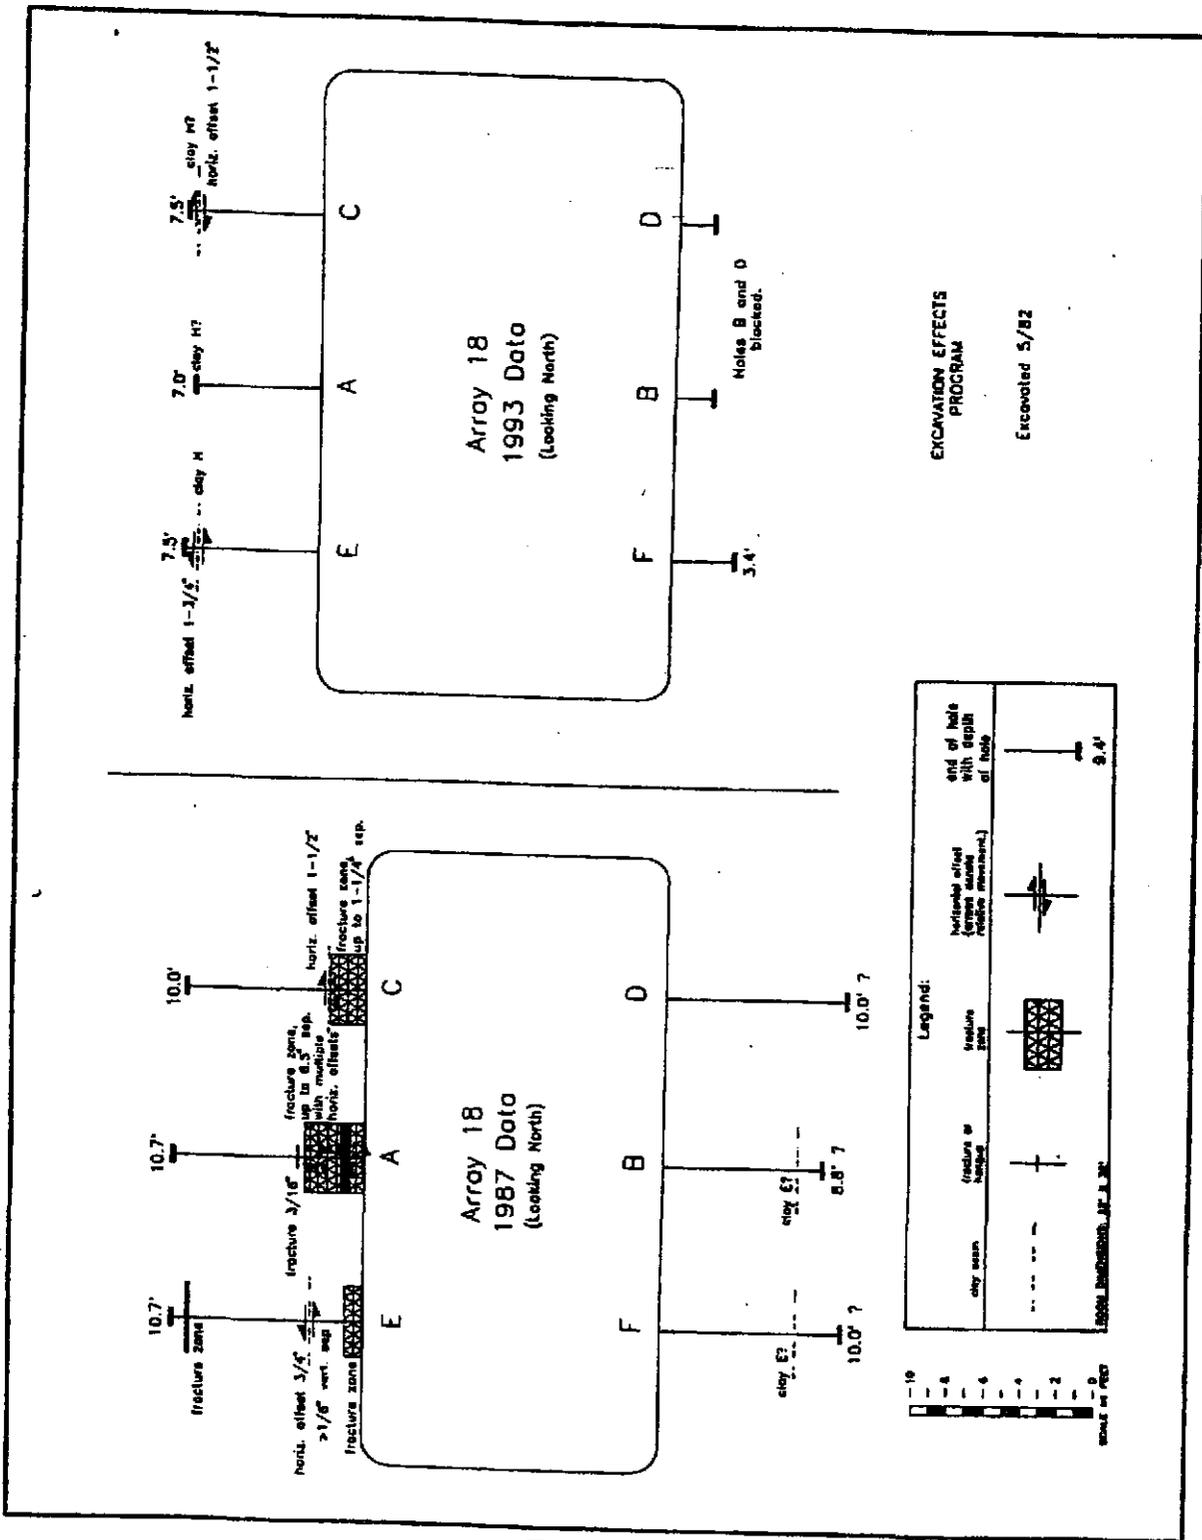
**Figure 7**  
**Salt Shaft Station Fracturing Comparison - 24 Feet South of Shaft**

Since the roof beam was removed in the Salt Station, large scale fracturing has not redeveloped. Figures 7 and 8 show fracturing in the roof in May 1987 before roof beam removal and six years after the roof was removed. There are far

fewer fractures with much smaller openings even six years after the roof was removed than there were before the roof was removed. Removing the roof beam has improved the condition (in terms of fracturing) of the Salt Shaft Station roof.

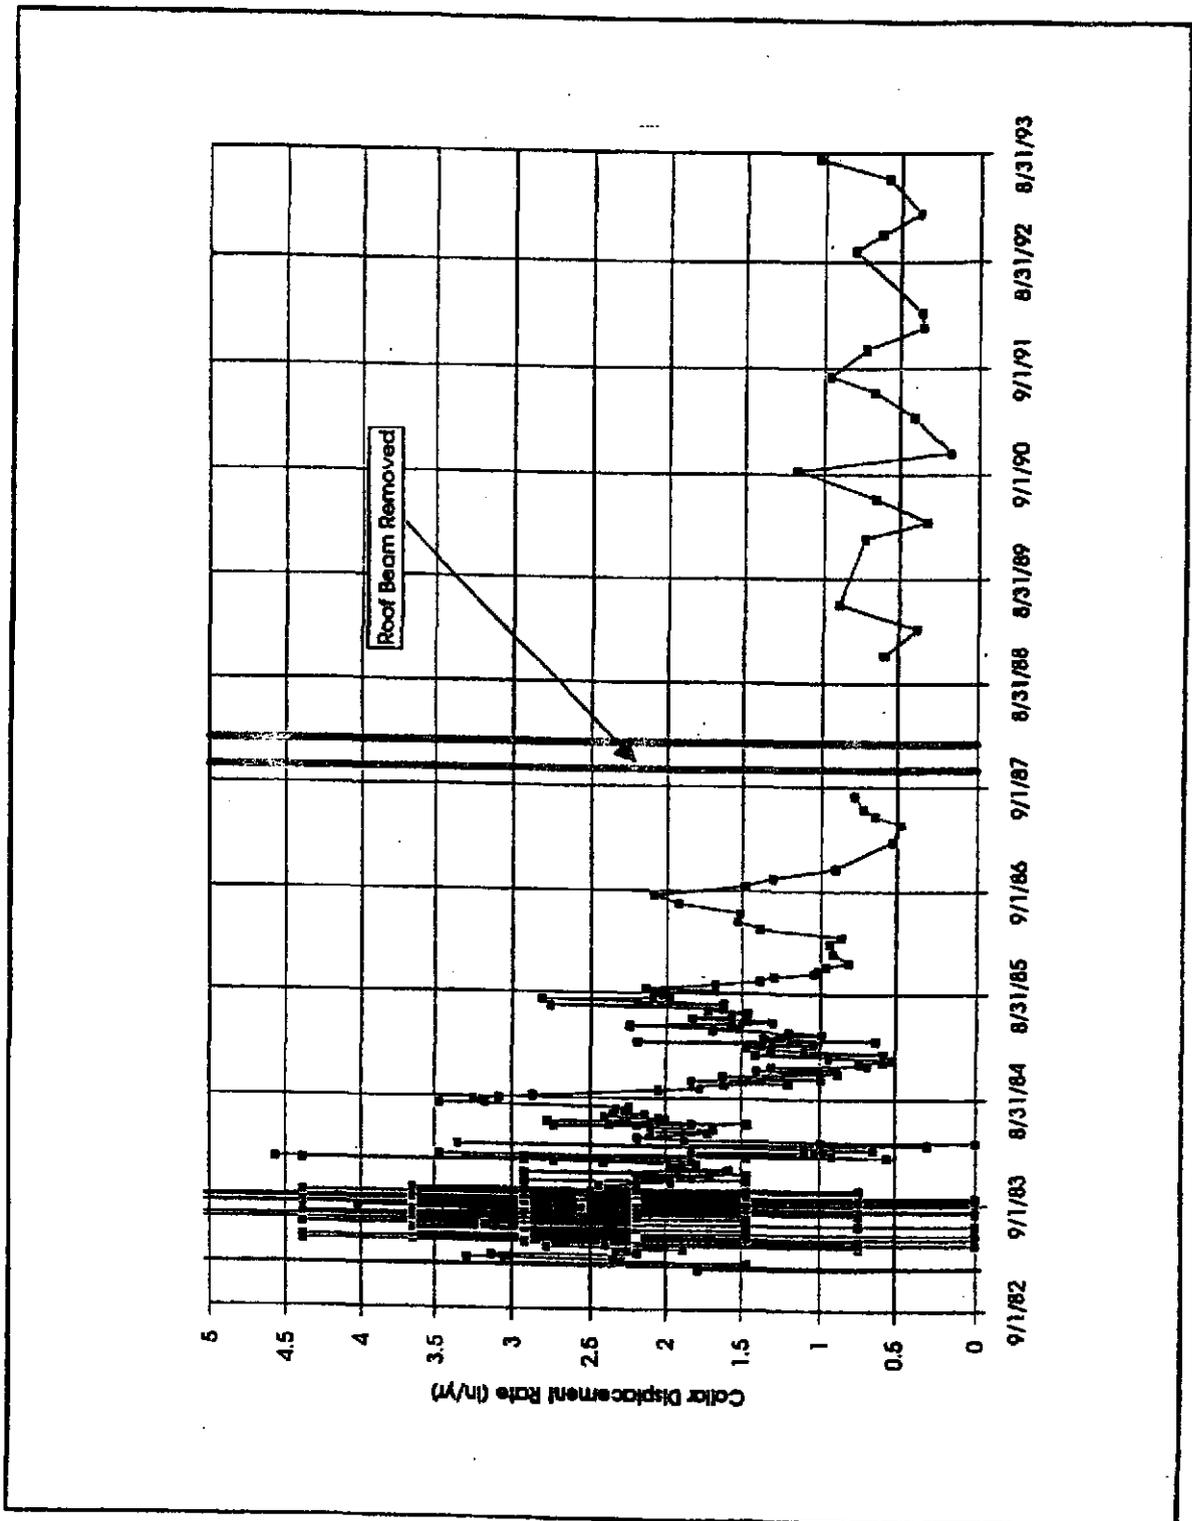
**Figure 10**  
**Salt Handling Shaft Station E0/S30 Roof Extensometer**

Geomechanical instrumentation in the Salt Station also indicate that the roof is much more stable since the roof beam was removed. Figure 9 shows the roof displacement rate in the station 65 feet south of the shaft. This extensometer is located in the thickest part of the station roof where the roof was about seven feet below Clay G. Displacement rates after the roof was removed are about 25 percent of the earlier rates. This indicates that the new roof is considerably more stable since the old roof was removed. Figure 10 shows the roof displacement rate in the station 30 feet south of the shaft. The old roof beam here was only three to four feet thick. The reduction in displacement rate after the beam was removed is not as obvious for the thin roof beam. Recalling that the roof was both highly fractured and extensively rockbolted, this is probably due to the ground support and the weight of the beam. Once the roof became highly fractured, the thinner beam would be subject to less dead weight load. The smaller dead weight load would be more easily supported by the rockbolts. The lighter slab would also be less likely to form additional fractures due to its own weight. The thicker slab would be heavy enough to continue fracturing and would be harder to support with the rockbolts. Once the fractured roof was removed, excessive displacement due to fracturing no longer occurred. Thus the reduction in displacement and closure rates.

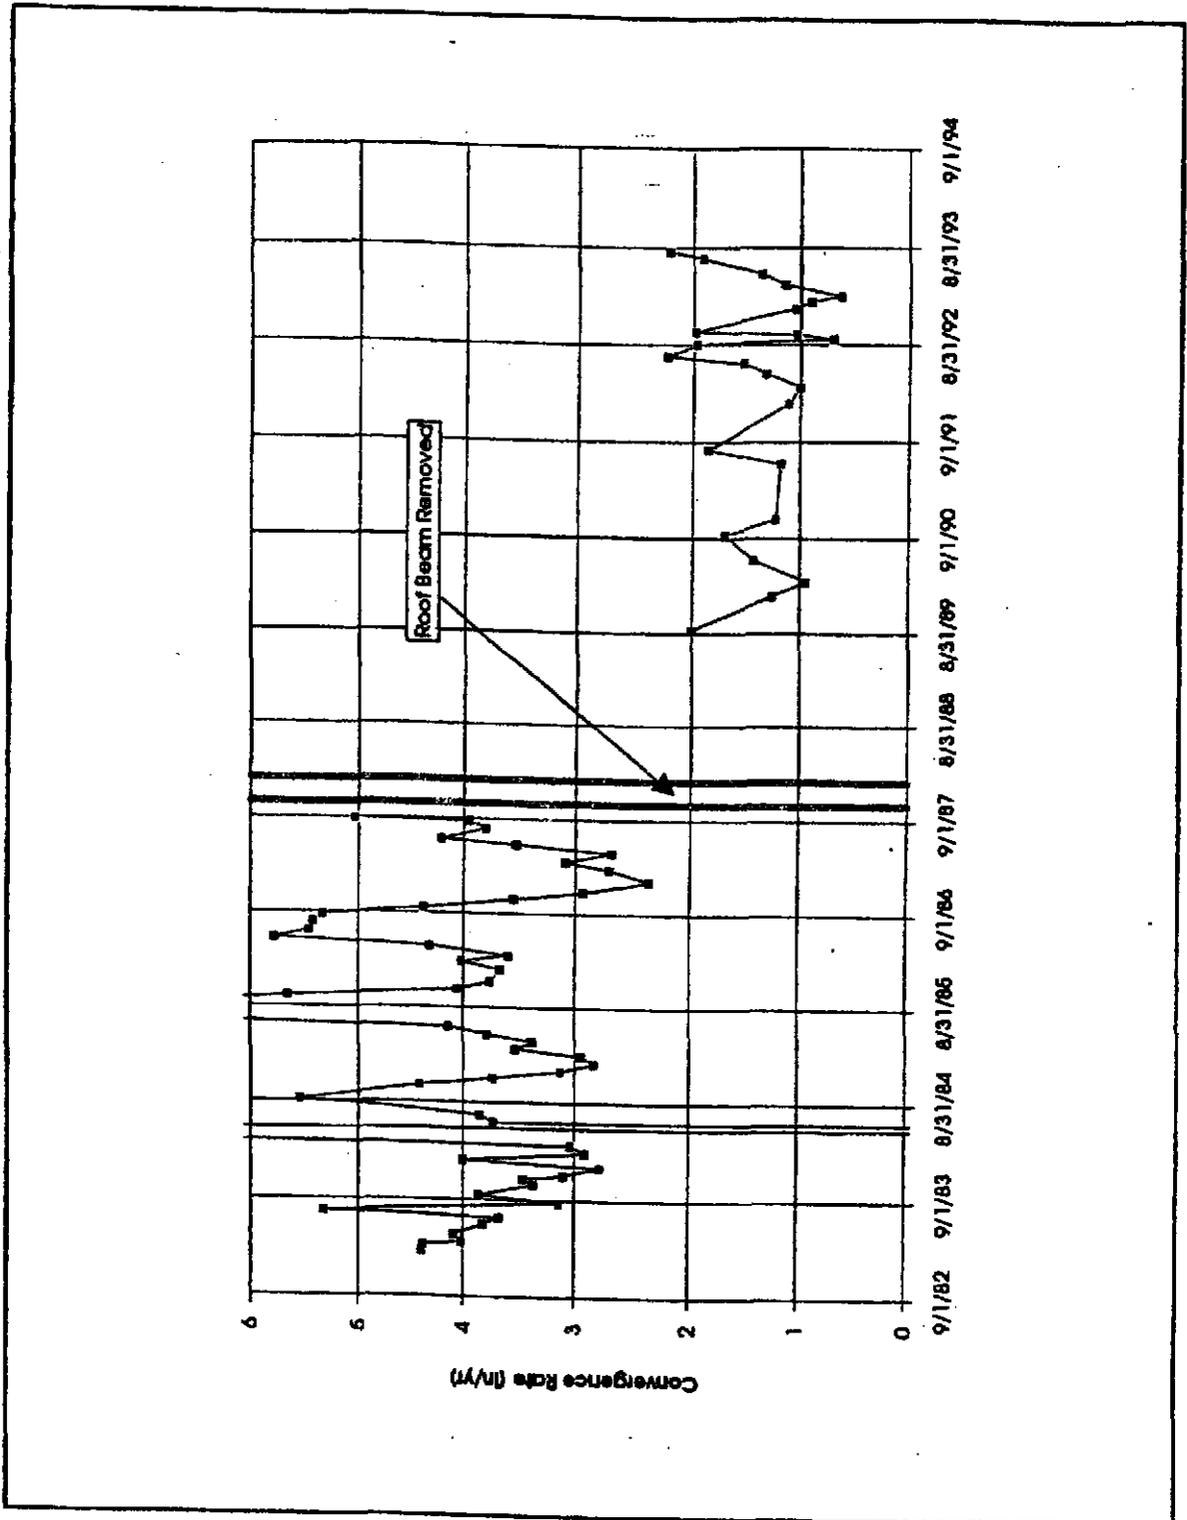
**Figure 11**  
**Salt Handling Shaft Station E0/S65 Vertical Convergence**

Roof to floor convergence measurements at S65 show similar results (Figure 11). After roof beam removal, convergence rates dropped to about 33 percent of the earlier rates. Again, the convergence points under the thinner section of the roof did not show such dramatic drops. Horizontal convergence rates remained about the same for all stations before and after roof beam removal.

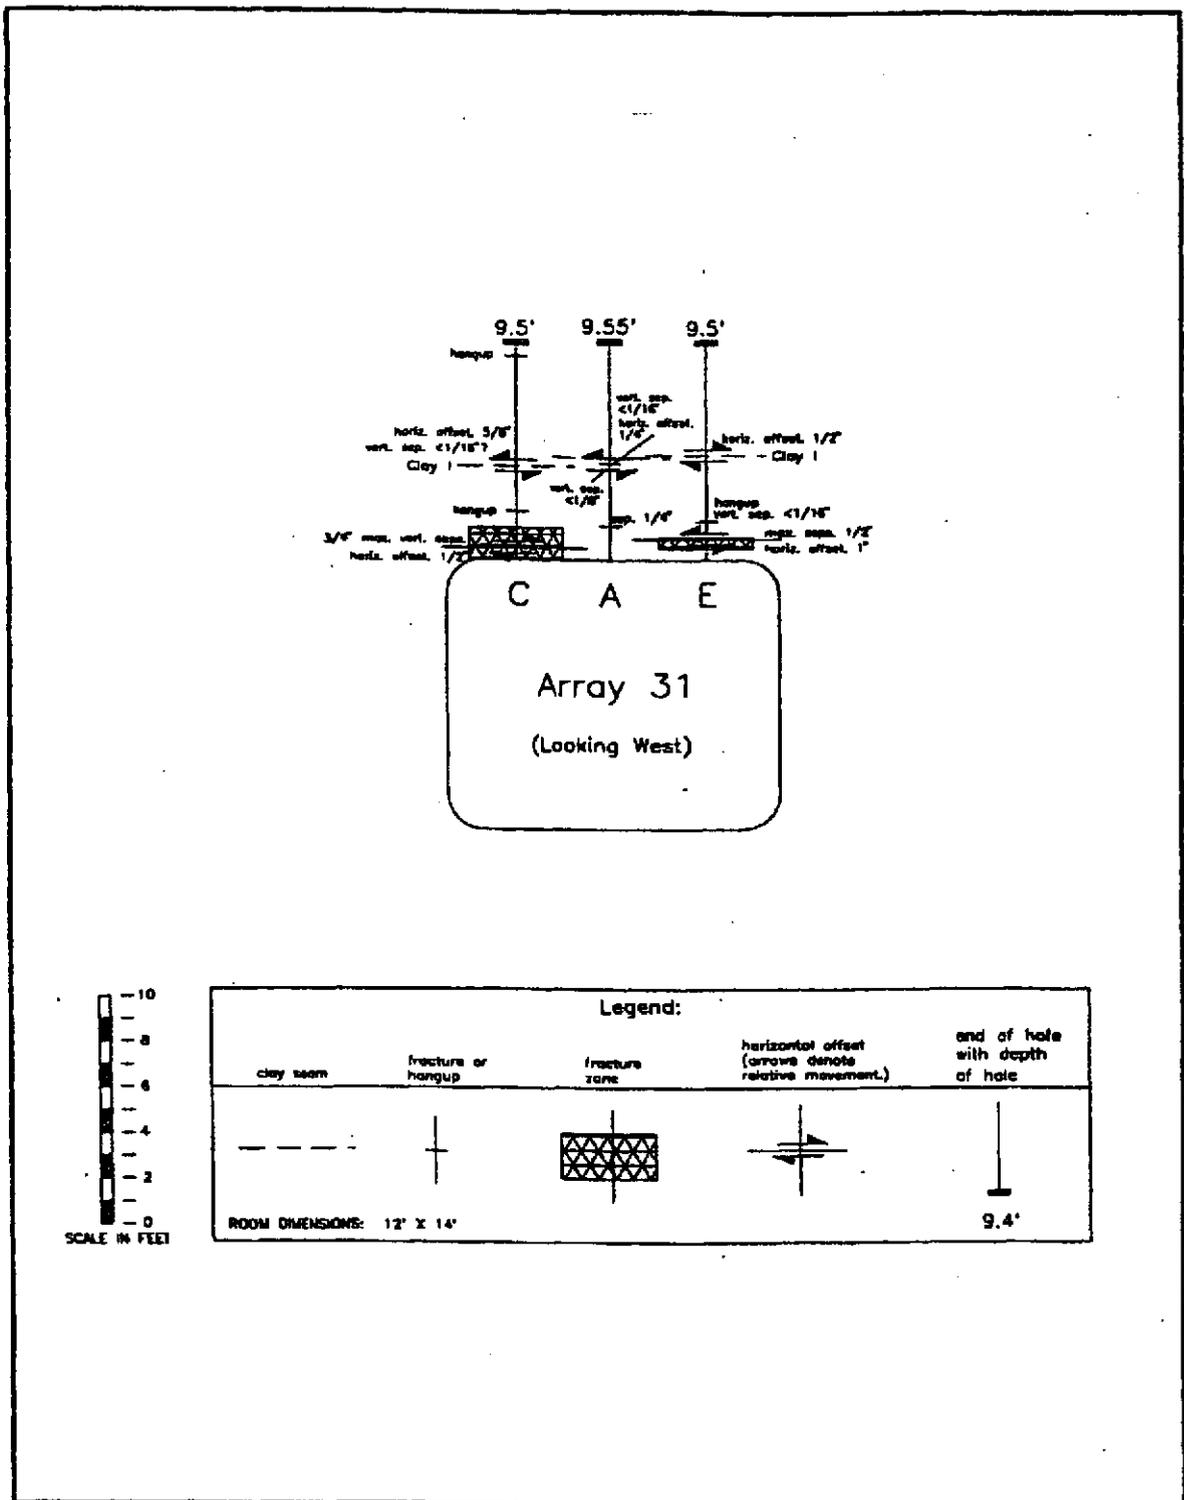
**Figure 13**  
**Fracture Data - N1420/E1375**

Roof fracturing is relatively intense in the N1420 drift, which has a five foot thick roof beam and no floor beam. Large scale diagonal fractures have developed along with vertical cracks in the roof (Figure 13). The N1100 drift, which has no roof or floor beam, has very little fracturing (Figure 14). It is clear from the fracture observations that of these two drifts of nearly the same age and size, the N1100 drift, with no roof beam, is in much better condition than the N1420 drift with a roof beam and no floor beam.

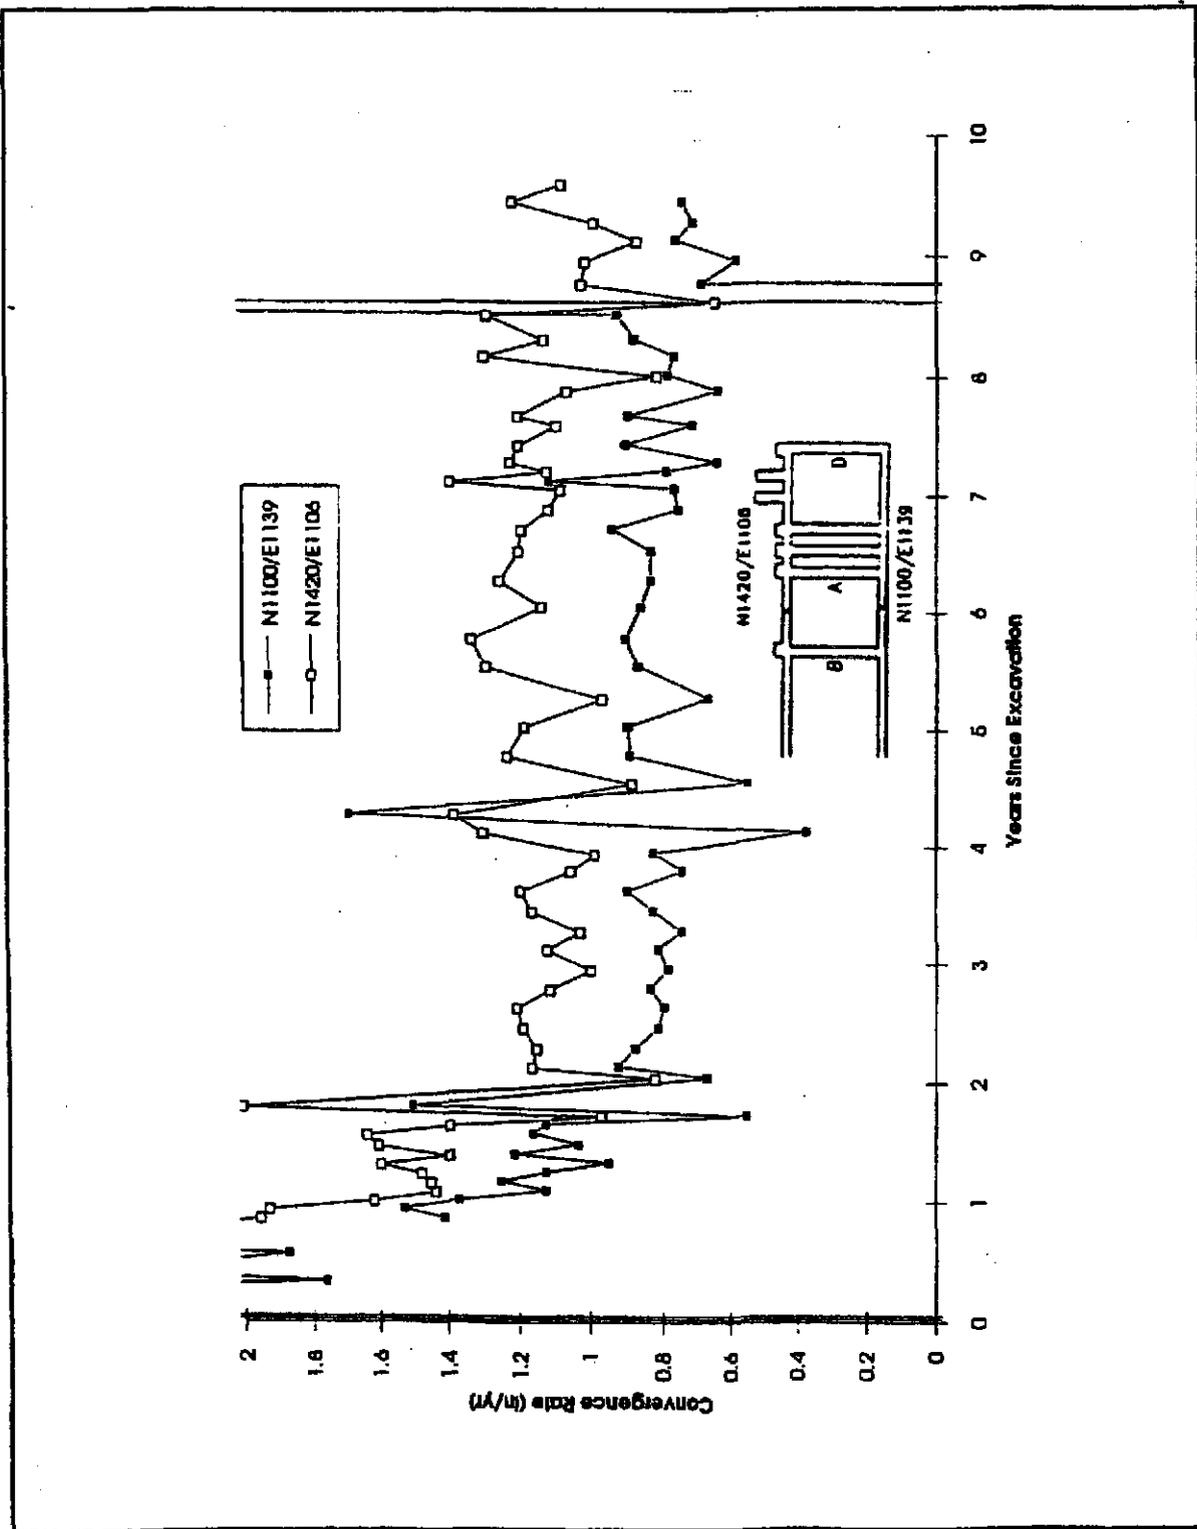
**Figure 15**  
**N1100 and N1420 Drifts Comparison Vertical Convergence**

The only instrumentation in the N1100 and N1420 drifts are vertical and horizontal convergence gauges. Vertical convergence rates in the N1420 drift between Room B and Room A2 are about 150% of the rates in N1100 (Figure 15) at the same relative location. The difference is probably due to bending and breakup of the roof beam in N1420. Horizontal rates are only slightly higher in the N1420 drift, indicating that the location of the clay seams at the roof and floor lines in N1100 does not cause high horizontal convergence rates (Figure 16).
