**Title 40 CFR Part 191  
Compliance Certification  
Application  
for the  
Waste Isolation Pilot Plant**

# Design Validation Report

WASTE ISOLATION PILOT PLANT

**DESIGN VALIDATION  
FINAL REPORT**

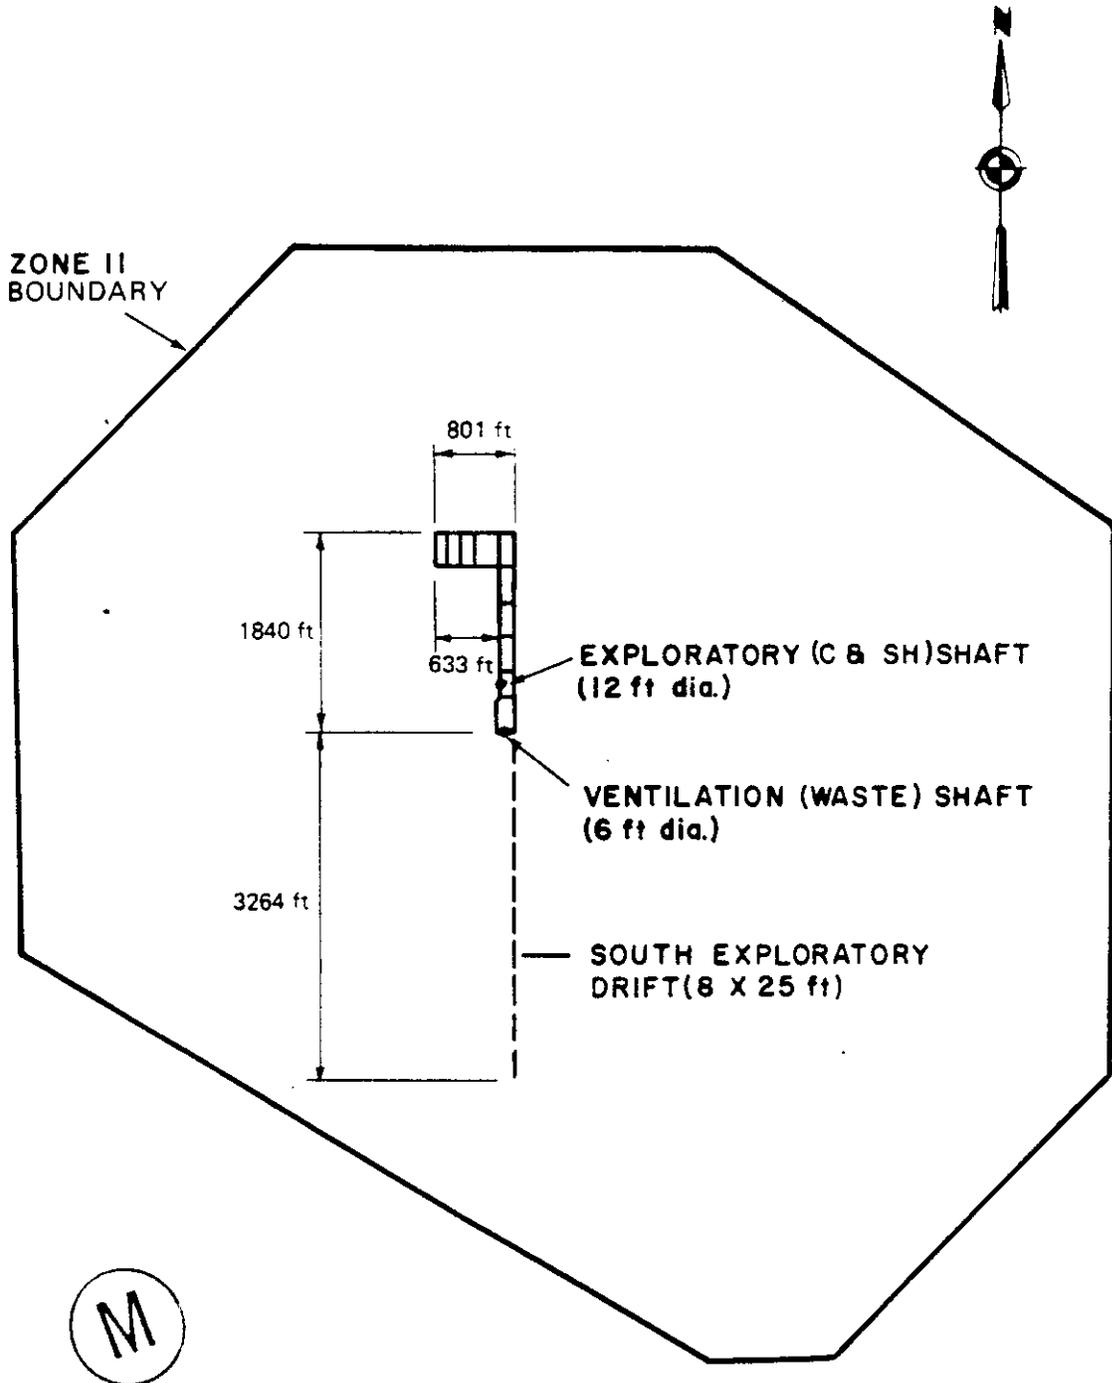
Figure 1-3

The general SPDV underground layout is shown on Figure 1-3. The underground development level is located in Zone II, a WIPP site control zone that delineates the limits of underground storage. A preliminary design validation report was issued on March 30, 1983. This report presented the results of early observations and analyses of the condition and behavior of the SPDV excavations and is discussed in Chapter 4.

THE SPDV UNDERGROUND LAYOUT

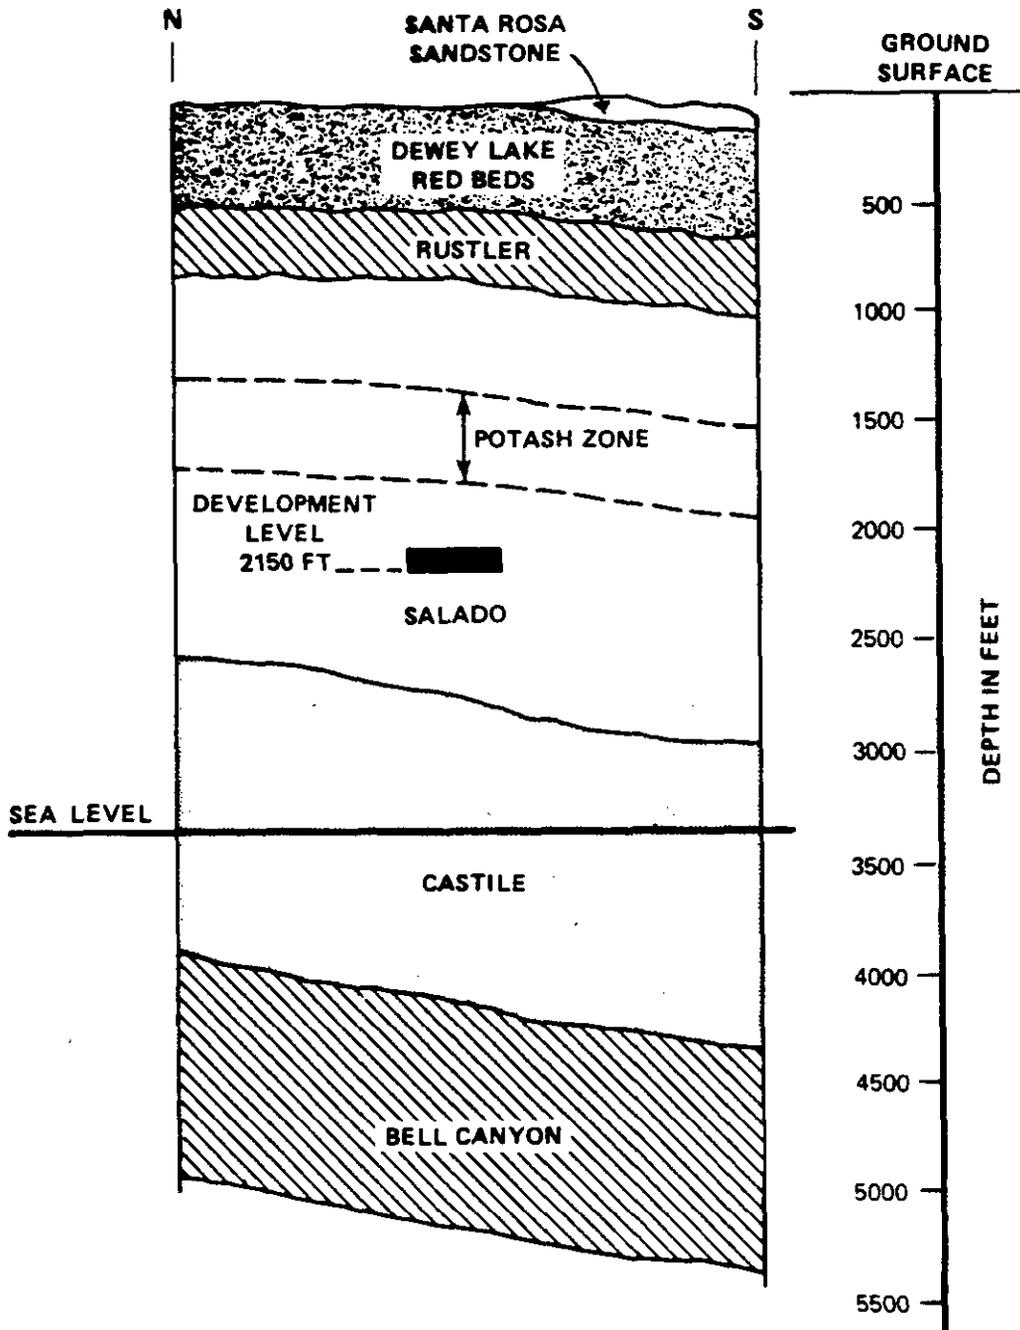
(M) The generalized stratigraphic relationship of the geologic formations of interest beneath the WIPP site is shown on Figure 2-1. Siltstone and fine-grained sandstone are the main rock types forming the Dewey Lake red beds. The Rustler formation, composed primarily of anhydrite and fine-grained sandstone, siltstone and mudstone, contains two water-bearing dolomite beds. Saline water is found in these beds, the Magenta and Culebra members, and at the contact between the Rustler and Salado formations. The Salado formation consists largely of halite containing thin beds of anhydrite and polyhalite with occasional thin clay seams. The Castile is a thick anhydrite and halite formation

Figure 2-1  
GENERAL SITE STRATIGRAPHY

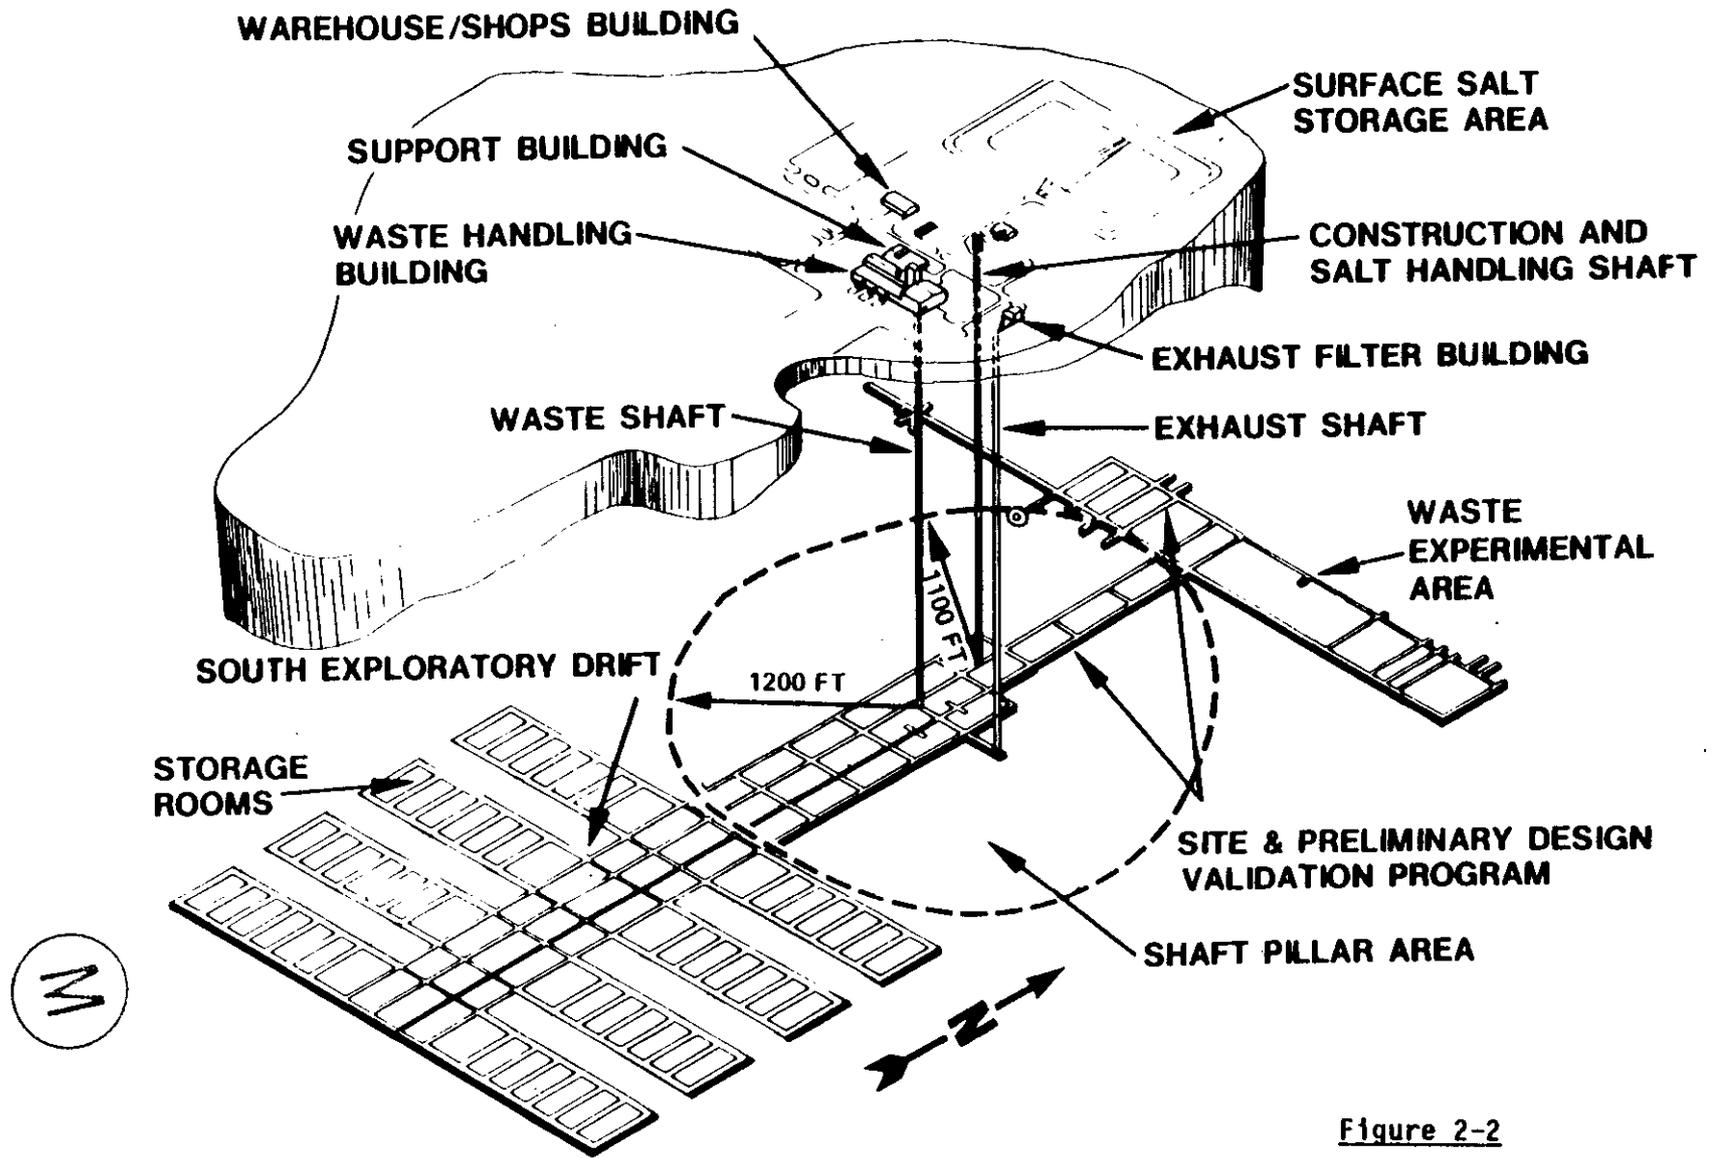
Figure 2-2

PERSPECTIVE VIEW OF THE WIPP

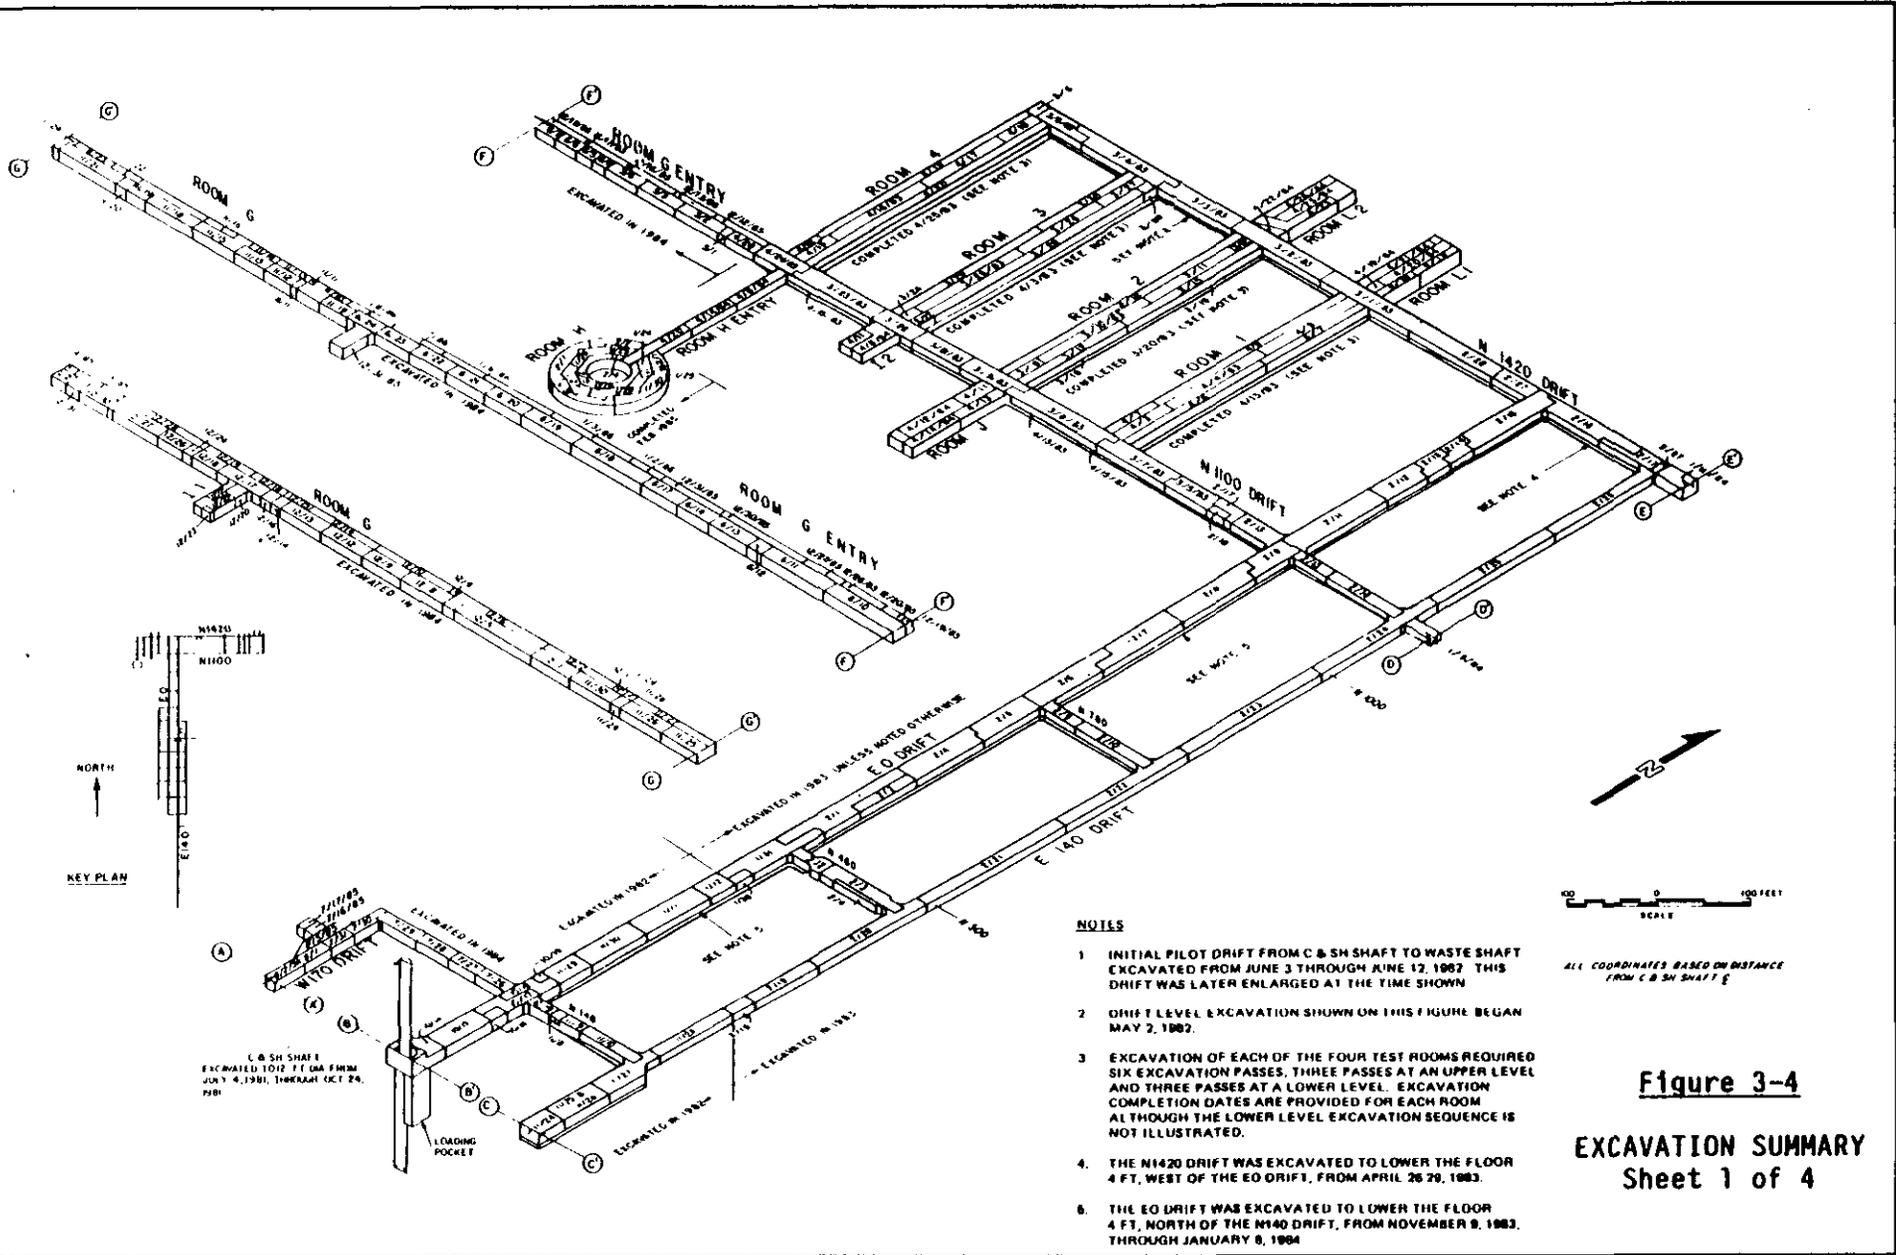
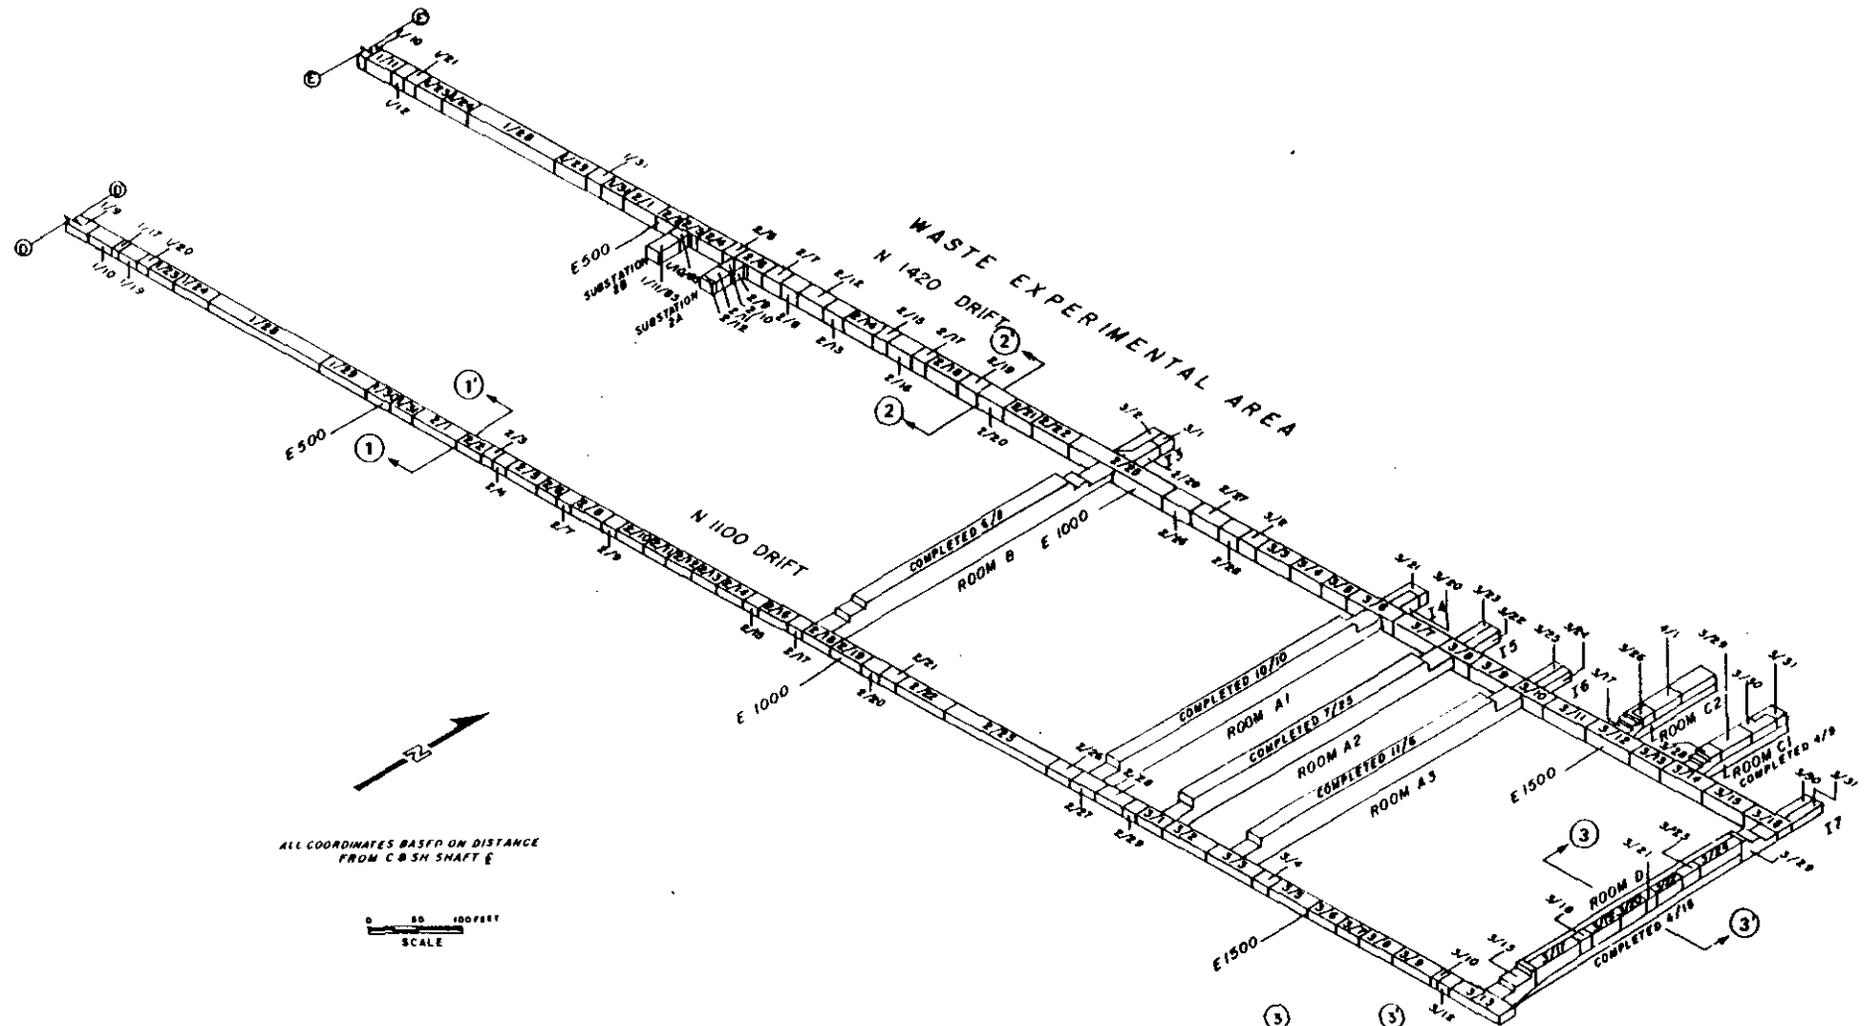
A summary of the excavation sequence for the underground horizontal openings is presented on Figure 3-4. This figure shows the mining progress on a daily basis from October 14, 1982, through March 31, 1986. The underground mining operation was performed in the same manner during both construction phases regardless of the type of mining machine being used. The rotating head on the boom of the mining machine cut the salt away from the working face. The "muck" was pulled through the machine on a conveyor and deposited in one of several types of haul vehicles. Typically, the haul vehicles were underground trucks capable of carrying about 5 tons of muck. Other vehicles used included LHDs (Load-Haul-Dump, a type of front-end loader) and a telescoping-bed haul truck. The trucks carried the muck to the C & SH shaft station

**Figure 3-4**  
**EXCAVATION SUMMARY**  
**Sheet 3 of 4**

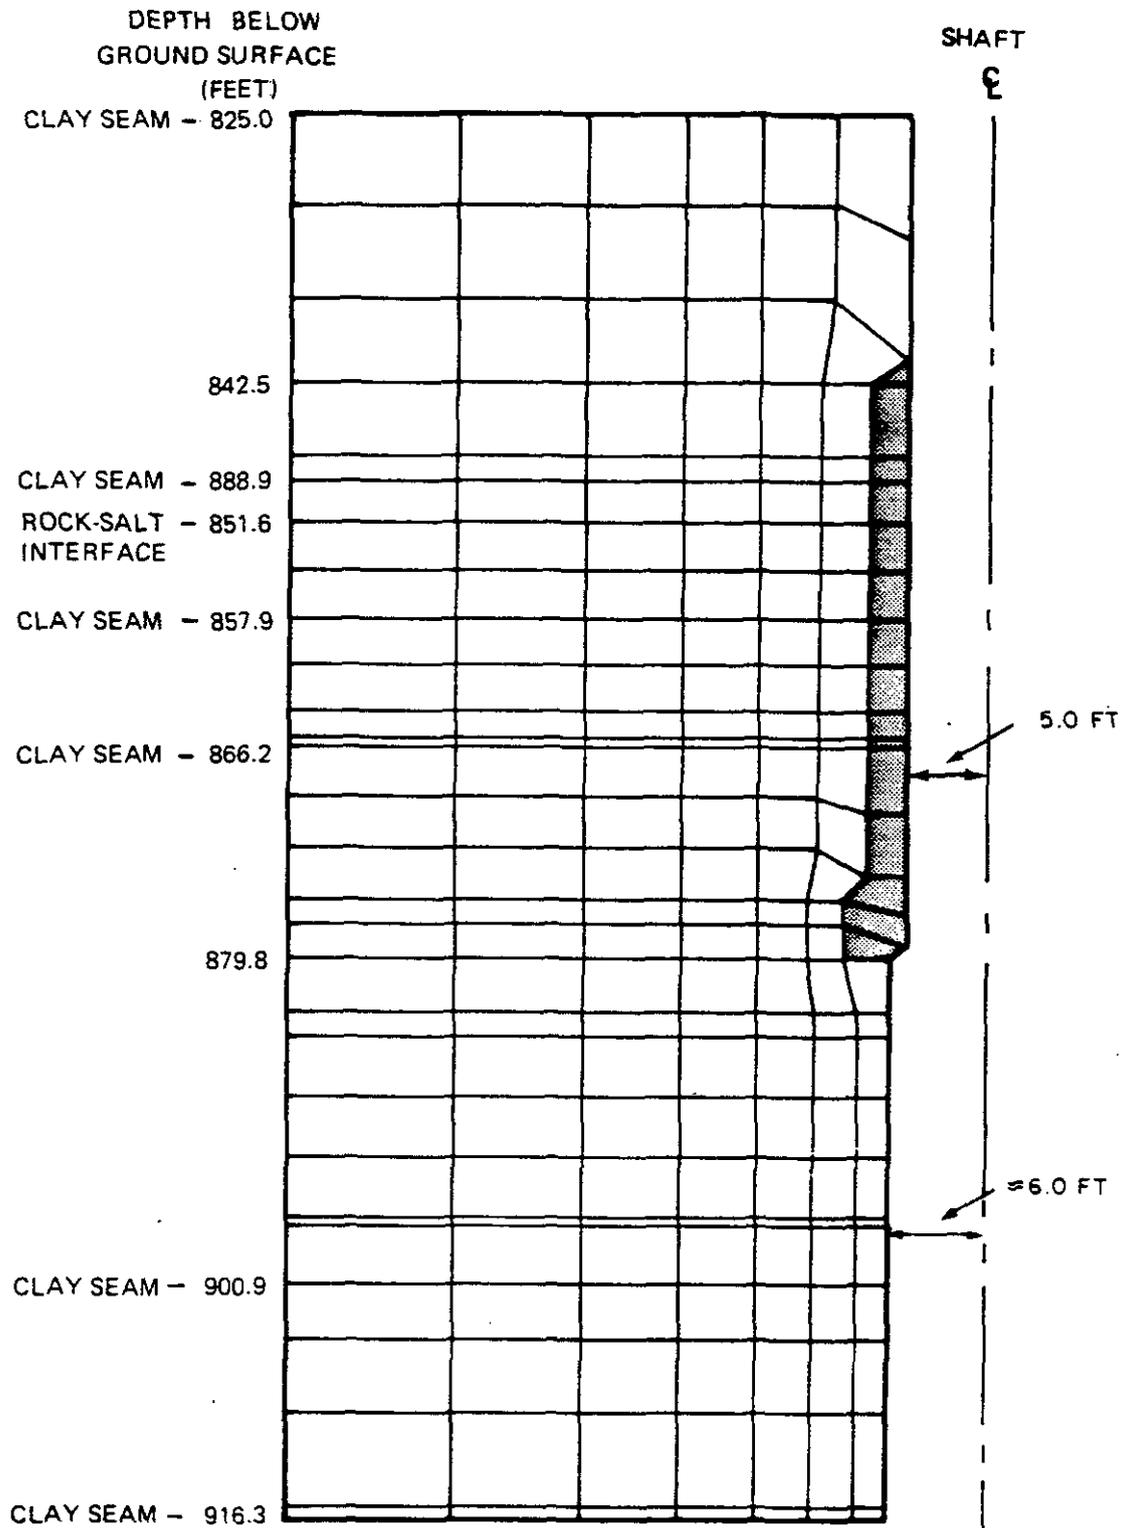
Figure 7-7

C & SH SHAFT KEY  
FINITE ELEMENT MODEL

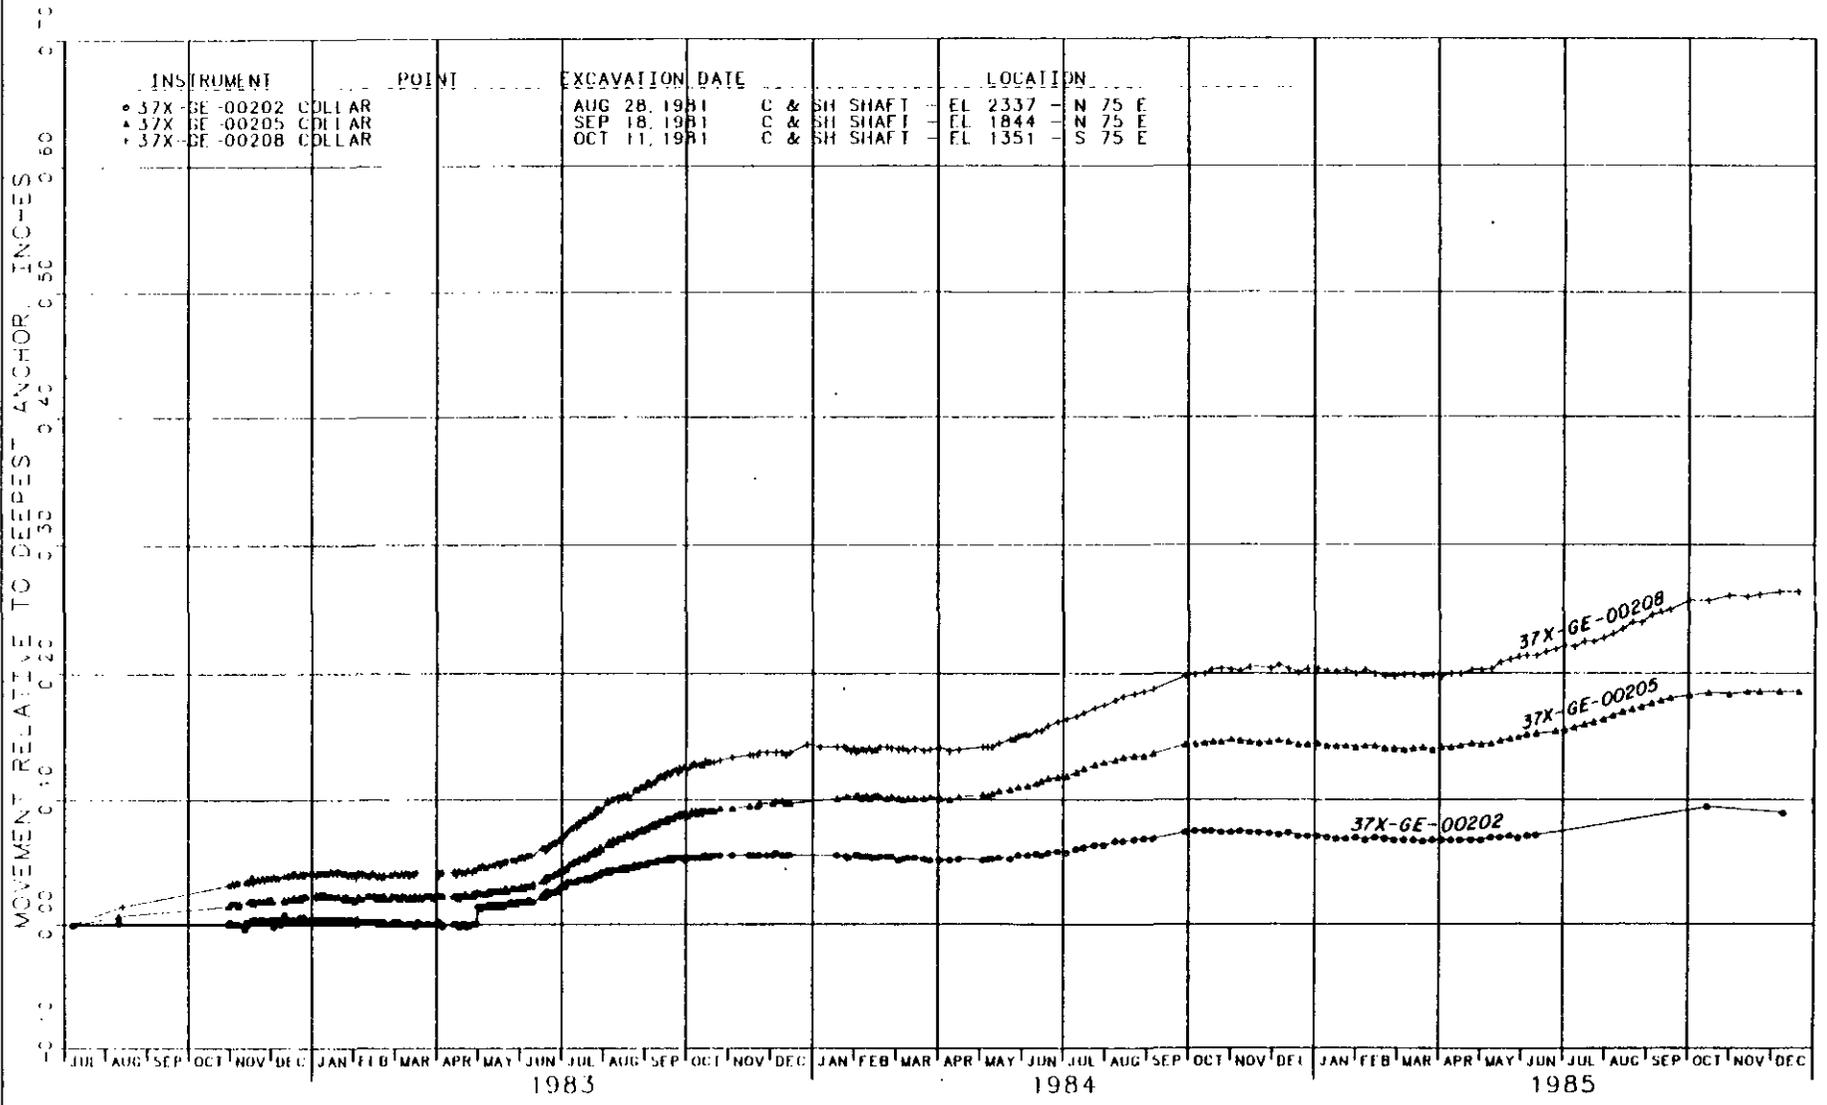
Figure 7-9

C & SH SHAFT UNLINED SECTION  
COLLAR MOVEMENT TIME HISTORY

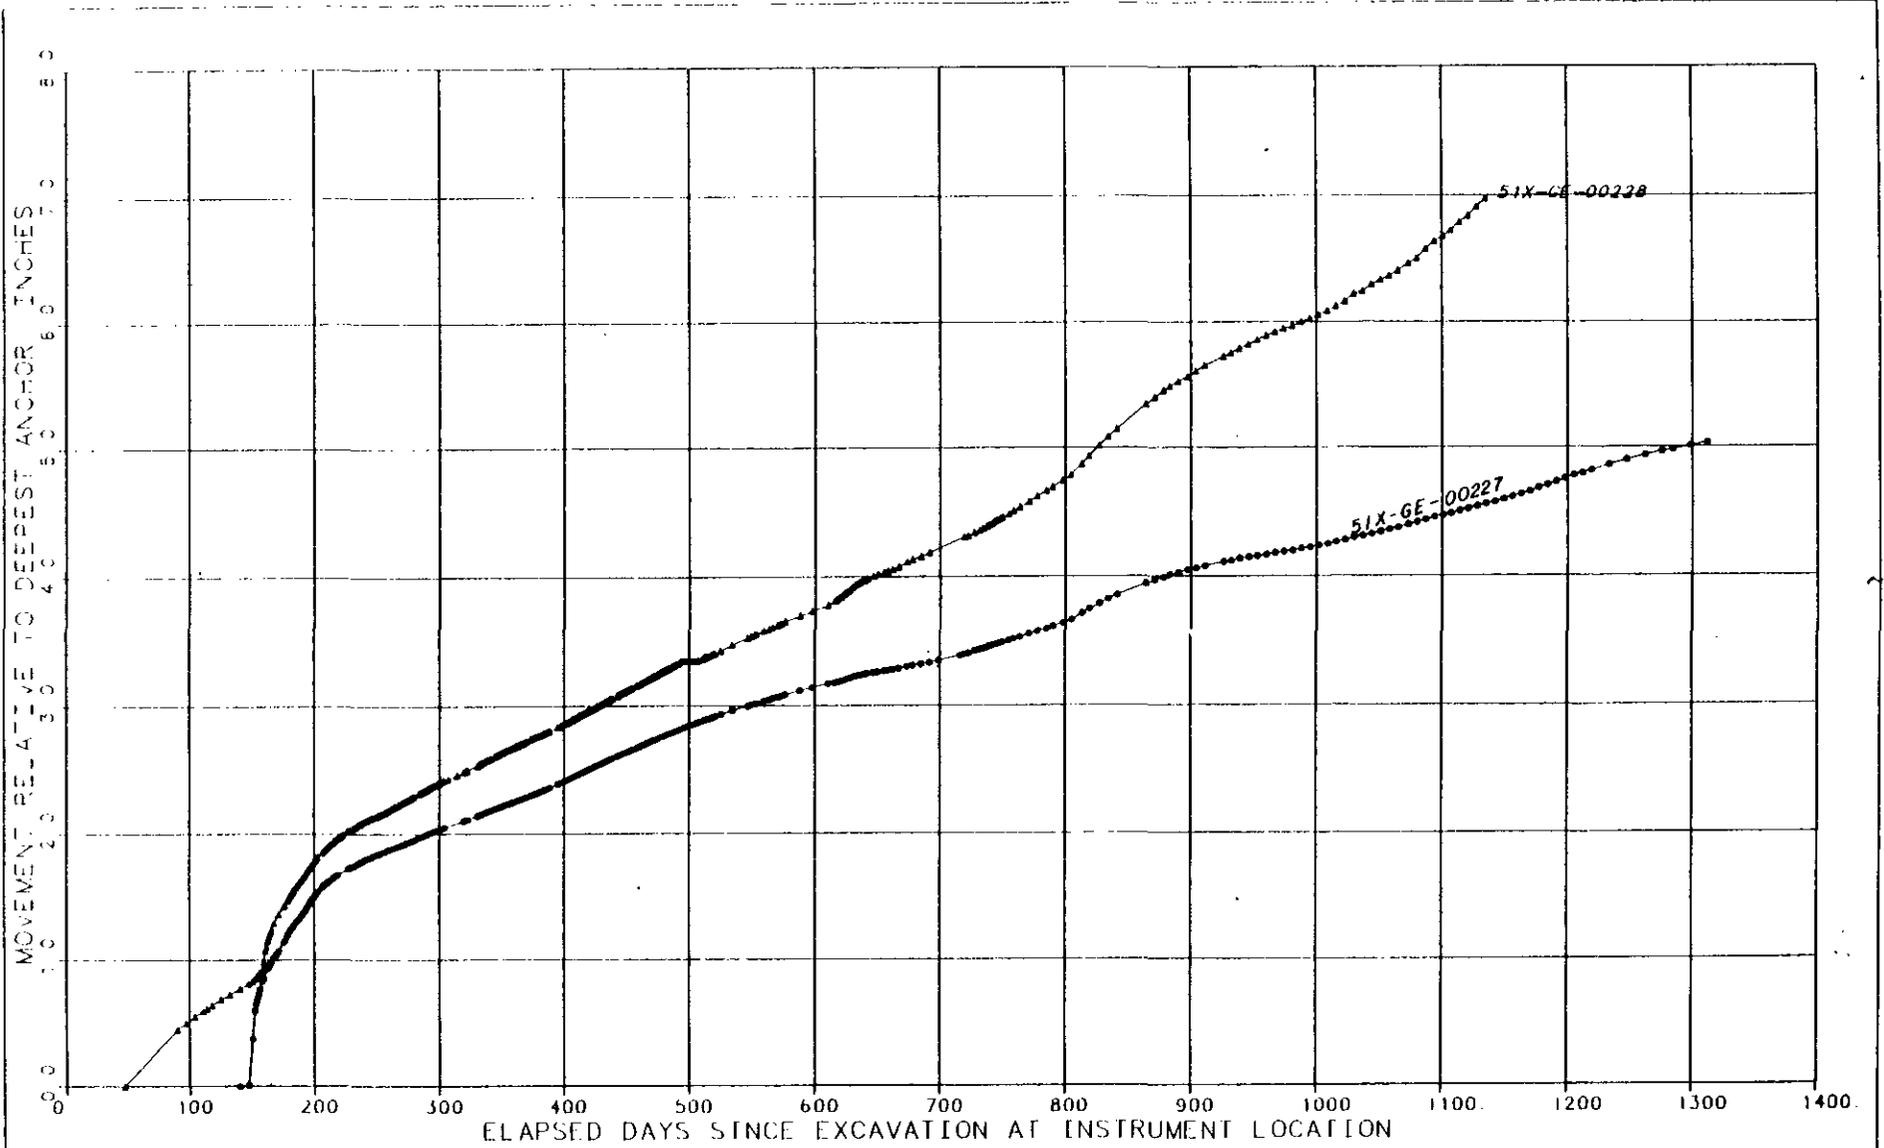
Figure 7-14

C & SH SHAFT STATION  
HISTORY OF COLLAR MOVEMENTS - ROOF EXTENSOMETERS

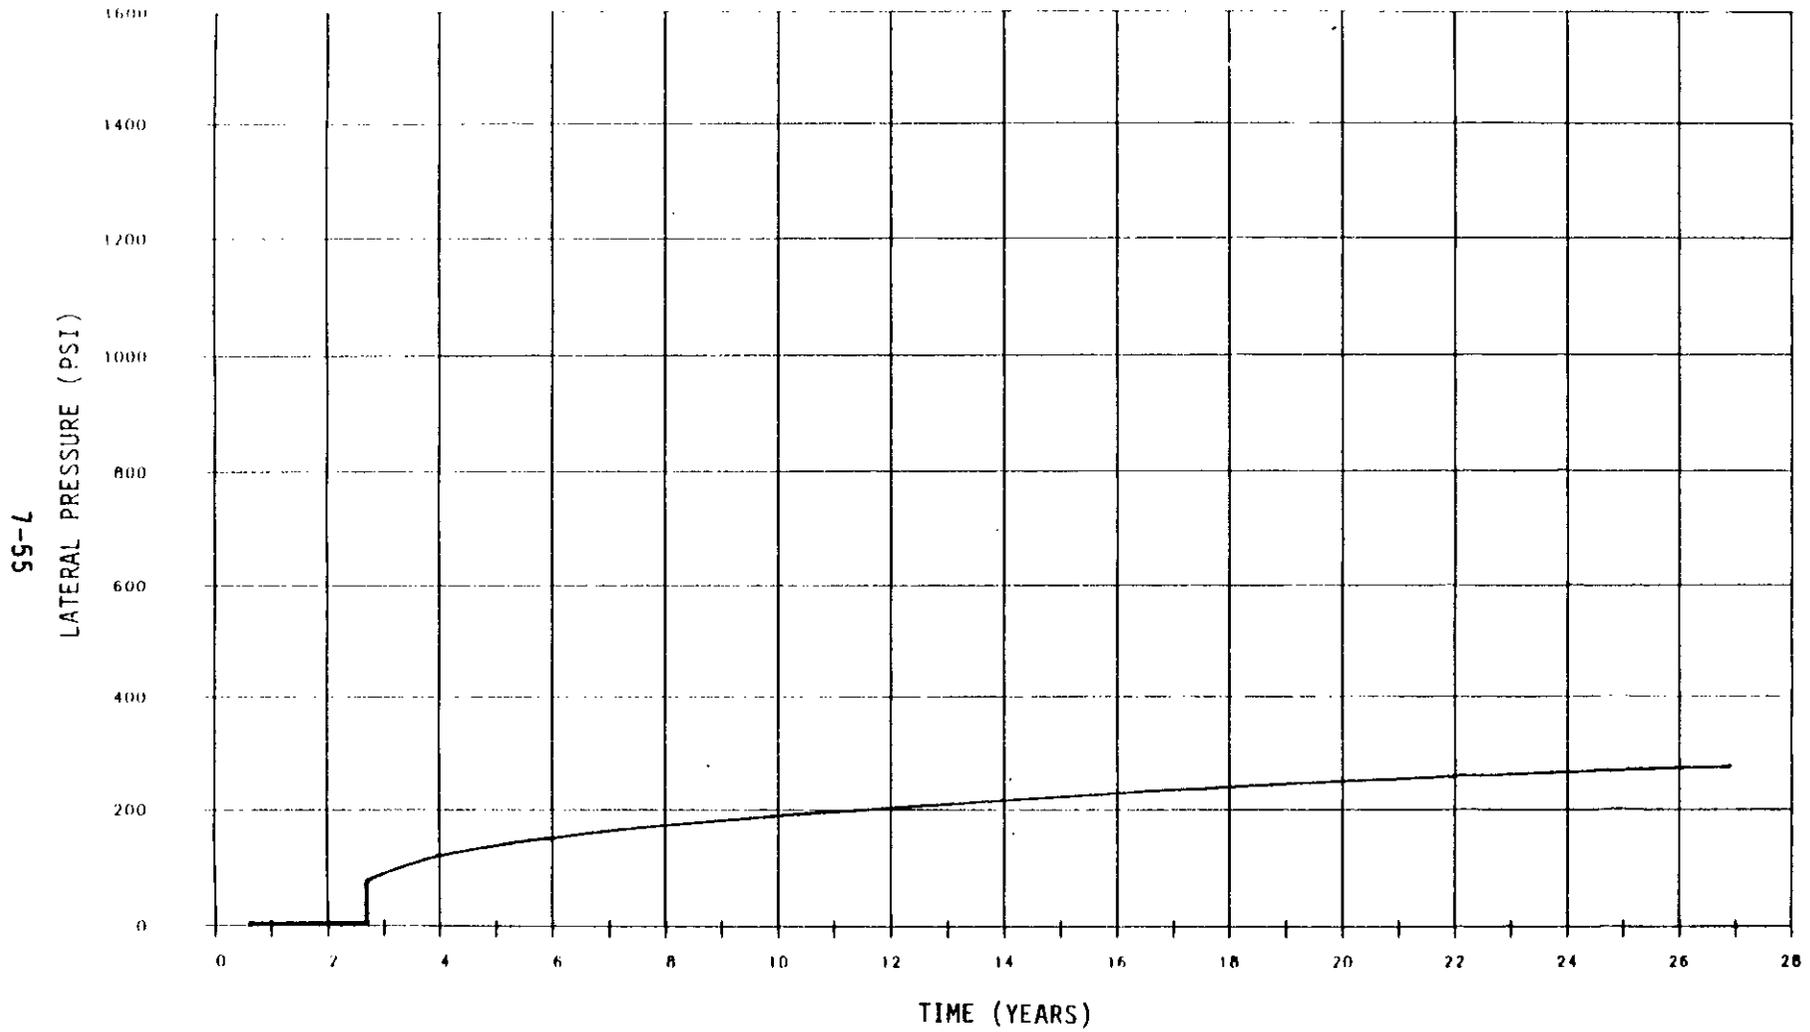
**Figure 7-20**

**C & SH SHAFT KEY  
LATERAL PRESSURE PREDICTION**

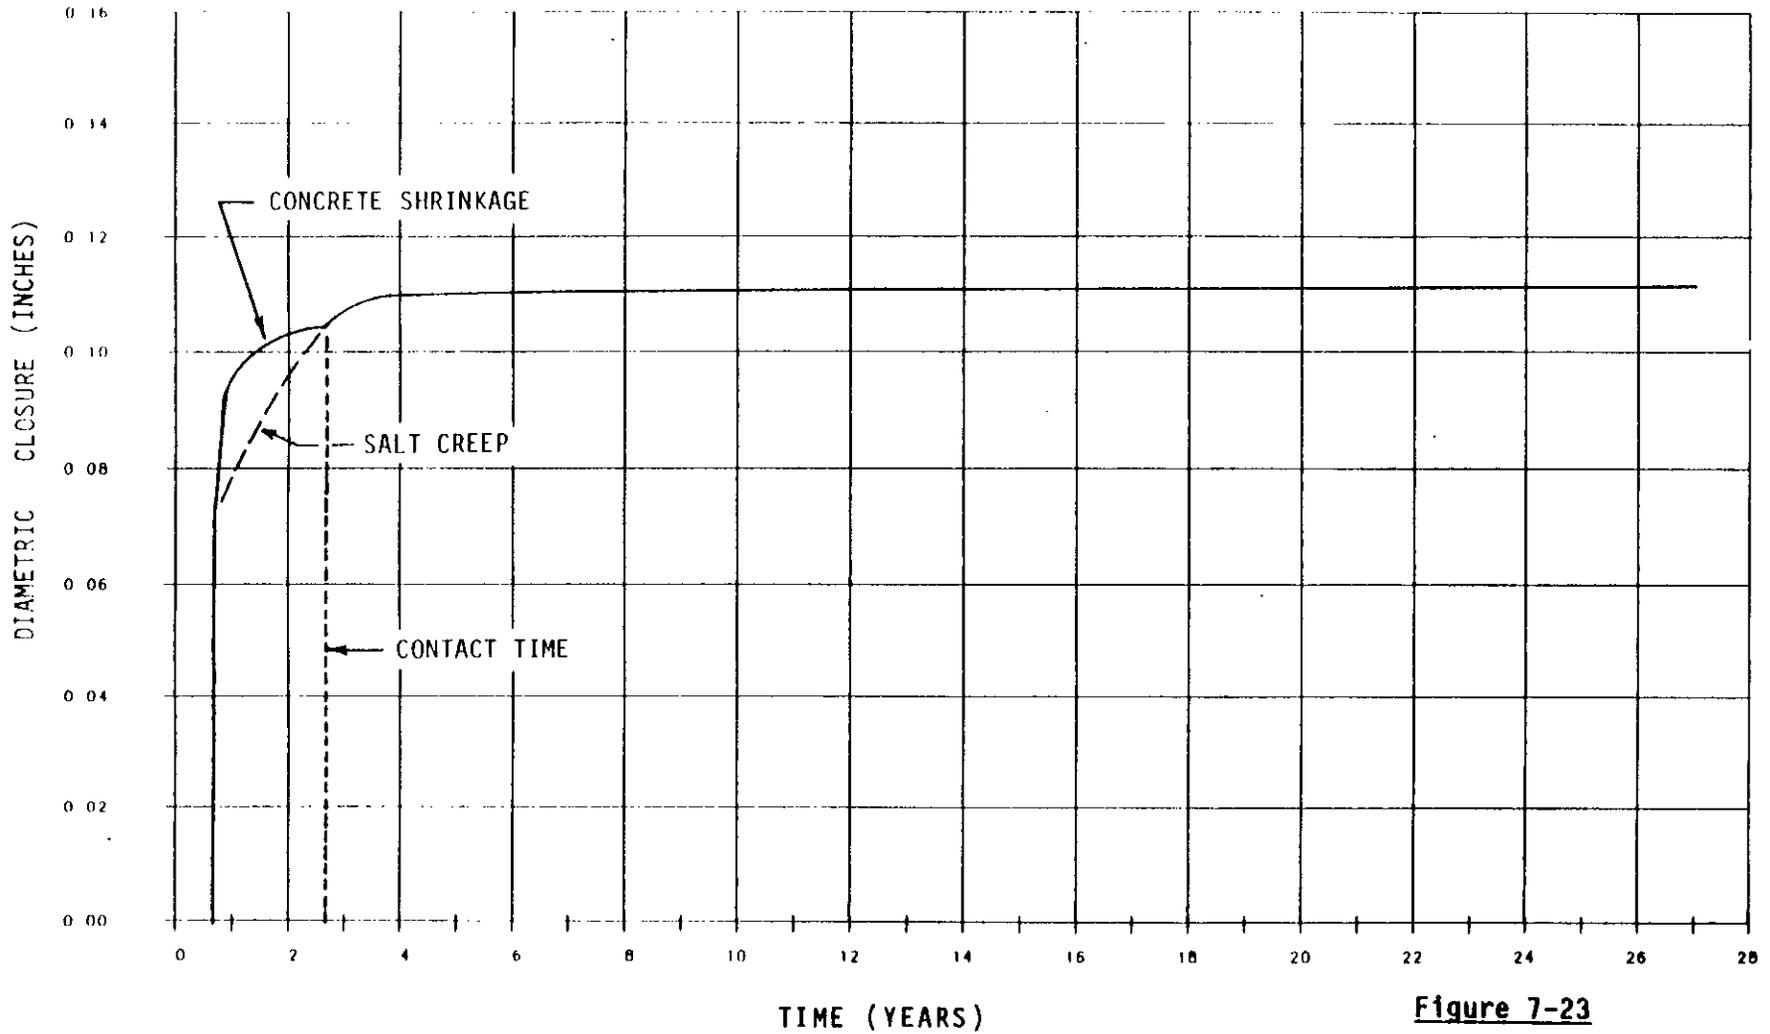
Figure 7-23

C & SH SHAFT KEY  
DIAMETRIC CLOSURE PREDICTION

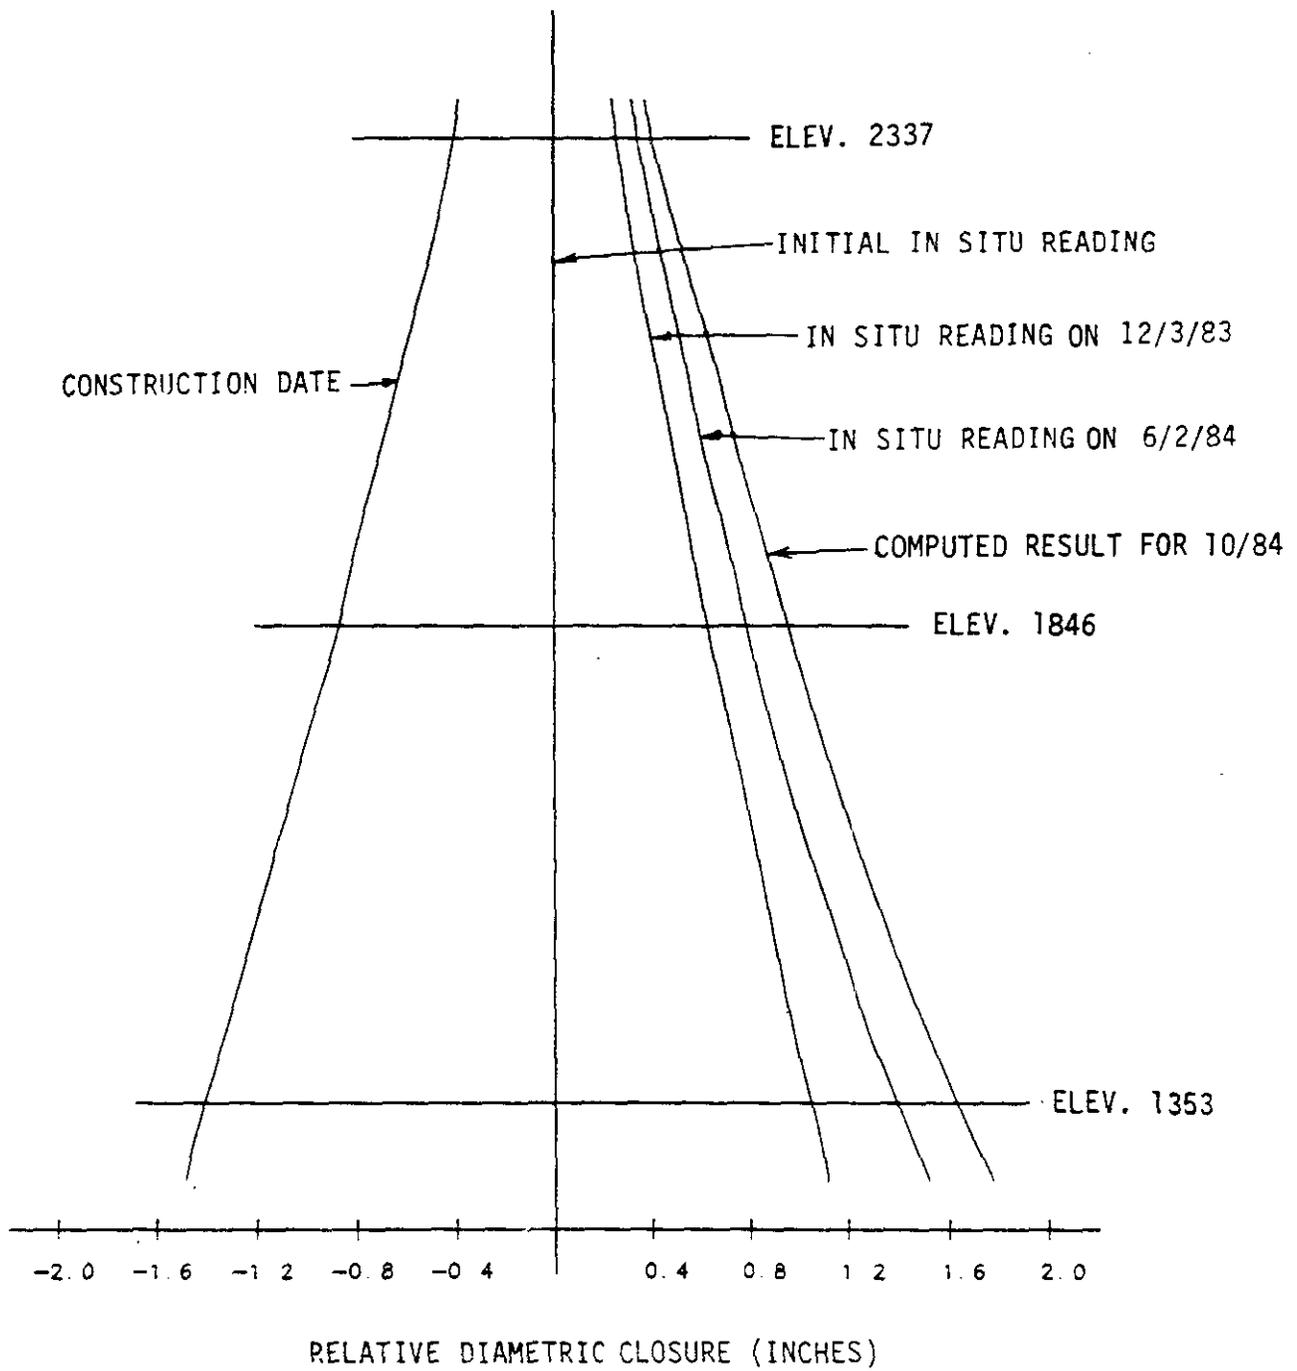
Figure 7-28

C & SH SHAFT UNLINED SECTION  
RELATIVE DIAMETRIC CLOSURE

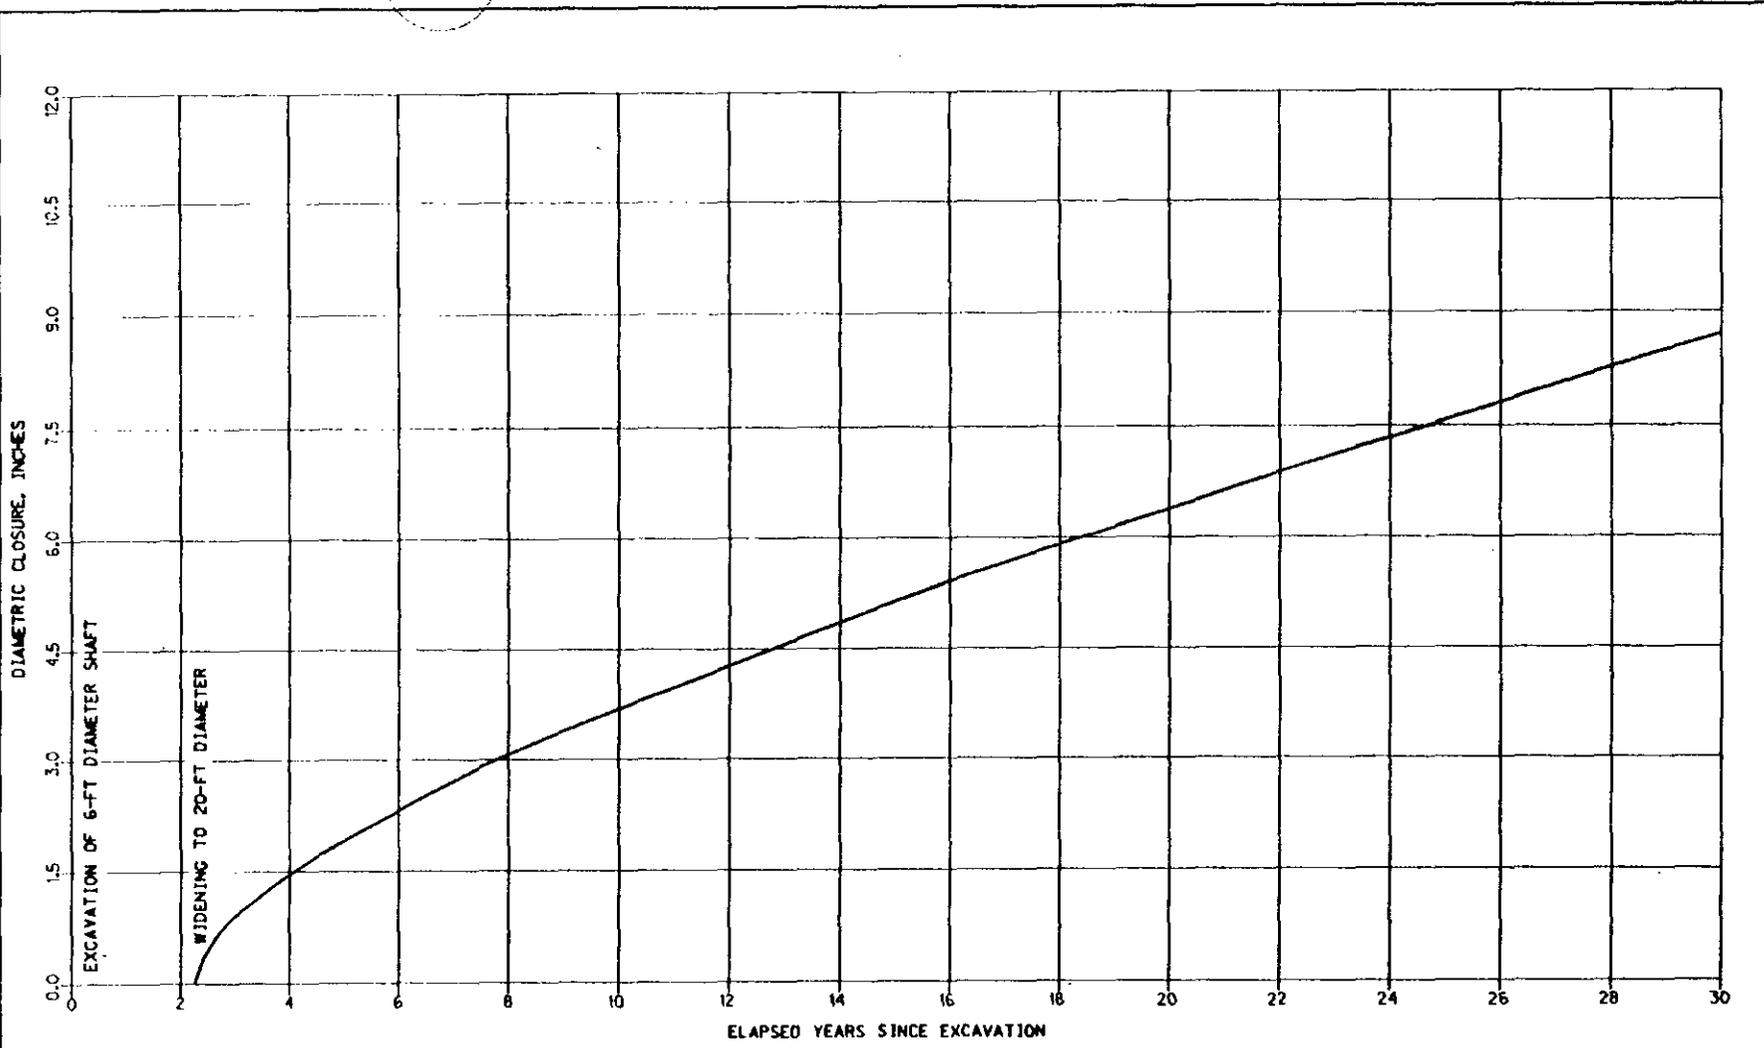
Figure 8-15

WASTE SHAFT UNLINED SECTION  
CLOSURE PREDICTION AT ELEVATION 1350 FEET
