**Title 40 CFR Part 191  
Compliance Certification  
Application  
for the  
Waste Isolation Pilot Plant**

# Design Validation Report

WASTE ISOLATION PILOT PLANT

**DESIGN VALIDATION  
FINAL REPORT**

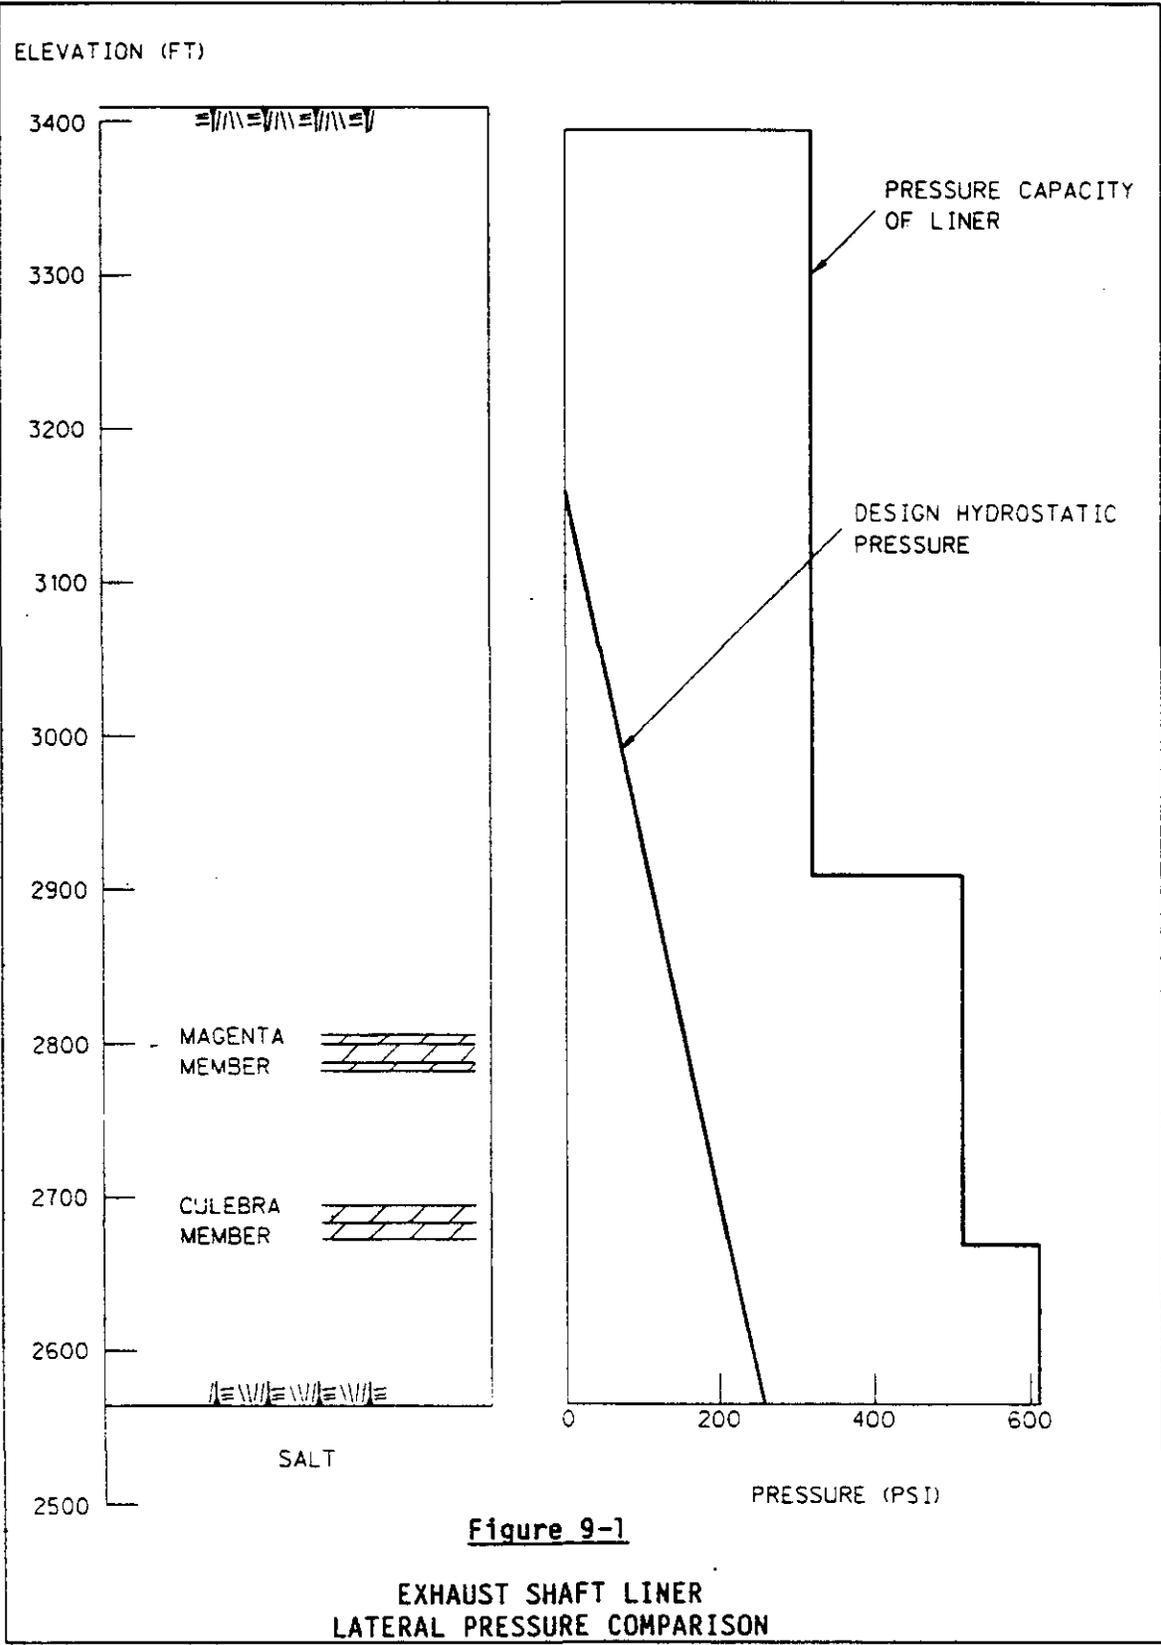
**Figure 9-1**

**EXHAUST SHAFT LINER  
LATERAL PRESSURE COMPARISON**

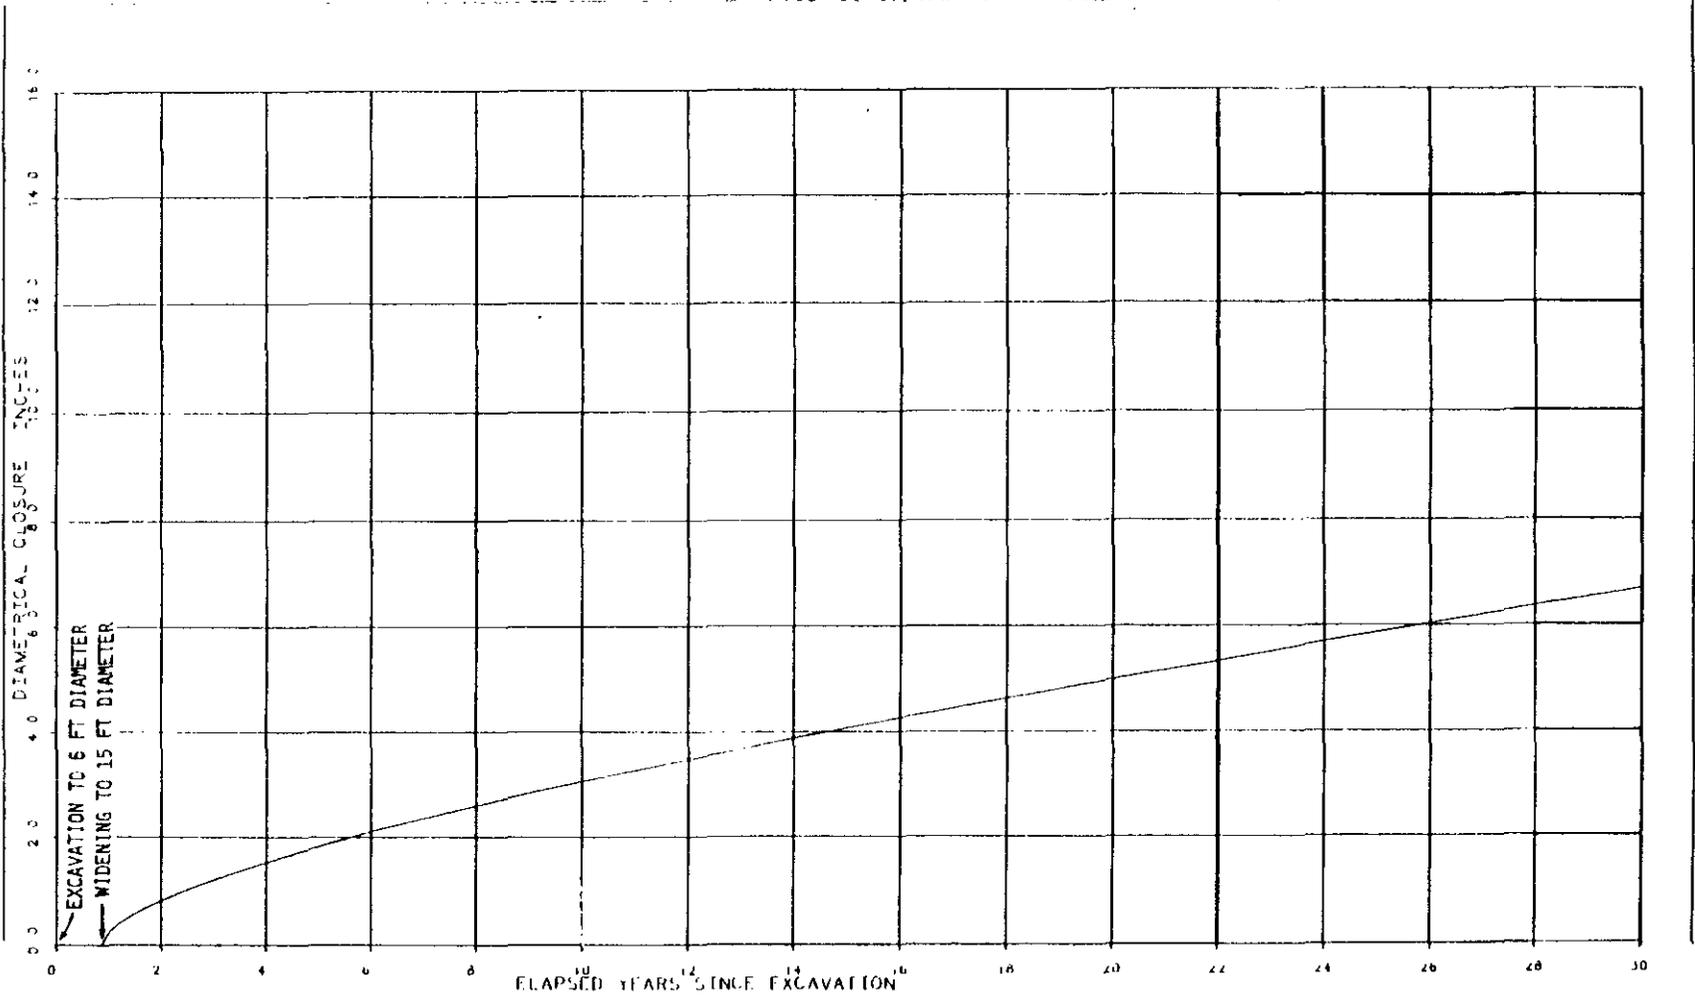
**Figure 9-9**

**EXHAUST SHAFT UNLINED SECTION  
CLOSURE PREDICTION AT ELEVATION 1343 FEET**

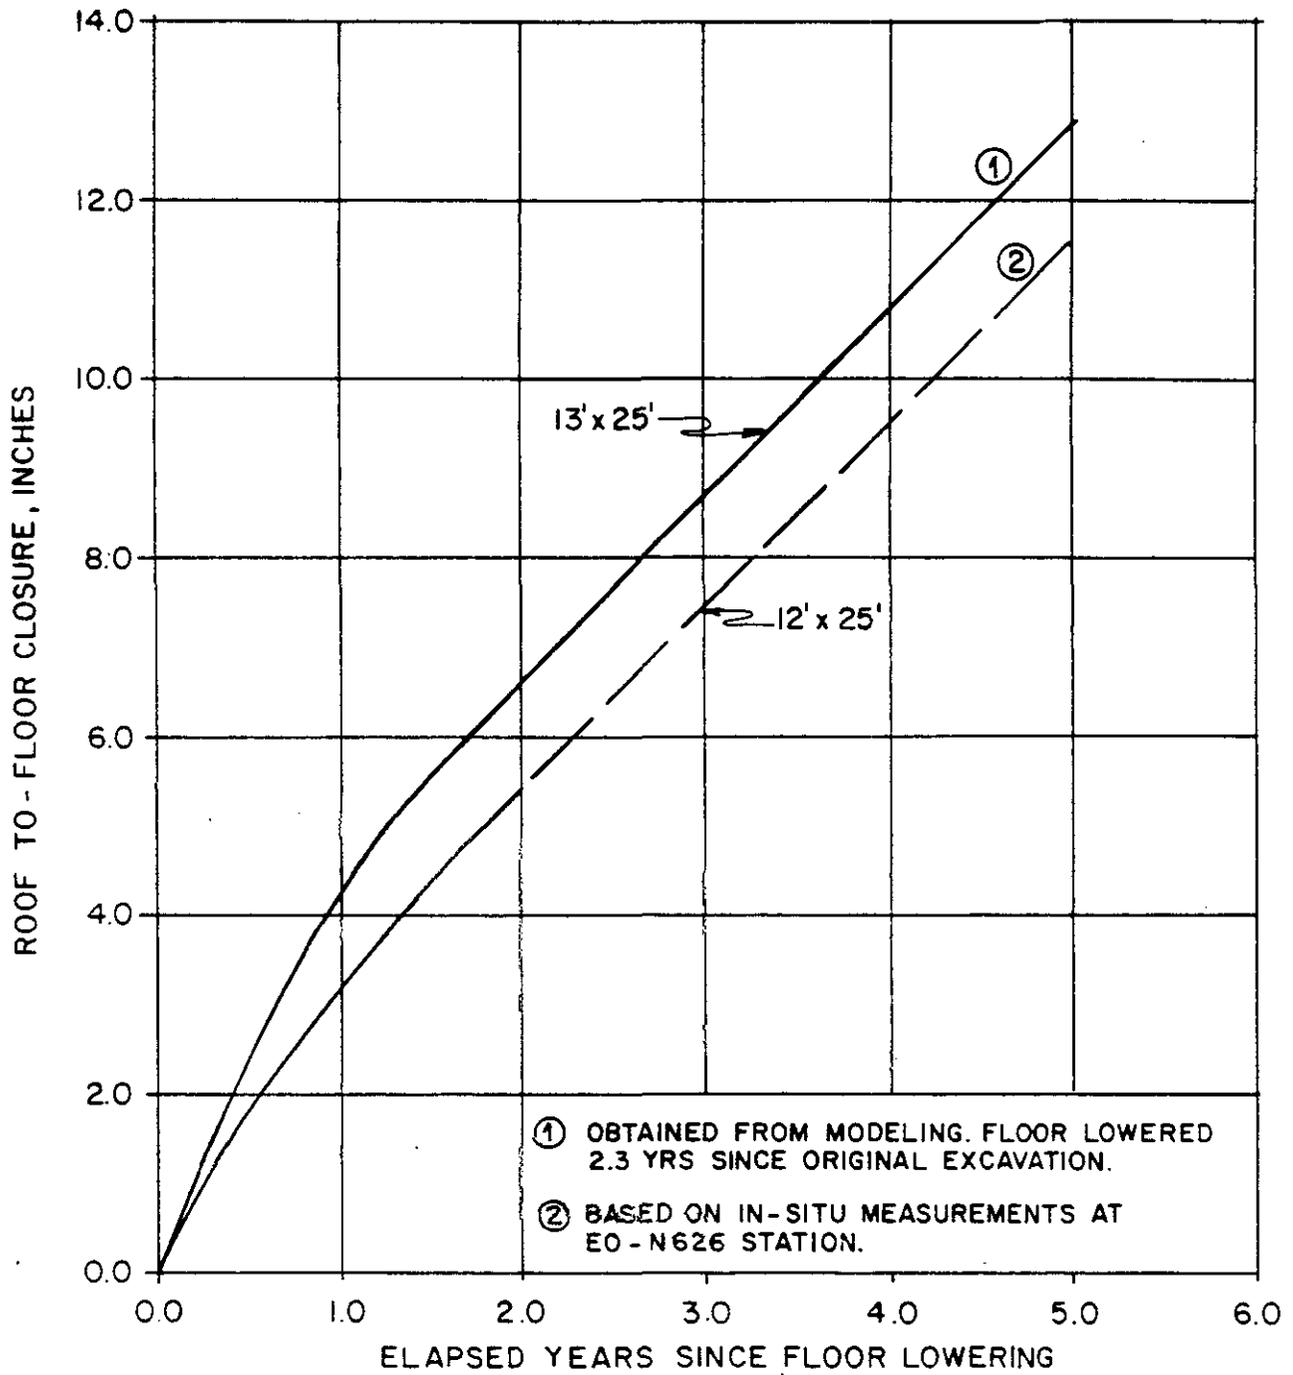
Figure 10-7 presents a comparison of the predicted closure of a 13 x 25-foot drift with the observed behavior of a 12 x 25-foot drift at E0/N626. The closure for the 13 x 25-foot drift was obtained by increasing the closure rate obtained from modeling the infinitely long, single drift by 30 percent. The roof-to-floor closure at E0/N626 does not include the values before the floor was lowered by 4 feet. This comparison indicates that it is reasonable to increase the closure rate of a single, infinitely long, 13 x 25-foot drift by 30 percent to account for the presence of adjacent parallel drifts and crosscuts.

DRIFTS  
 COMPARISON OF PREDICTED AND OBSERVED  
 ROOF-TO-FLOOR CLOSURE

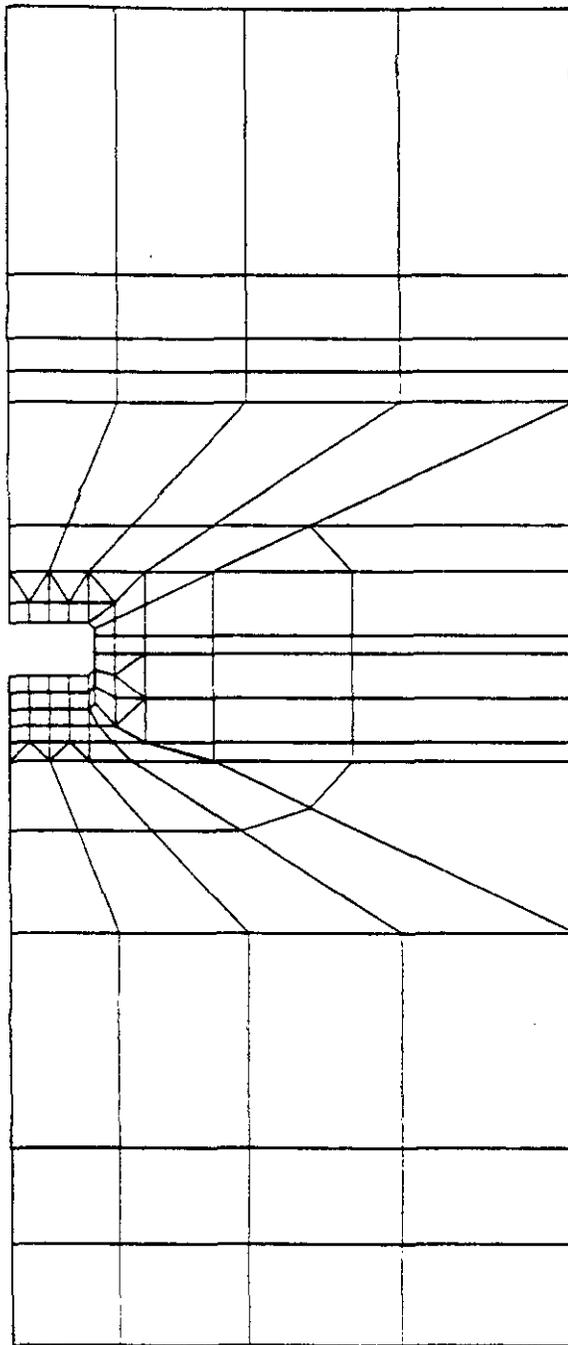
Figure 10-12

DRIFTS  
FINITE ELEMENT MODEL - BEFORE FLOOR LOWERING

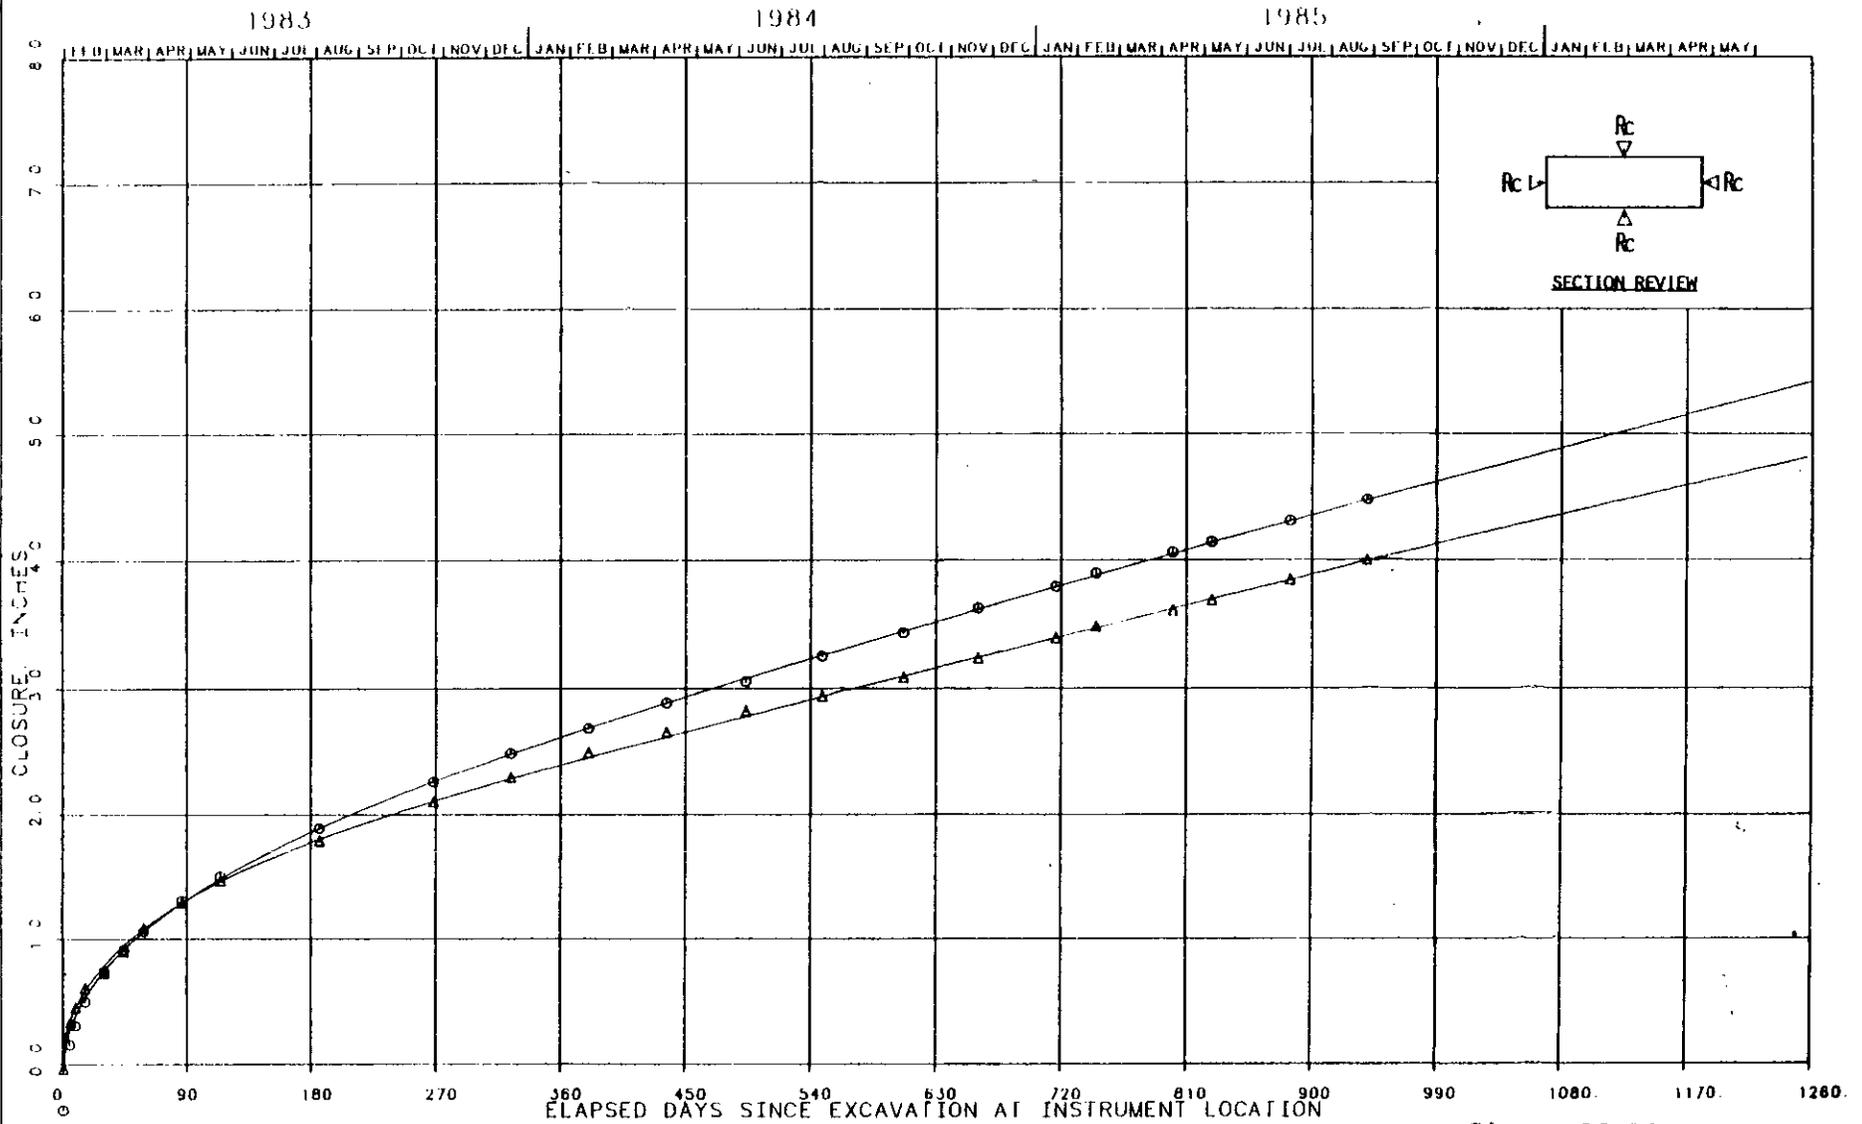
Figure 10-13

DRIFTS  
CORRELATED CLOSURE HISTORIES

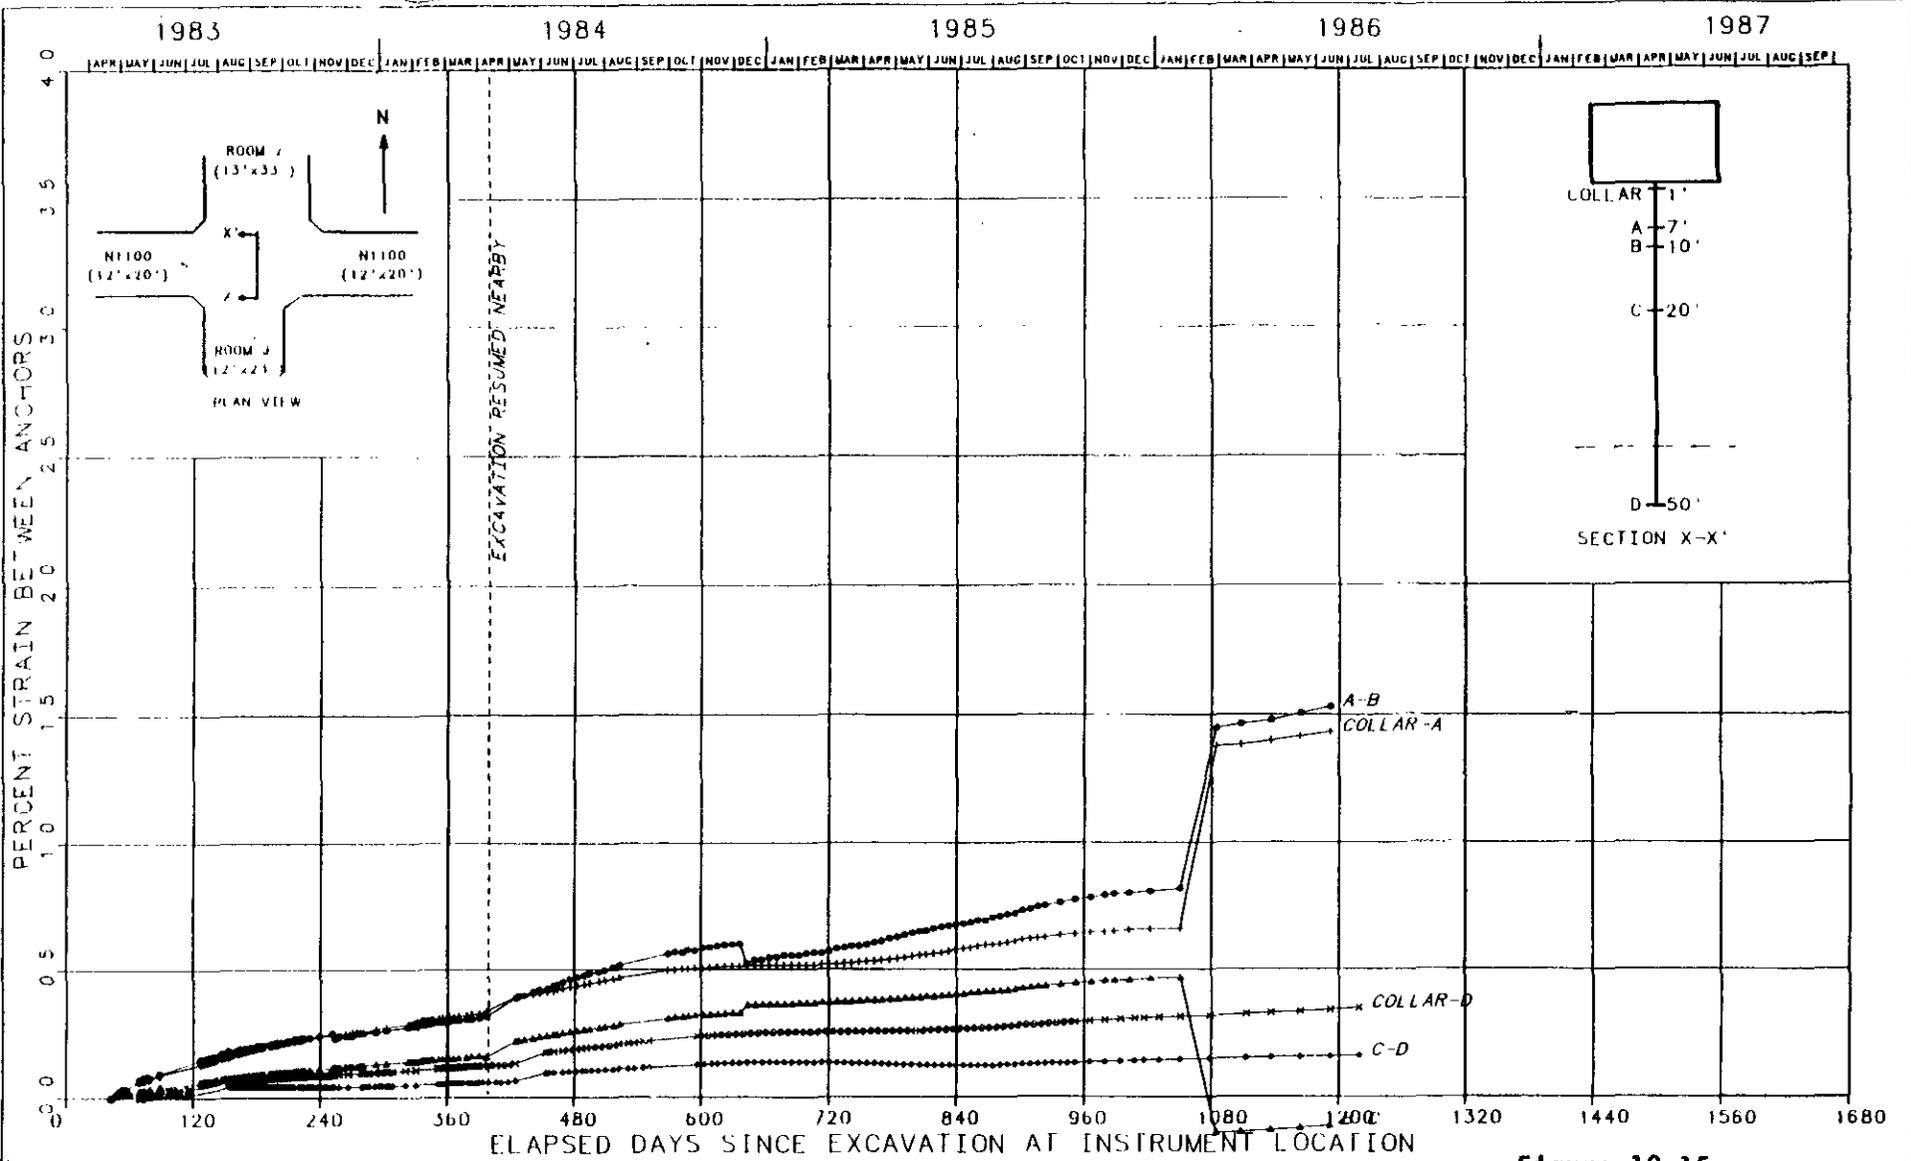
Figure 10-15

DRIFTS  
STRAIN VERSUS TIME SINCE EXCAVATION  
N1100/TEST ROOM 2 INTERSECTION

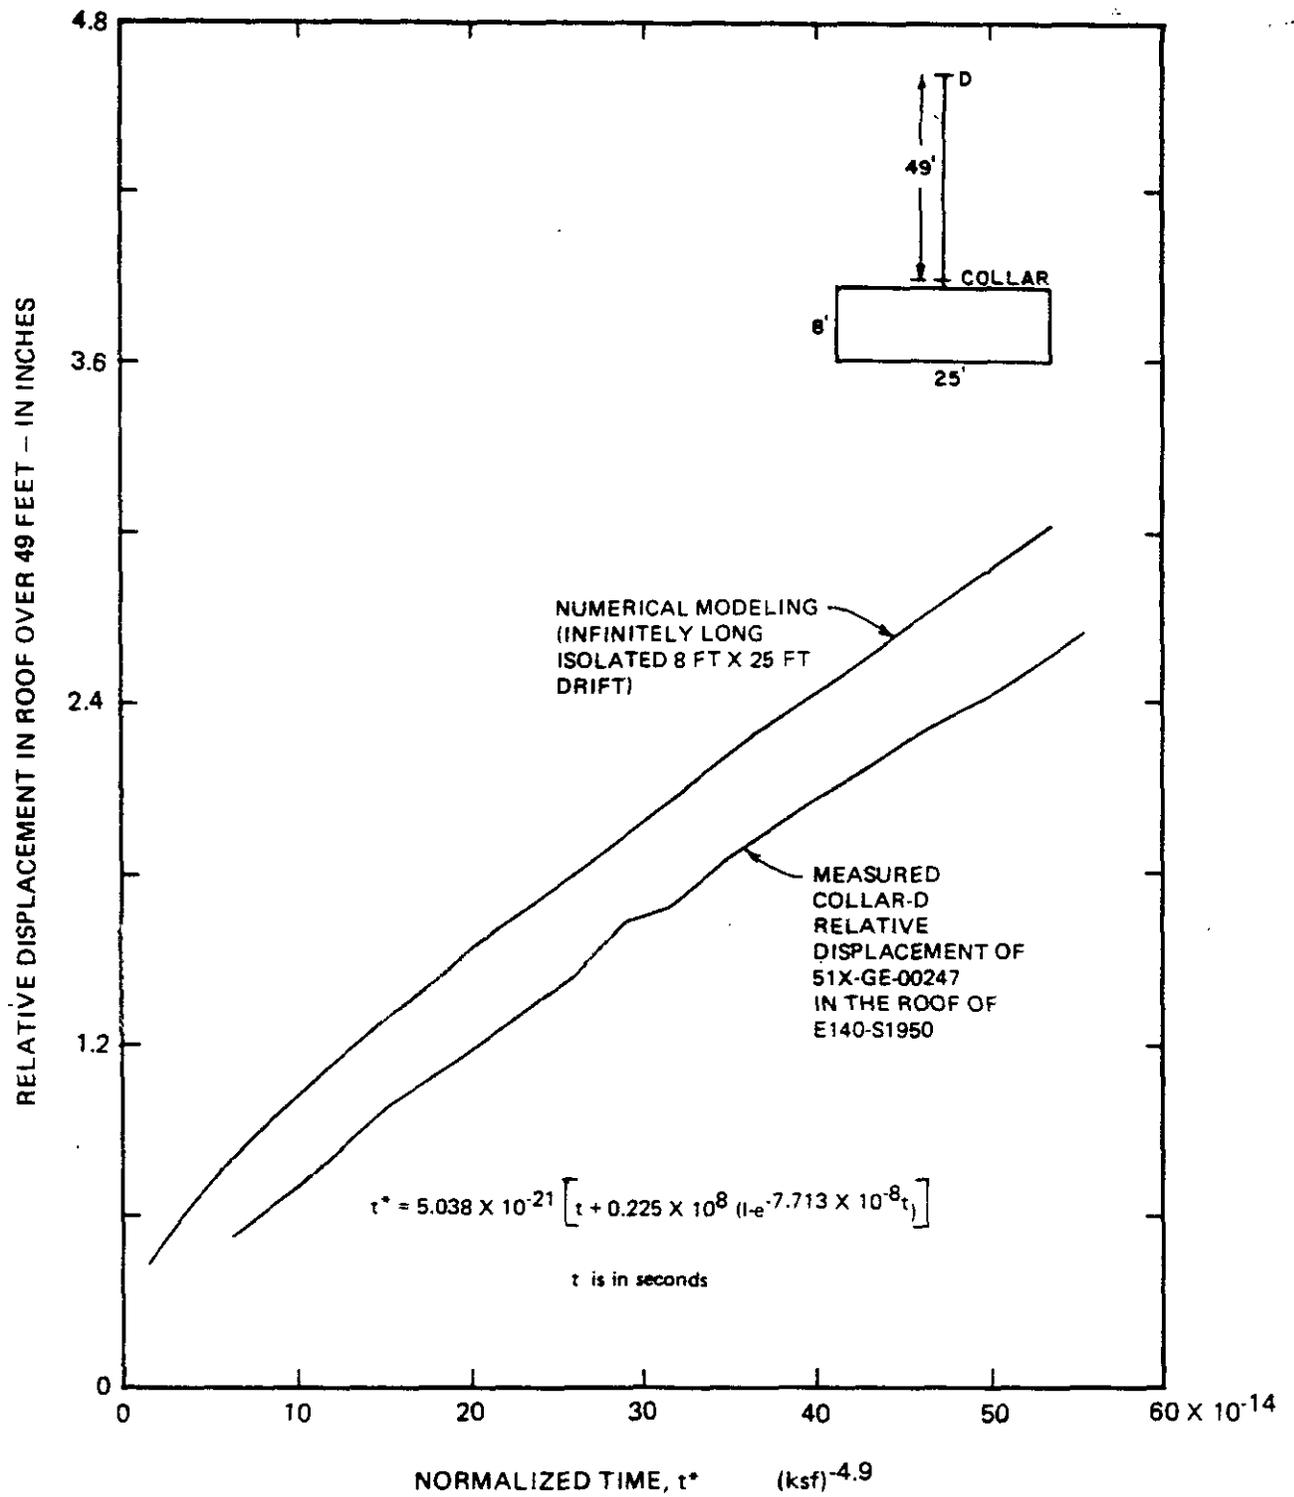
Figure 10-24

DRIFTS  
NUMERICAL MODELING VERSUS IN SITU MEASUREMENT  
DATA FROM ROOF EXTENSOMETER

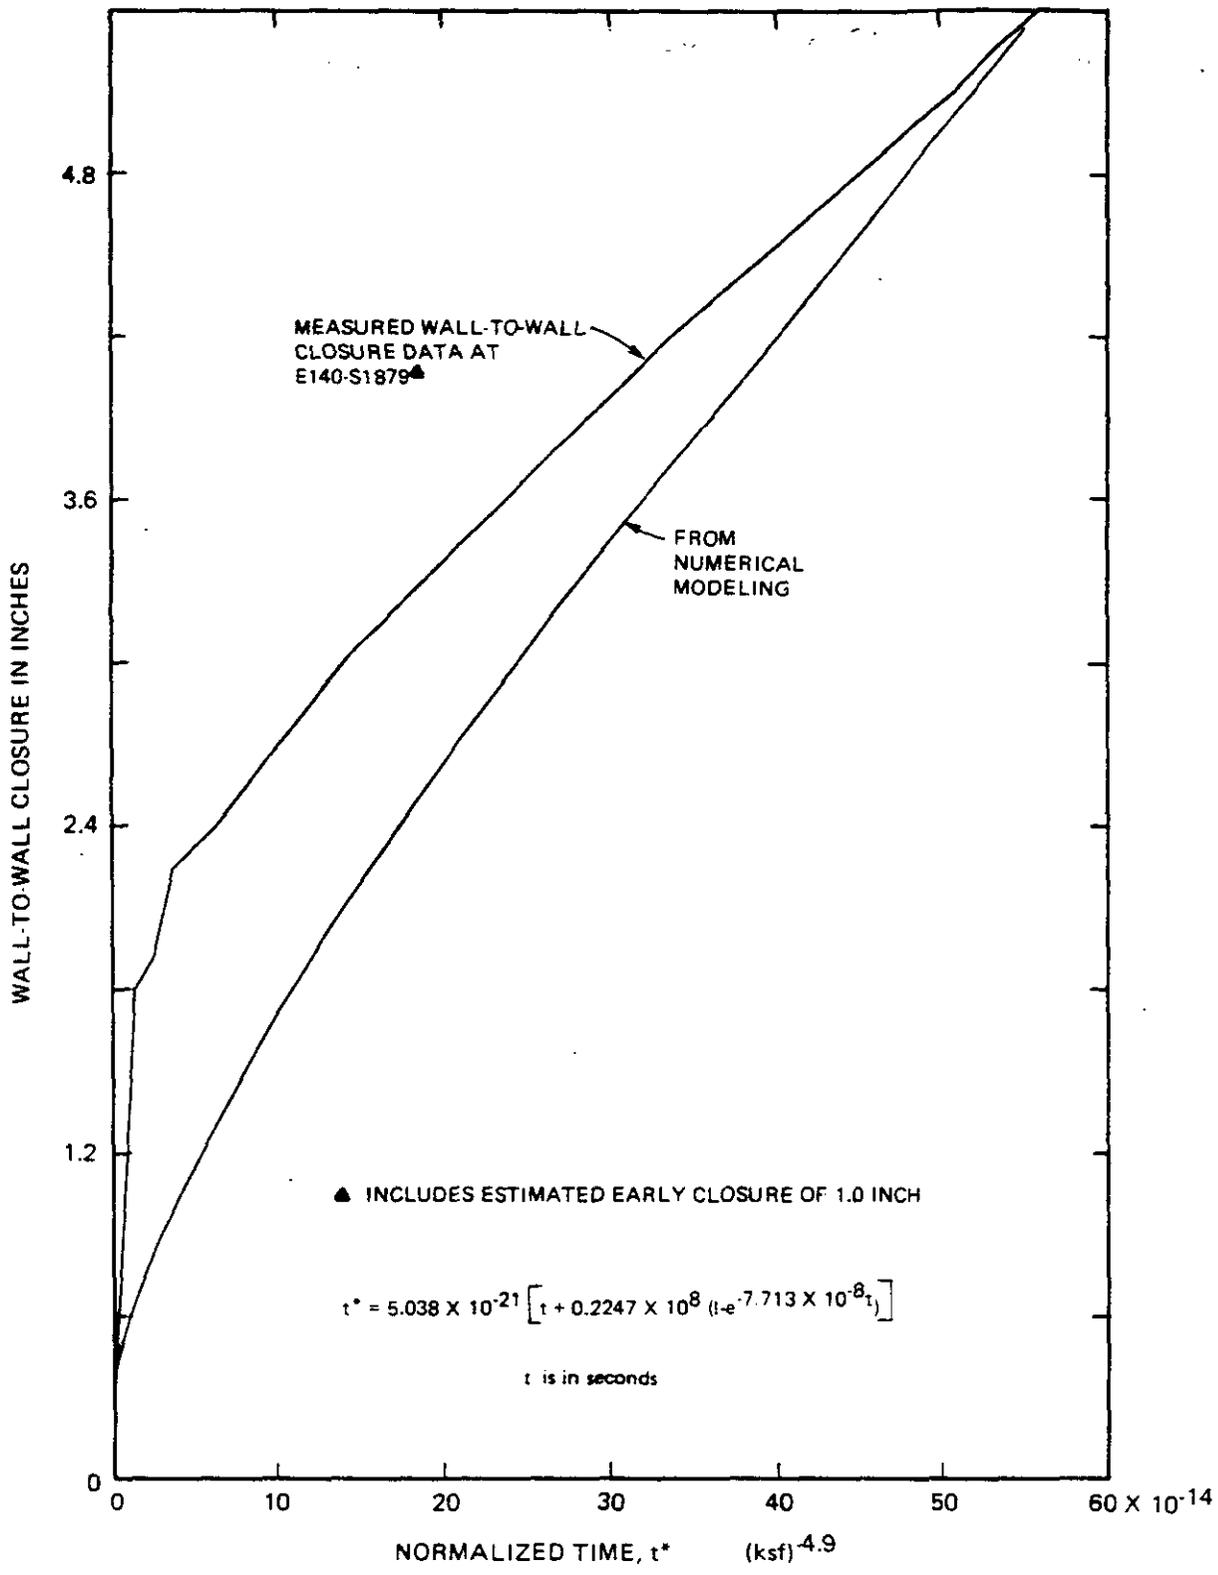
Figure 10-26

DRIFTS  
 NUMERICAL MODELING VERSUS MEASURED WALL-TO-WALL CLOSURE  
 AT E140/S1879

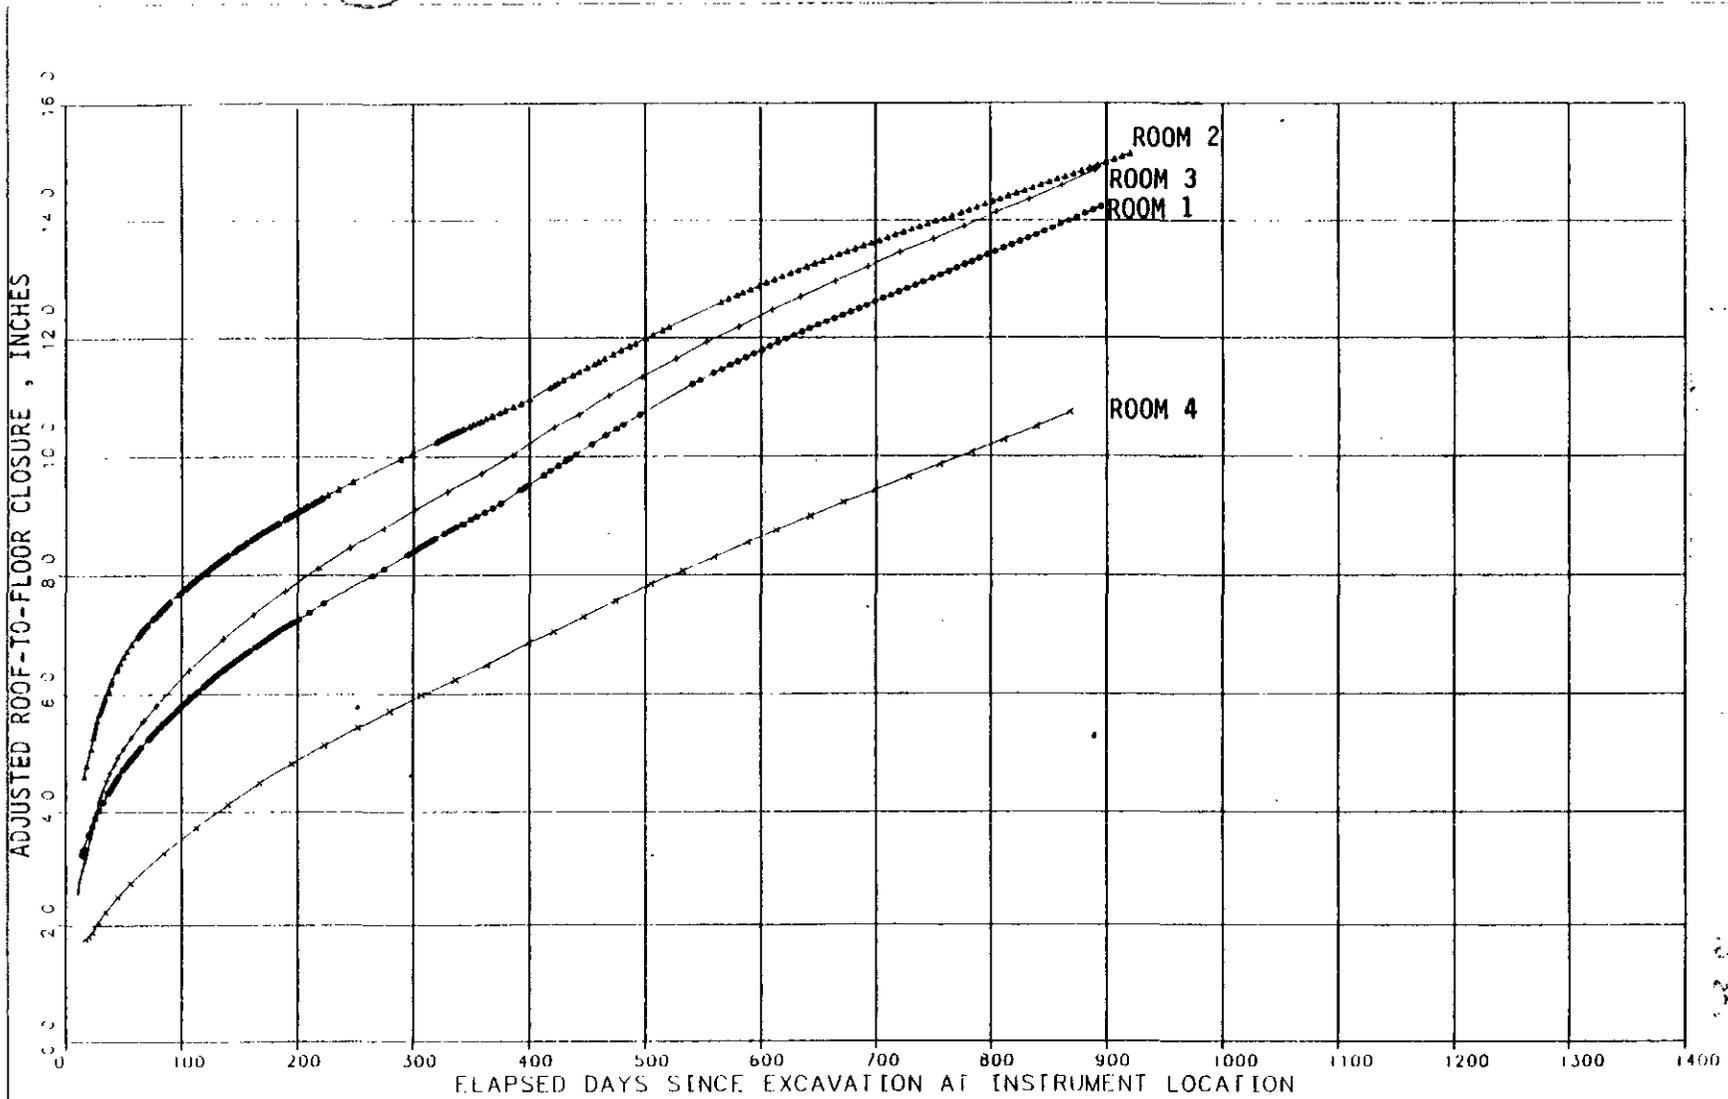
Figure 11-4

TEST ROOMS  
ADJUSTED ROOF-TO-FLOOR CLOSURE

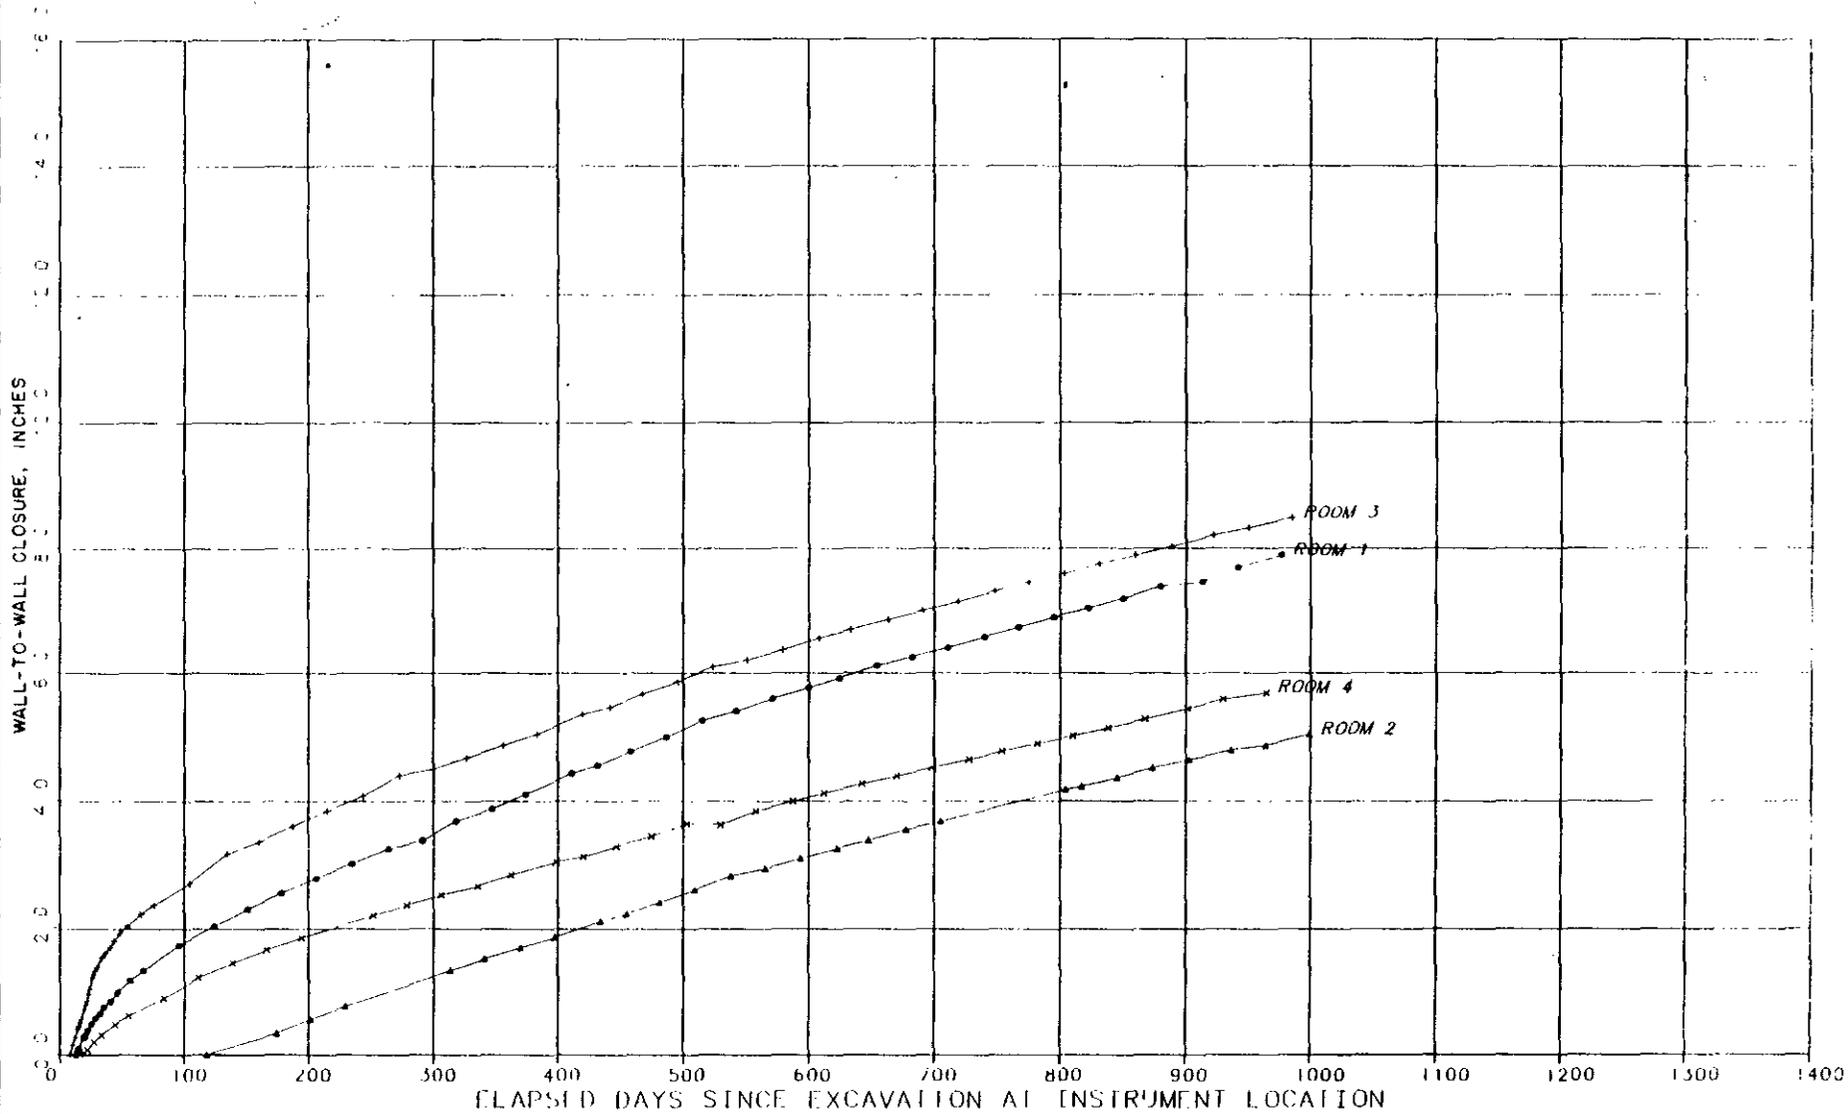
Figure 11-12

Table 11-9 is a summary of the results of the regression analyses for the wall-to-wall closure rates in Test Rooms 1 through 4. The closure rate values determined from temporary convergence point readings were included in the analysis of Test Room 2. The fitted curves for Test Rooms 2 and 3 are relatively poor. Figures 11-13 through 11-16 show the fitted equations for the wall-to-wall closure rate versus elapsed time curves for Test Rooms 1 through 4.

TEST ROOMS  
WALL-TO-WALL CLOSURE COMPARISON

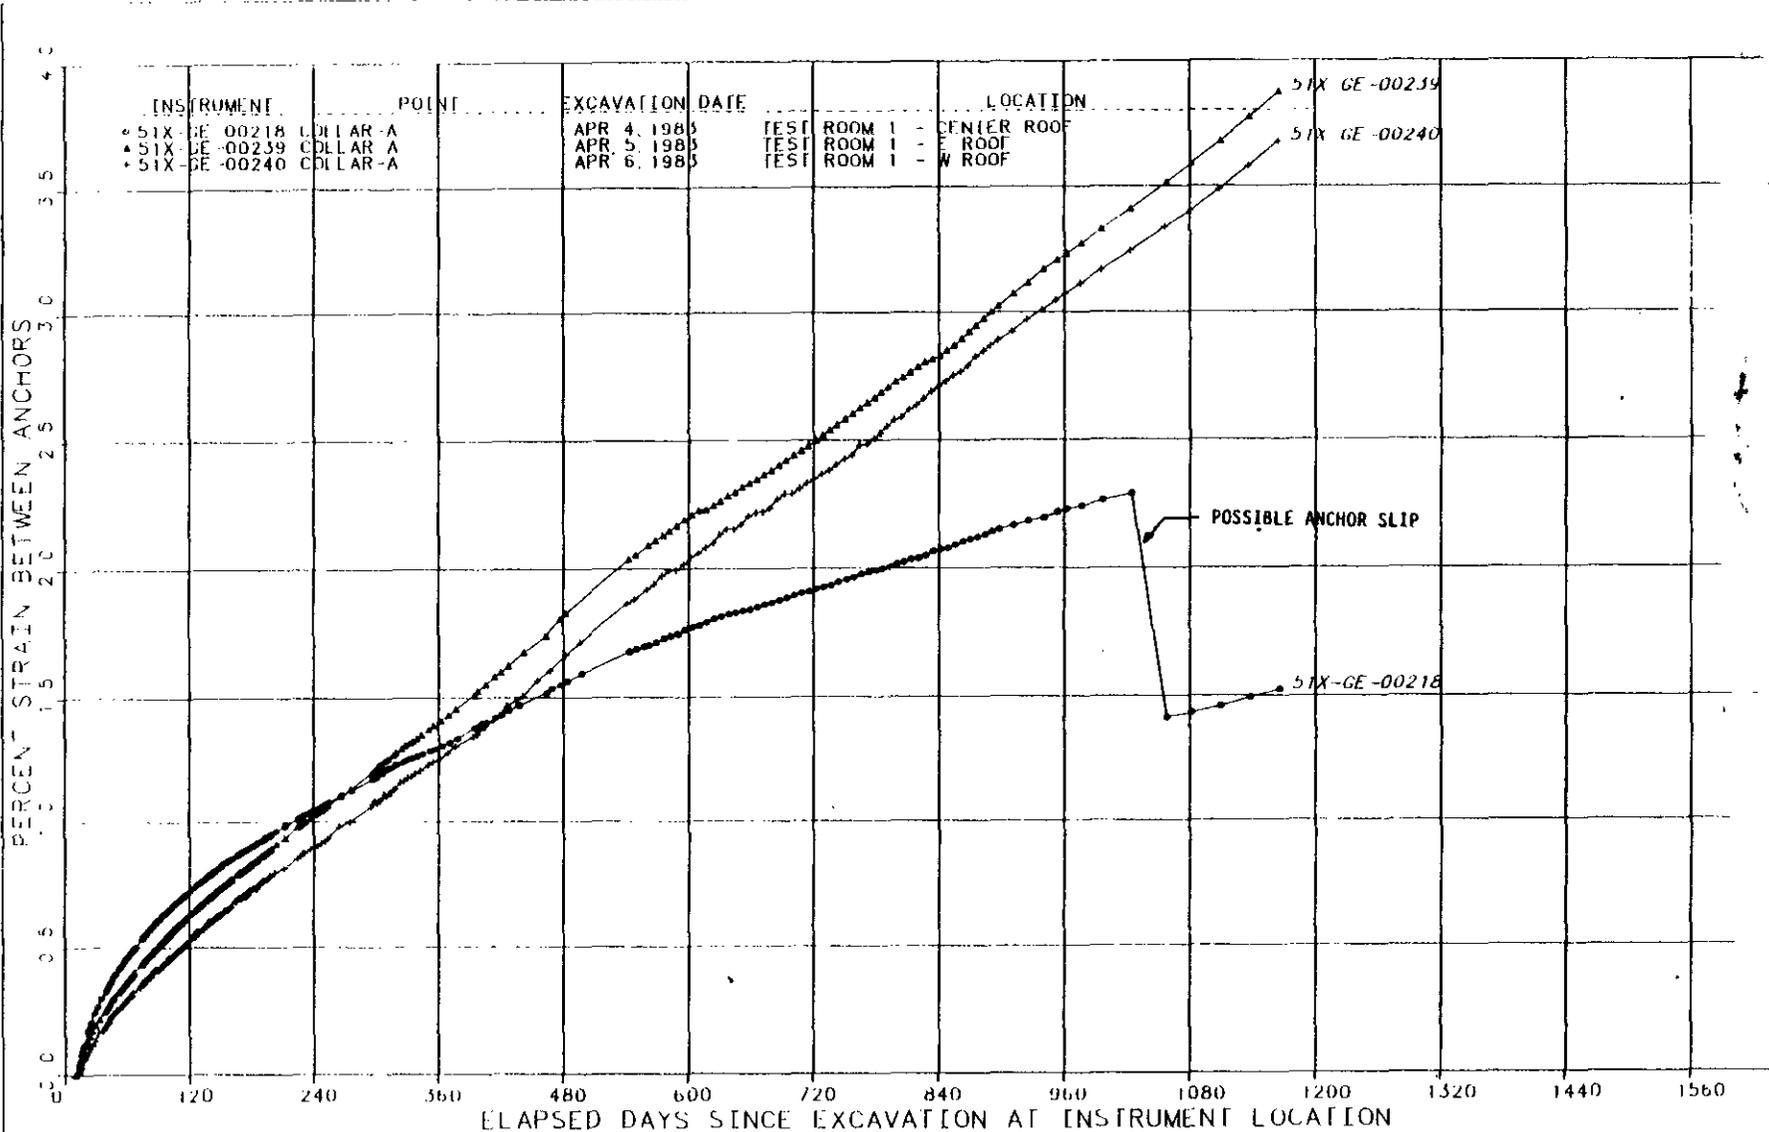
Figure 11-19

TEST ROOM 1 ROOF EXTENSOMETER STRAIN VERSUS TIME SINCE EXCAVATION

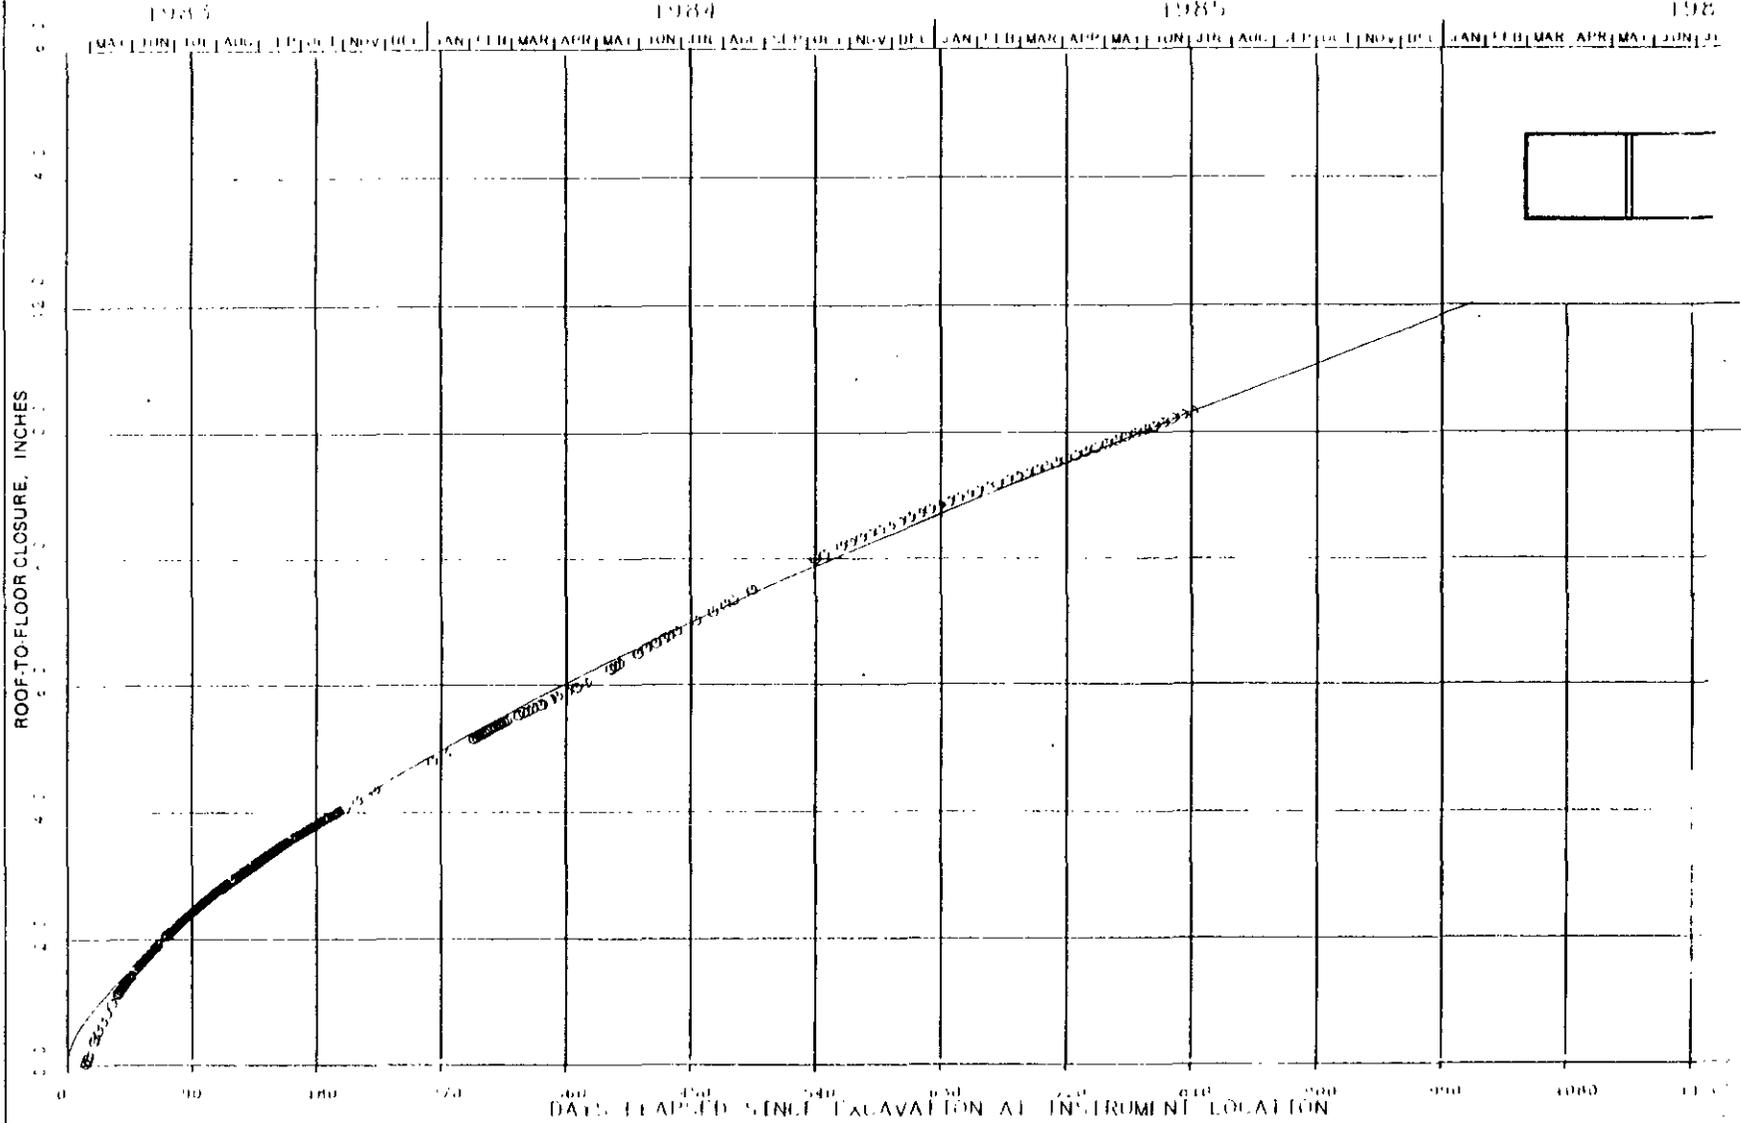
Figure 11-22

TEST ROOM 1  
ROOF-TO-FLOOR CLOSURE HISTORY
