**Title 40 CFR Part 191  
Compliance Certification  
Application  
for the  
Waste Isolation Pilot Plant**

# Design Validation Report

WASTE ISOLATION PILOT PLANT

**DESIGN VALIDATION  
FINAL REPORT**

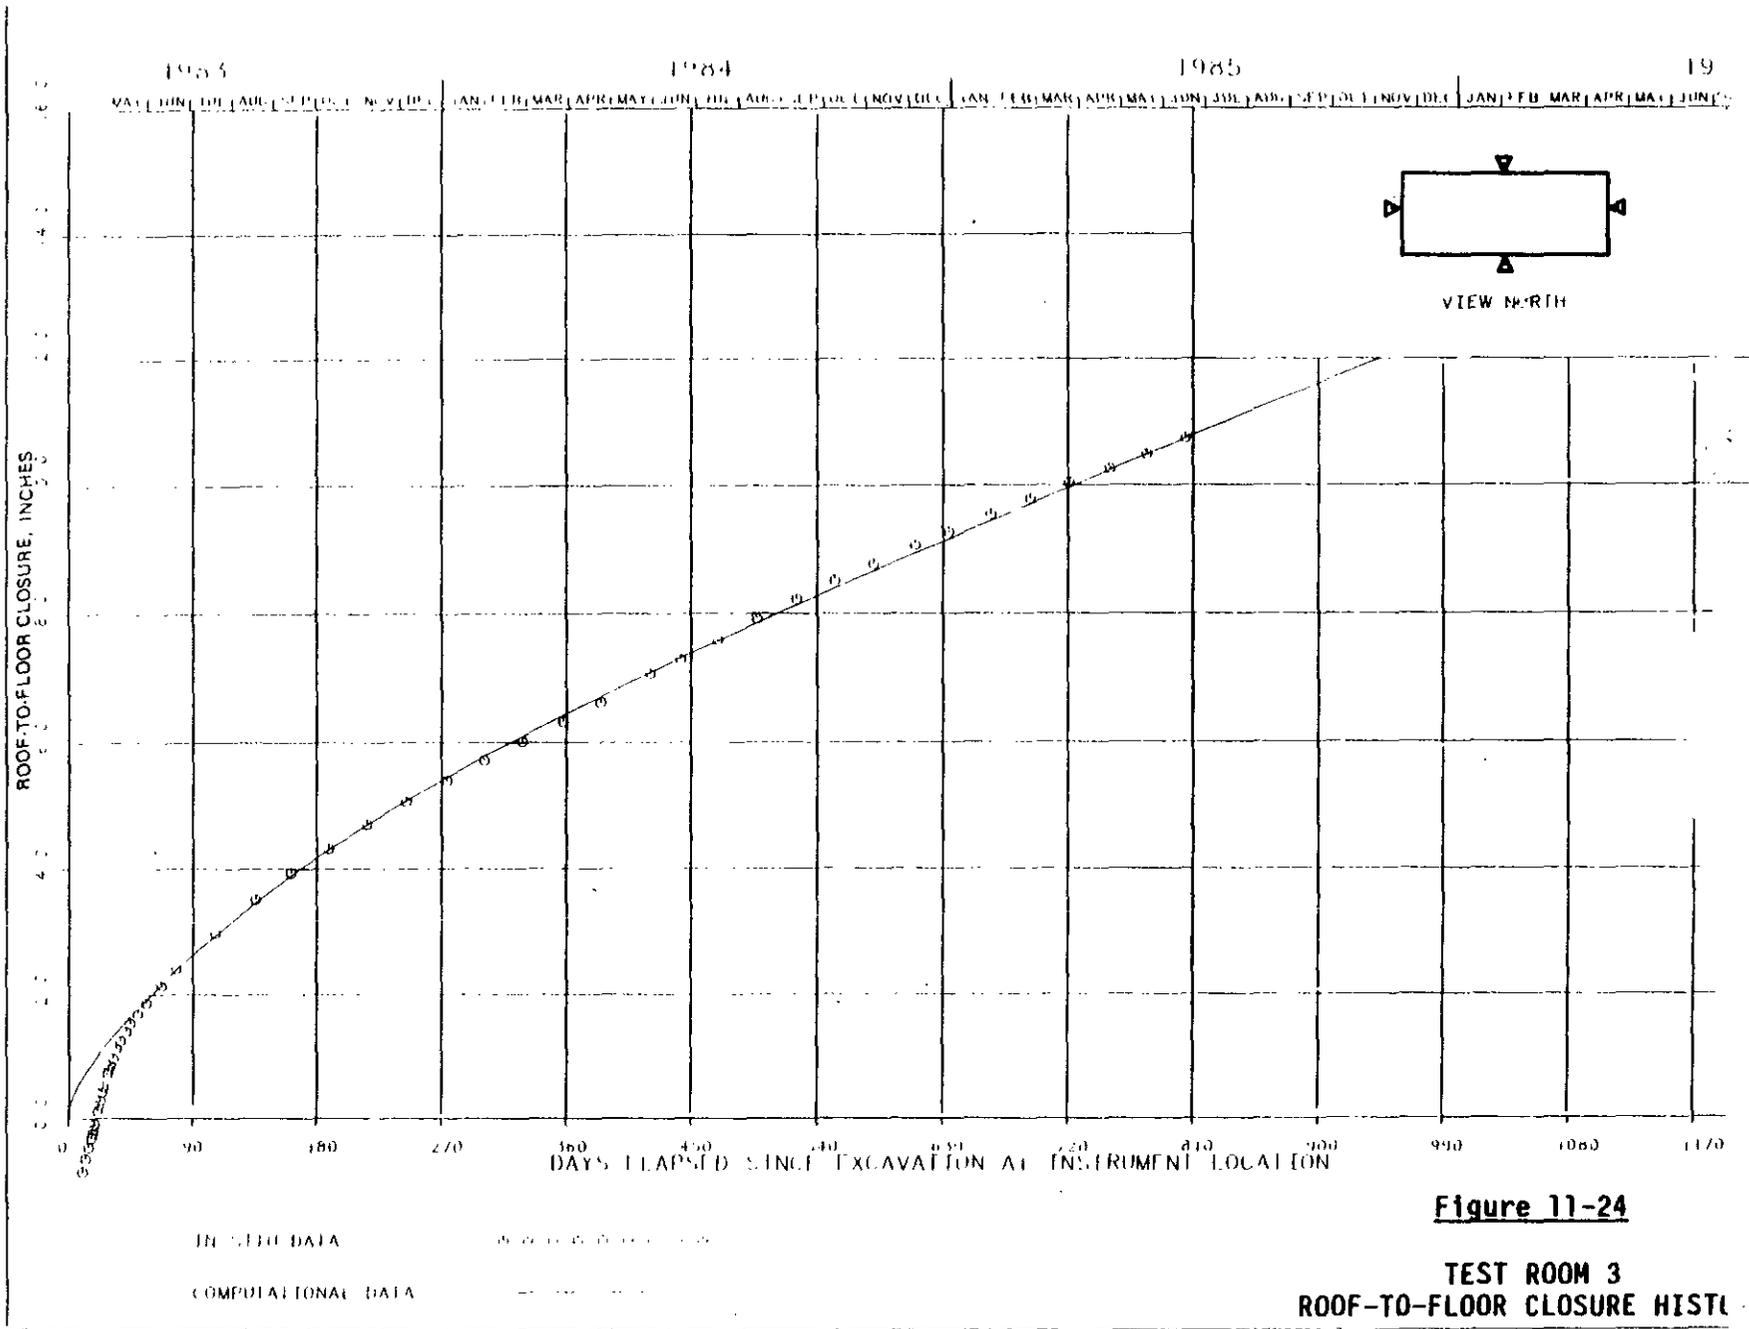
Figure 11-24

TEST ROOM 3  
ROOF-TO-FLOOR CLOSURE HISTO

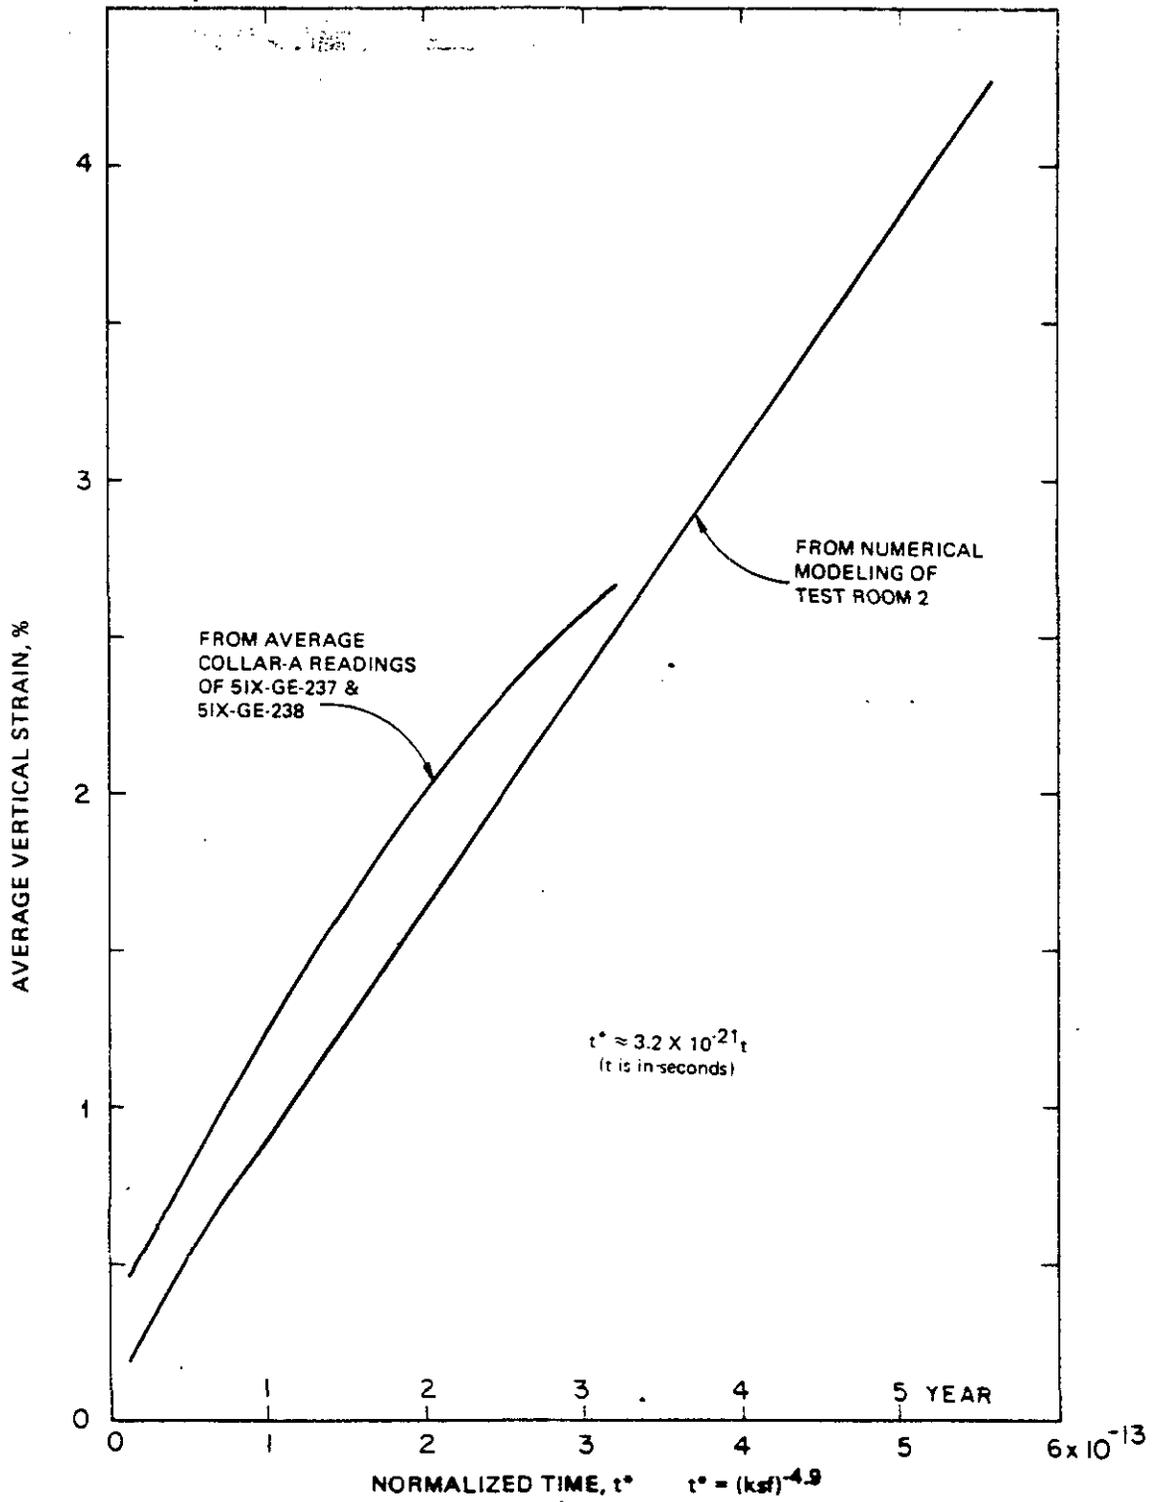
**Figure 11-30**  
**TEST ROOM 2**  
**VERTICAL STRAIN AT ROOF AND PILLAR CORNER**

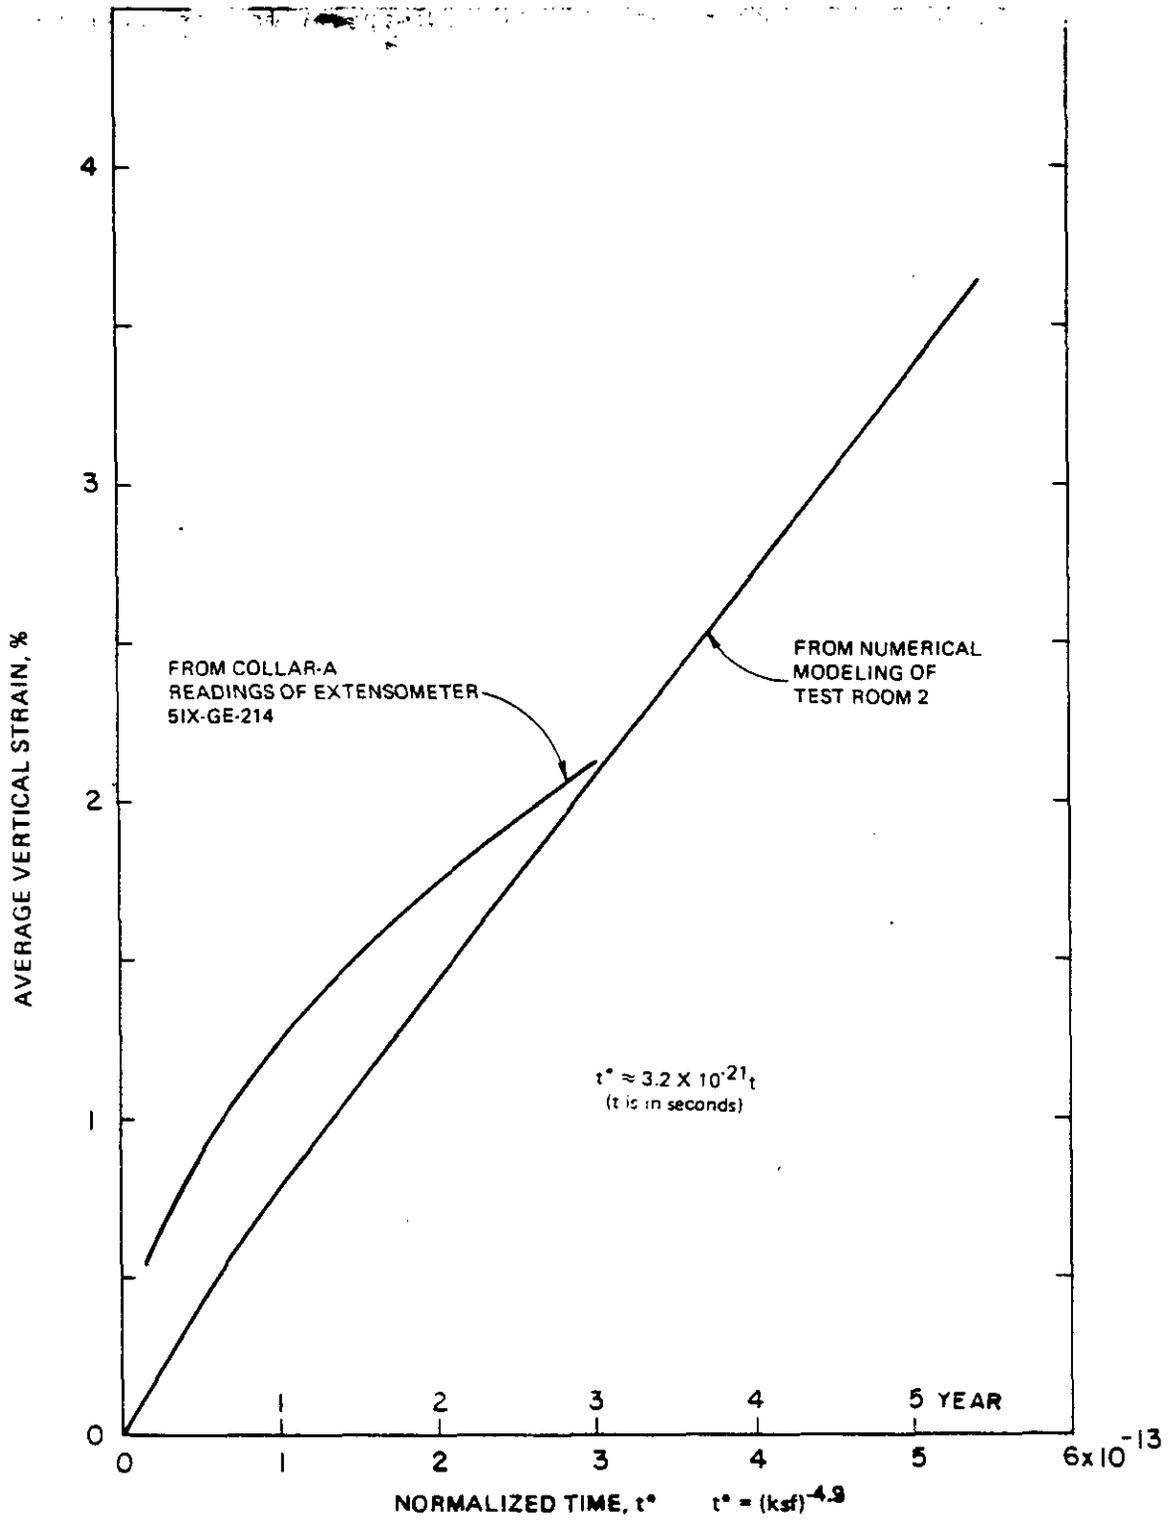
Figure 11-31

TEST ROOM 2  
VERTICAL STRAIN AT ROOF CENTER

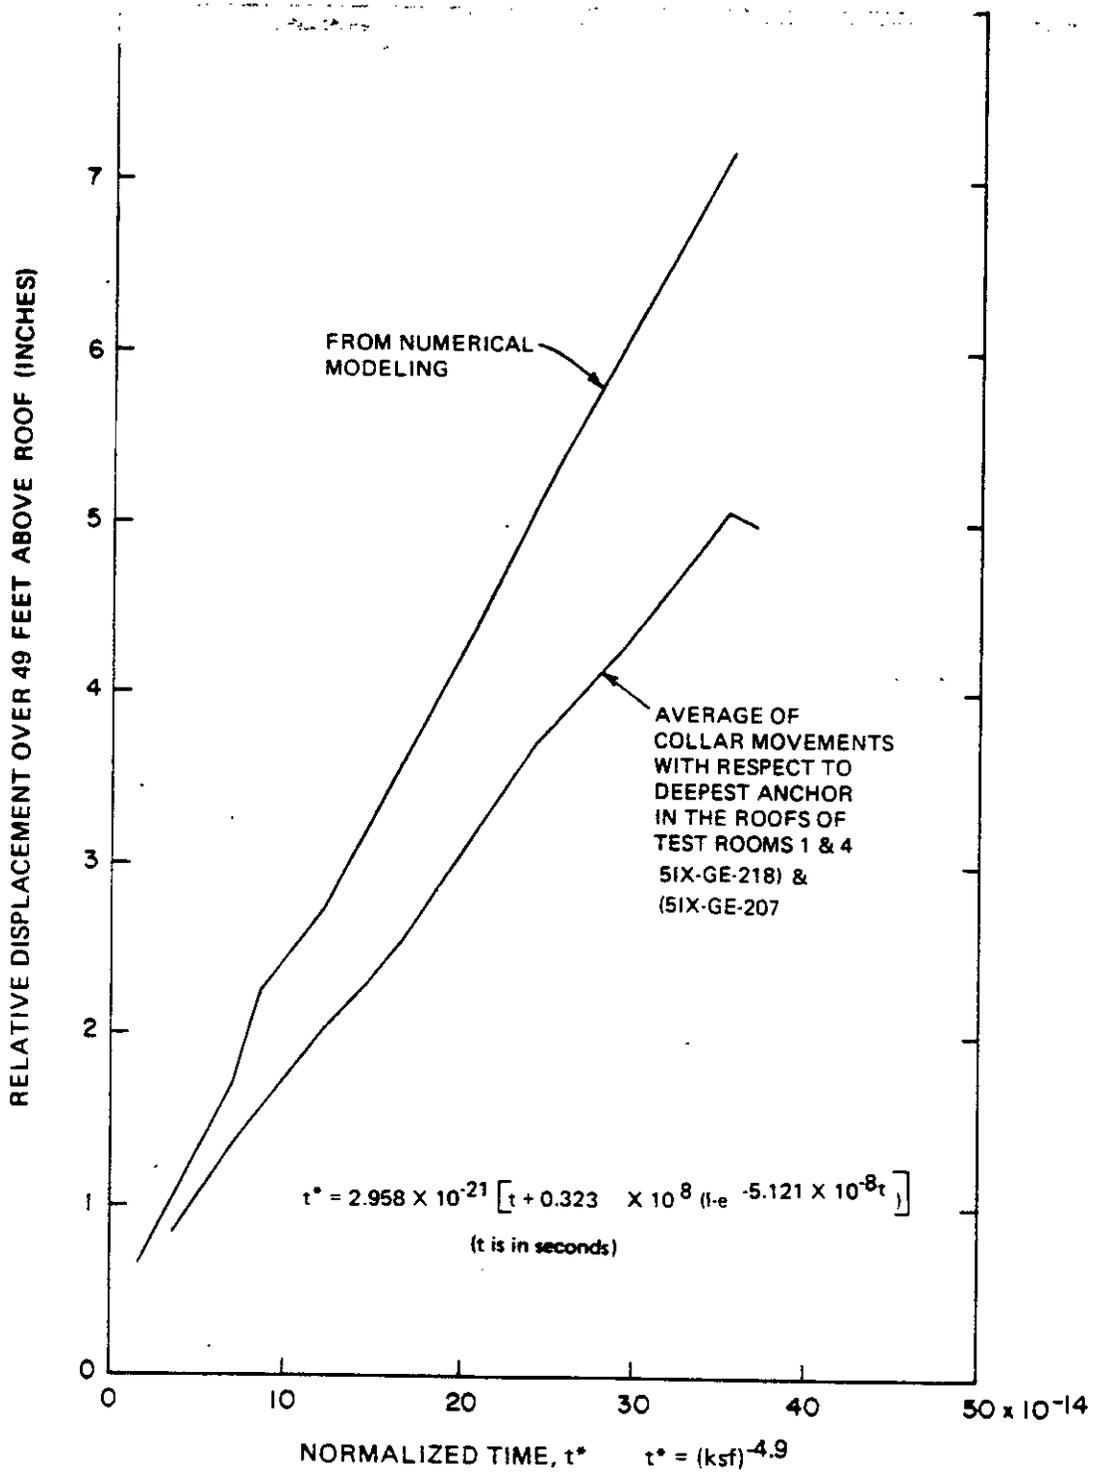
Figure 11-32

TEST ROOMS 1 AND 4 ROOF EXTENSOMETERS  
 NUMERICAL MODELING VERSUS IN SITU MEASUREMENT DATA

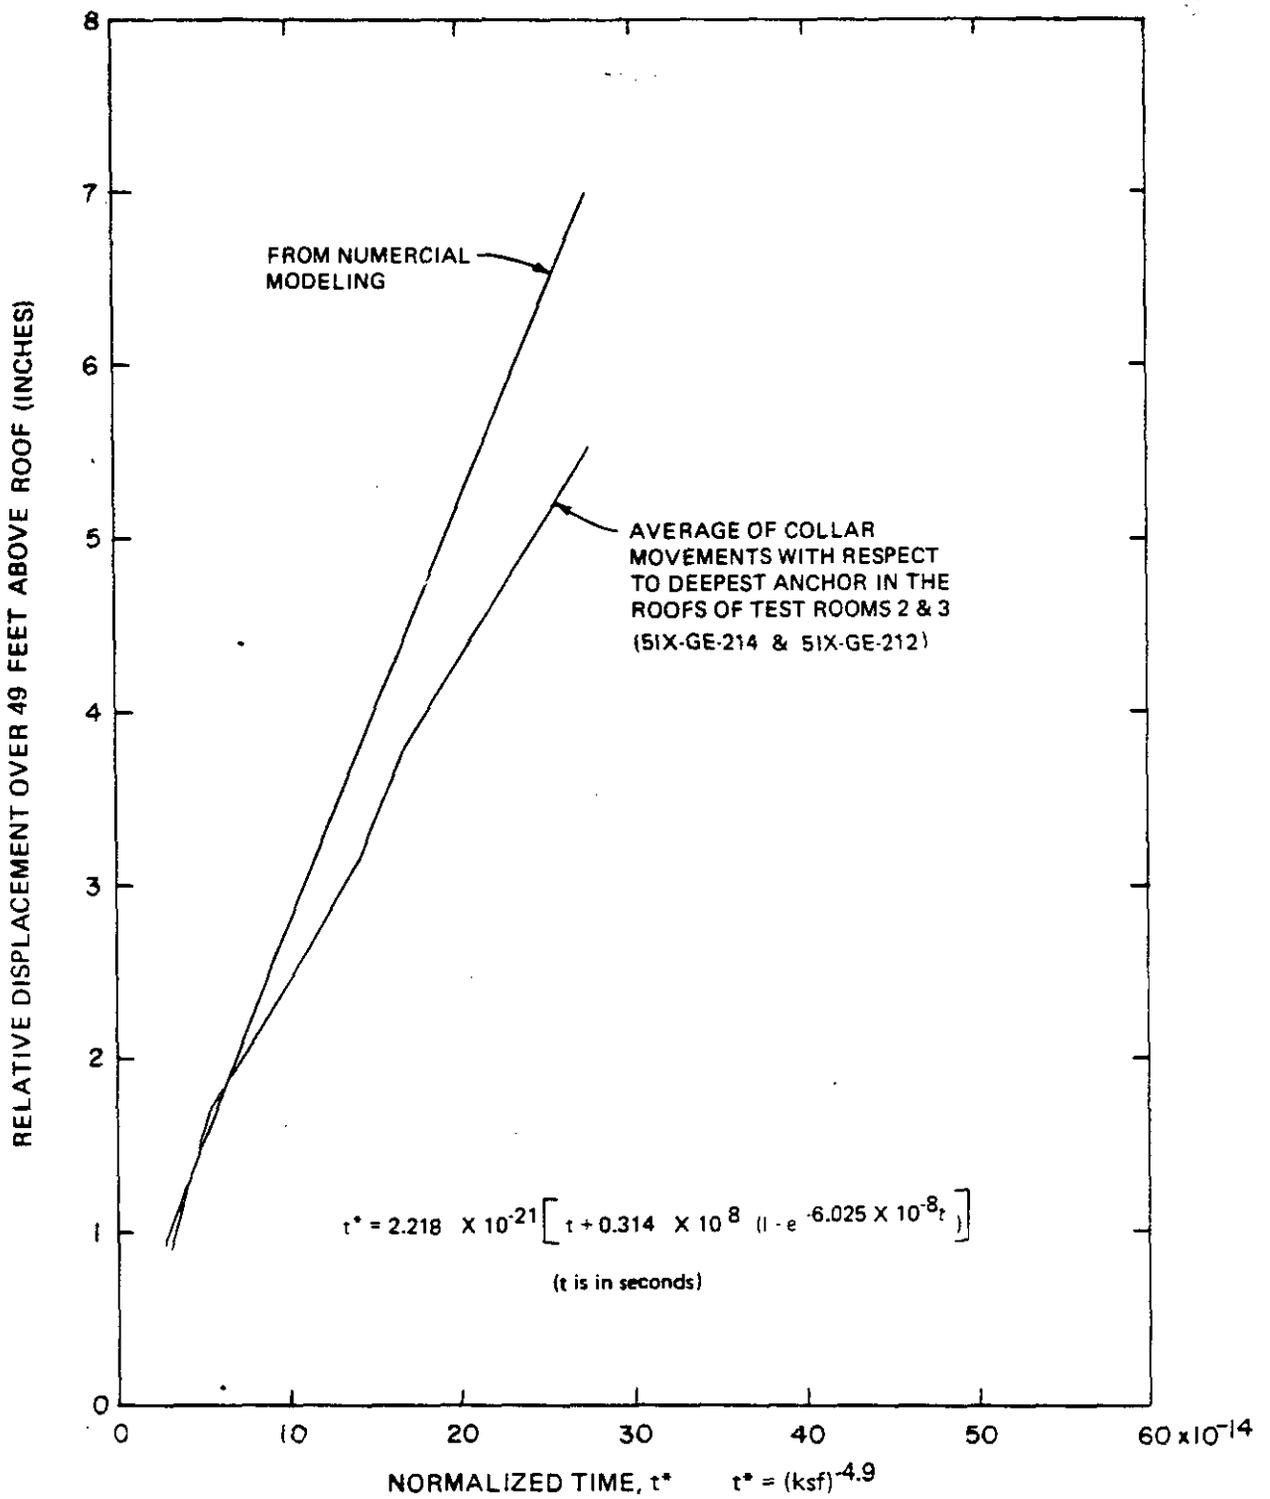
**Figure 11-33**

TEST ROOMS 2 AND 3 ROOF EXTENSOMETERS  
 NUMERICAL MODELING VERSUS IN SITU MEASUREMENT DATA

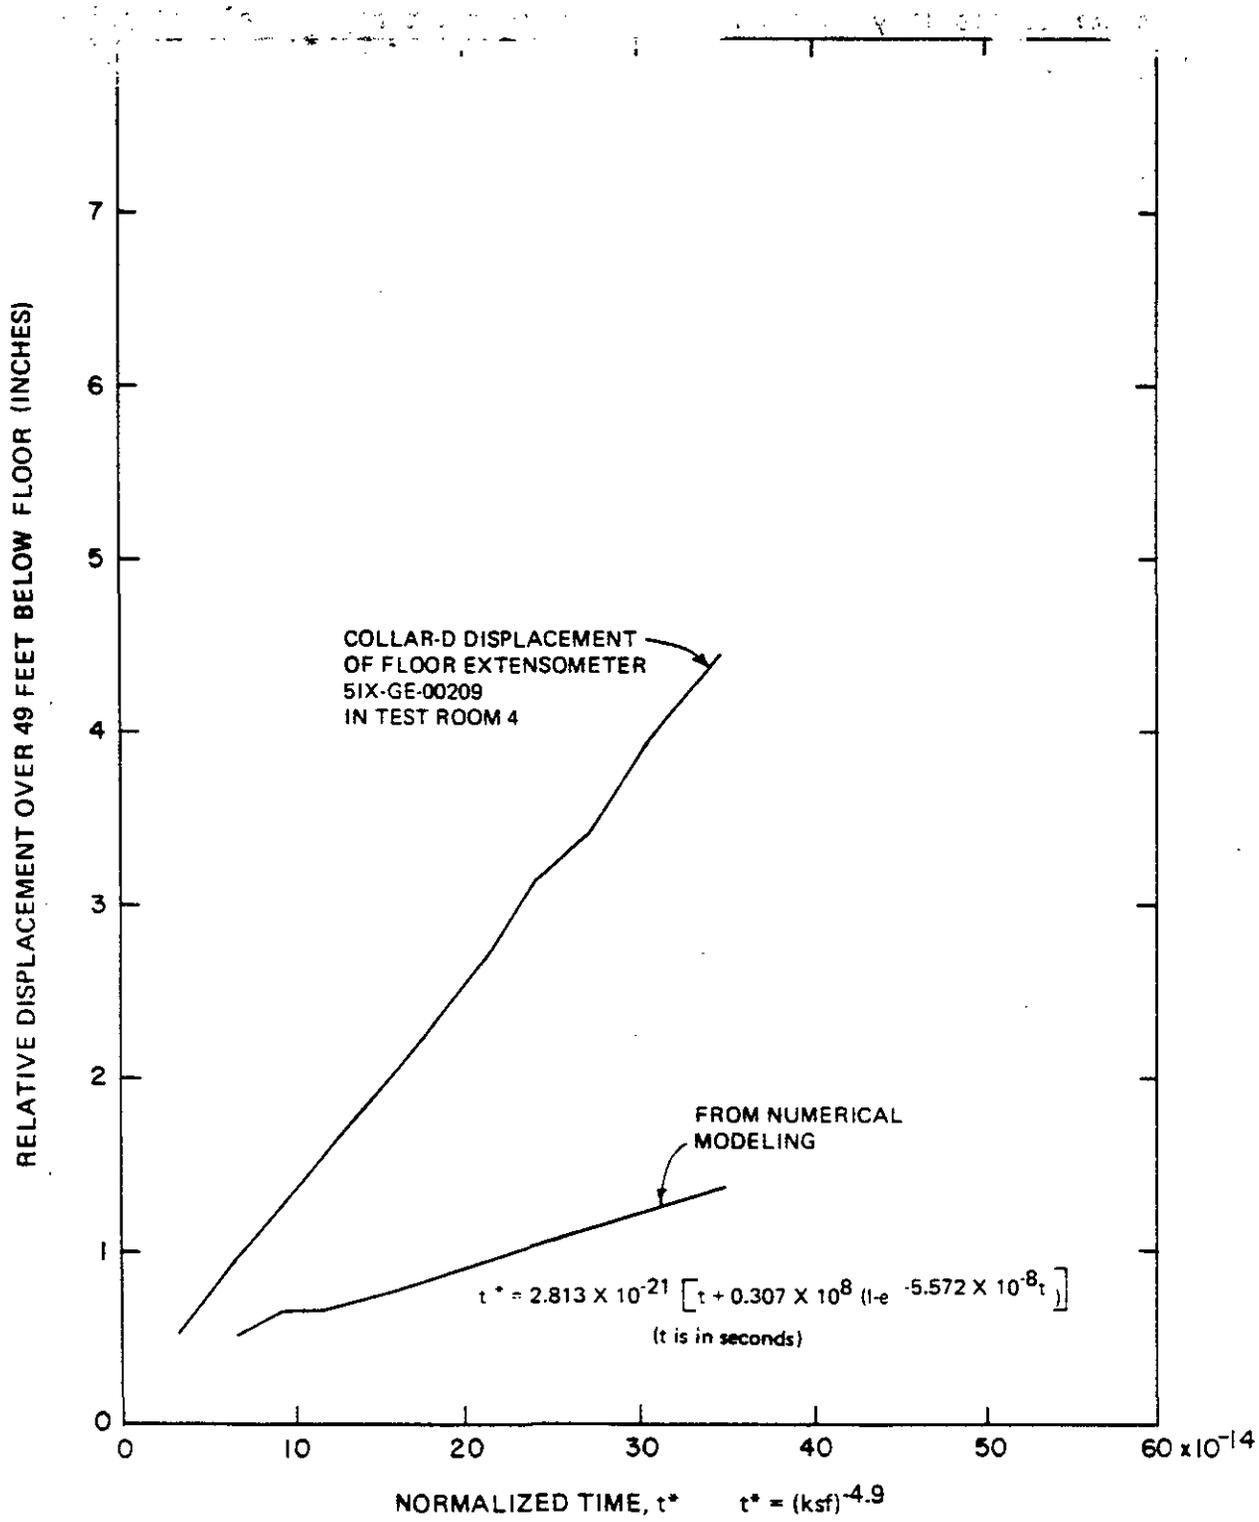
A comparison of salt heave measurement data from a floor extensometer in Test Room 4 was made with the values computed from numerical modeling. Figure 11-34 shows the results of this comparison. The numerical model underestimates the salt heave in the floor by approximately 70 percent of the measured value. This discrepancy is probably due to the assumption in the model that MB-139, 4.8 feet below the floor, is elastic and has infinite strength. Measurements from the floor extensometer and observations of fracturing indicate that MB-139 cannot be strictly considered as elastic. As discussed in subsection 11.3.2.1, borehole P4X-84 indicates the presence of lateral displacements and vertical separations in MB-139 beneath the floor of Test Room 4. This indicates that stresses in parts of the anhydrite bed may have reached the failure state.

**Figure 11-34**  
**TEST ROOM 4 FLOOR EXTENSOMETER**  
**NUMERICAL MODELING VERSUS IN SITU MEASUREMENT DATA**

Another possibility is that the fractures might have developed prior to excavation of the test rooms (ref. 6-6). In either case, assumptions of linear elasticity for the anhydrite bed become untenable. Modifications to the material characterization of this anhydrite material will be required to better represent its deformational behavior.

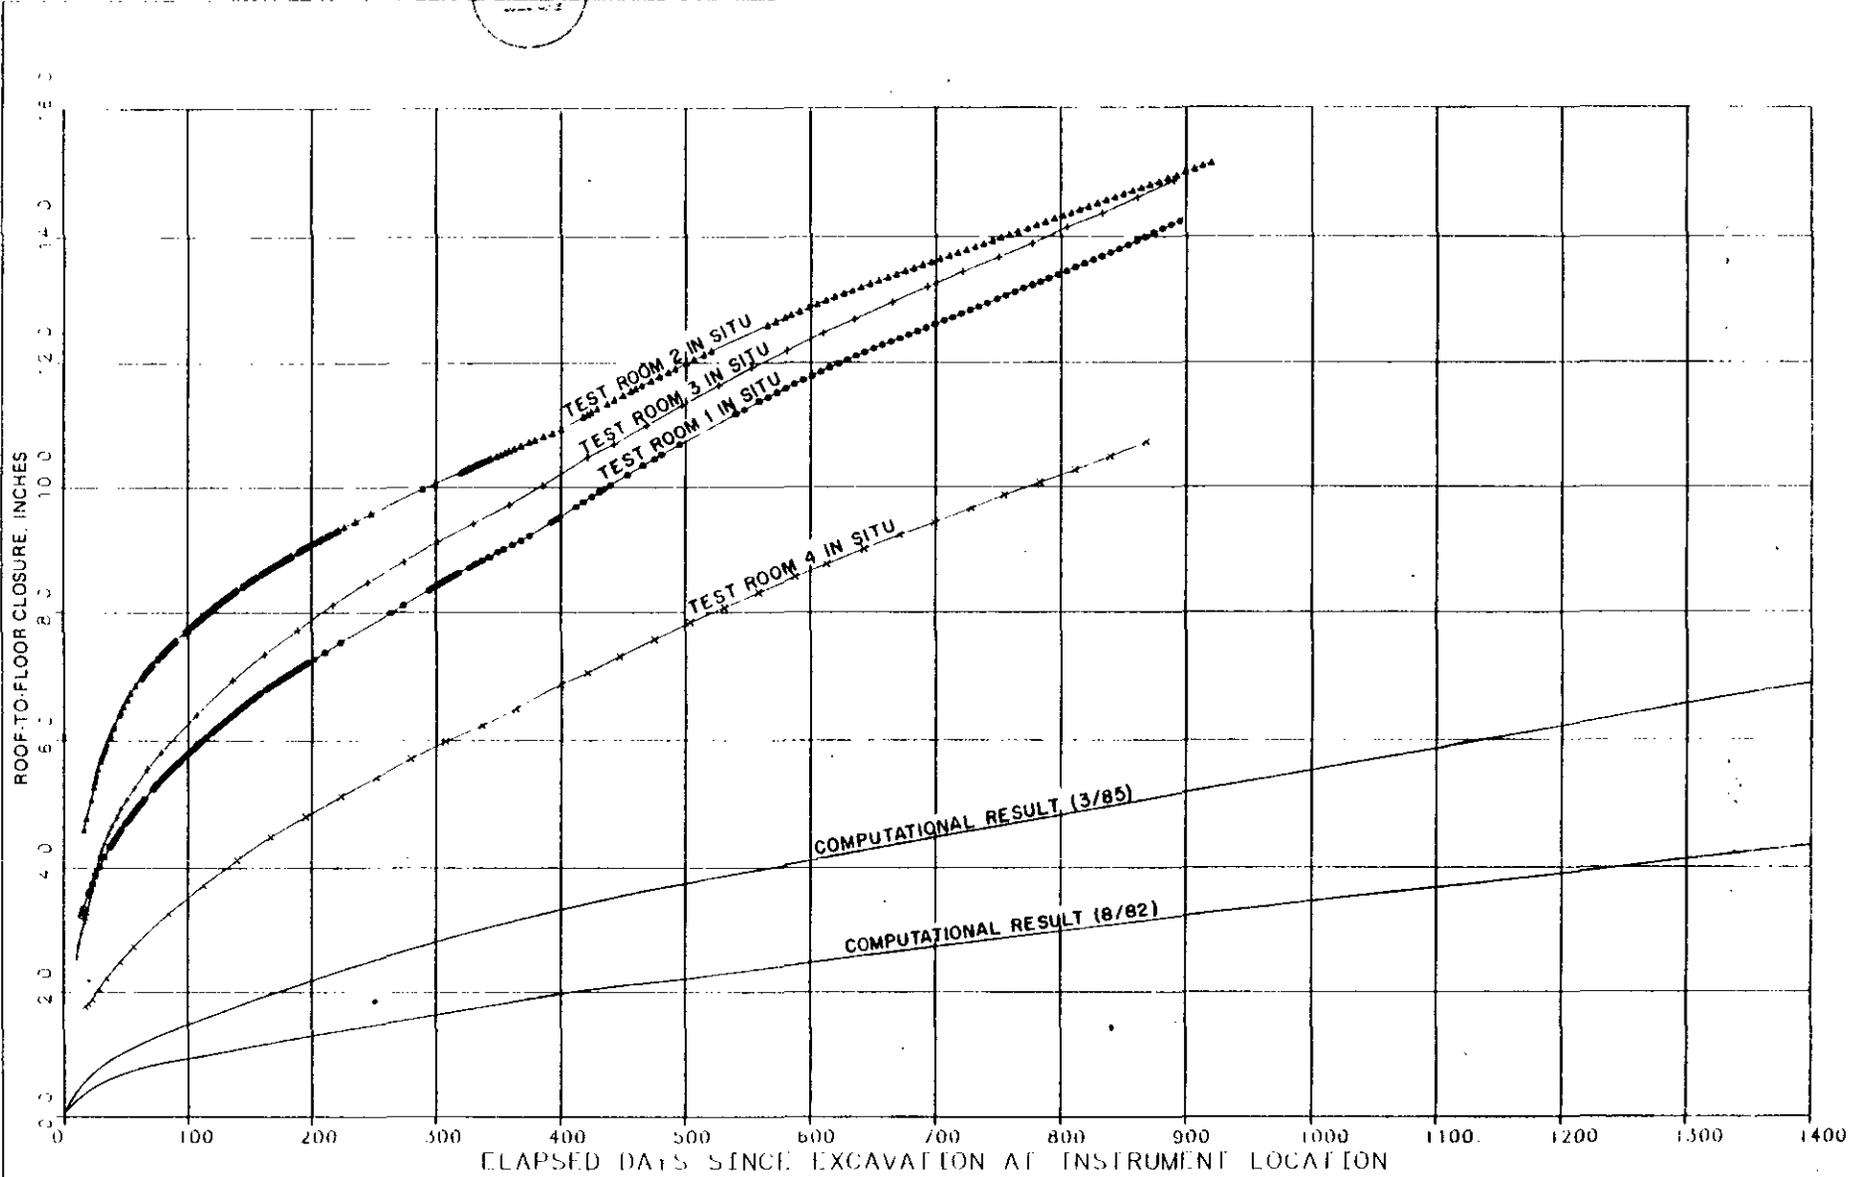
Figure 11-35

TEST ROOMS  
COMPARISON OF LABORATORY VERSUS IN SITU DATA

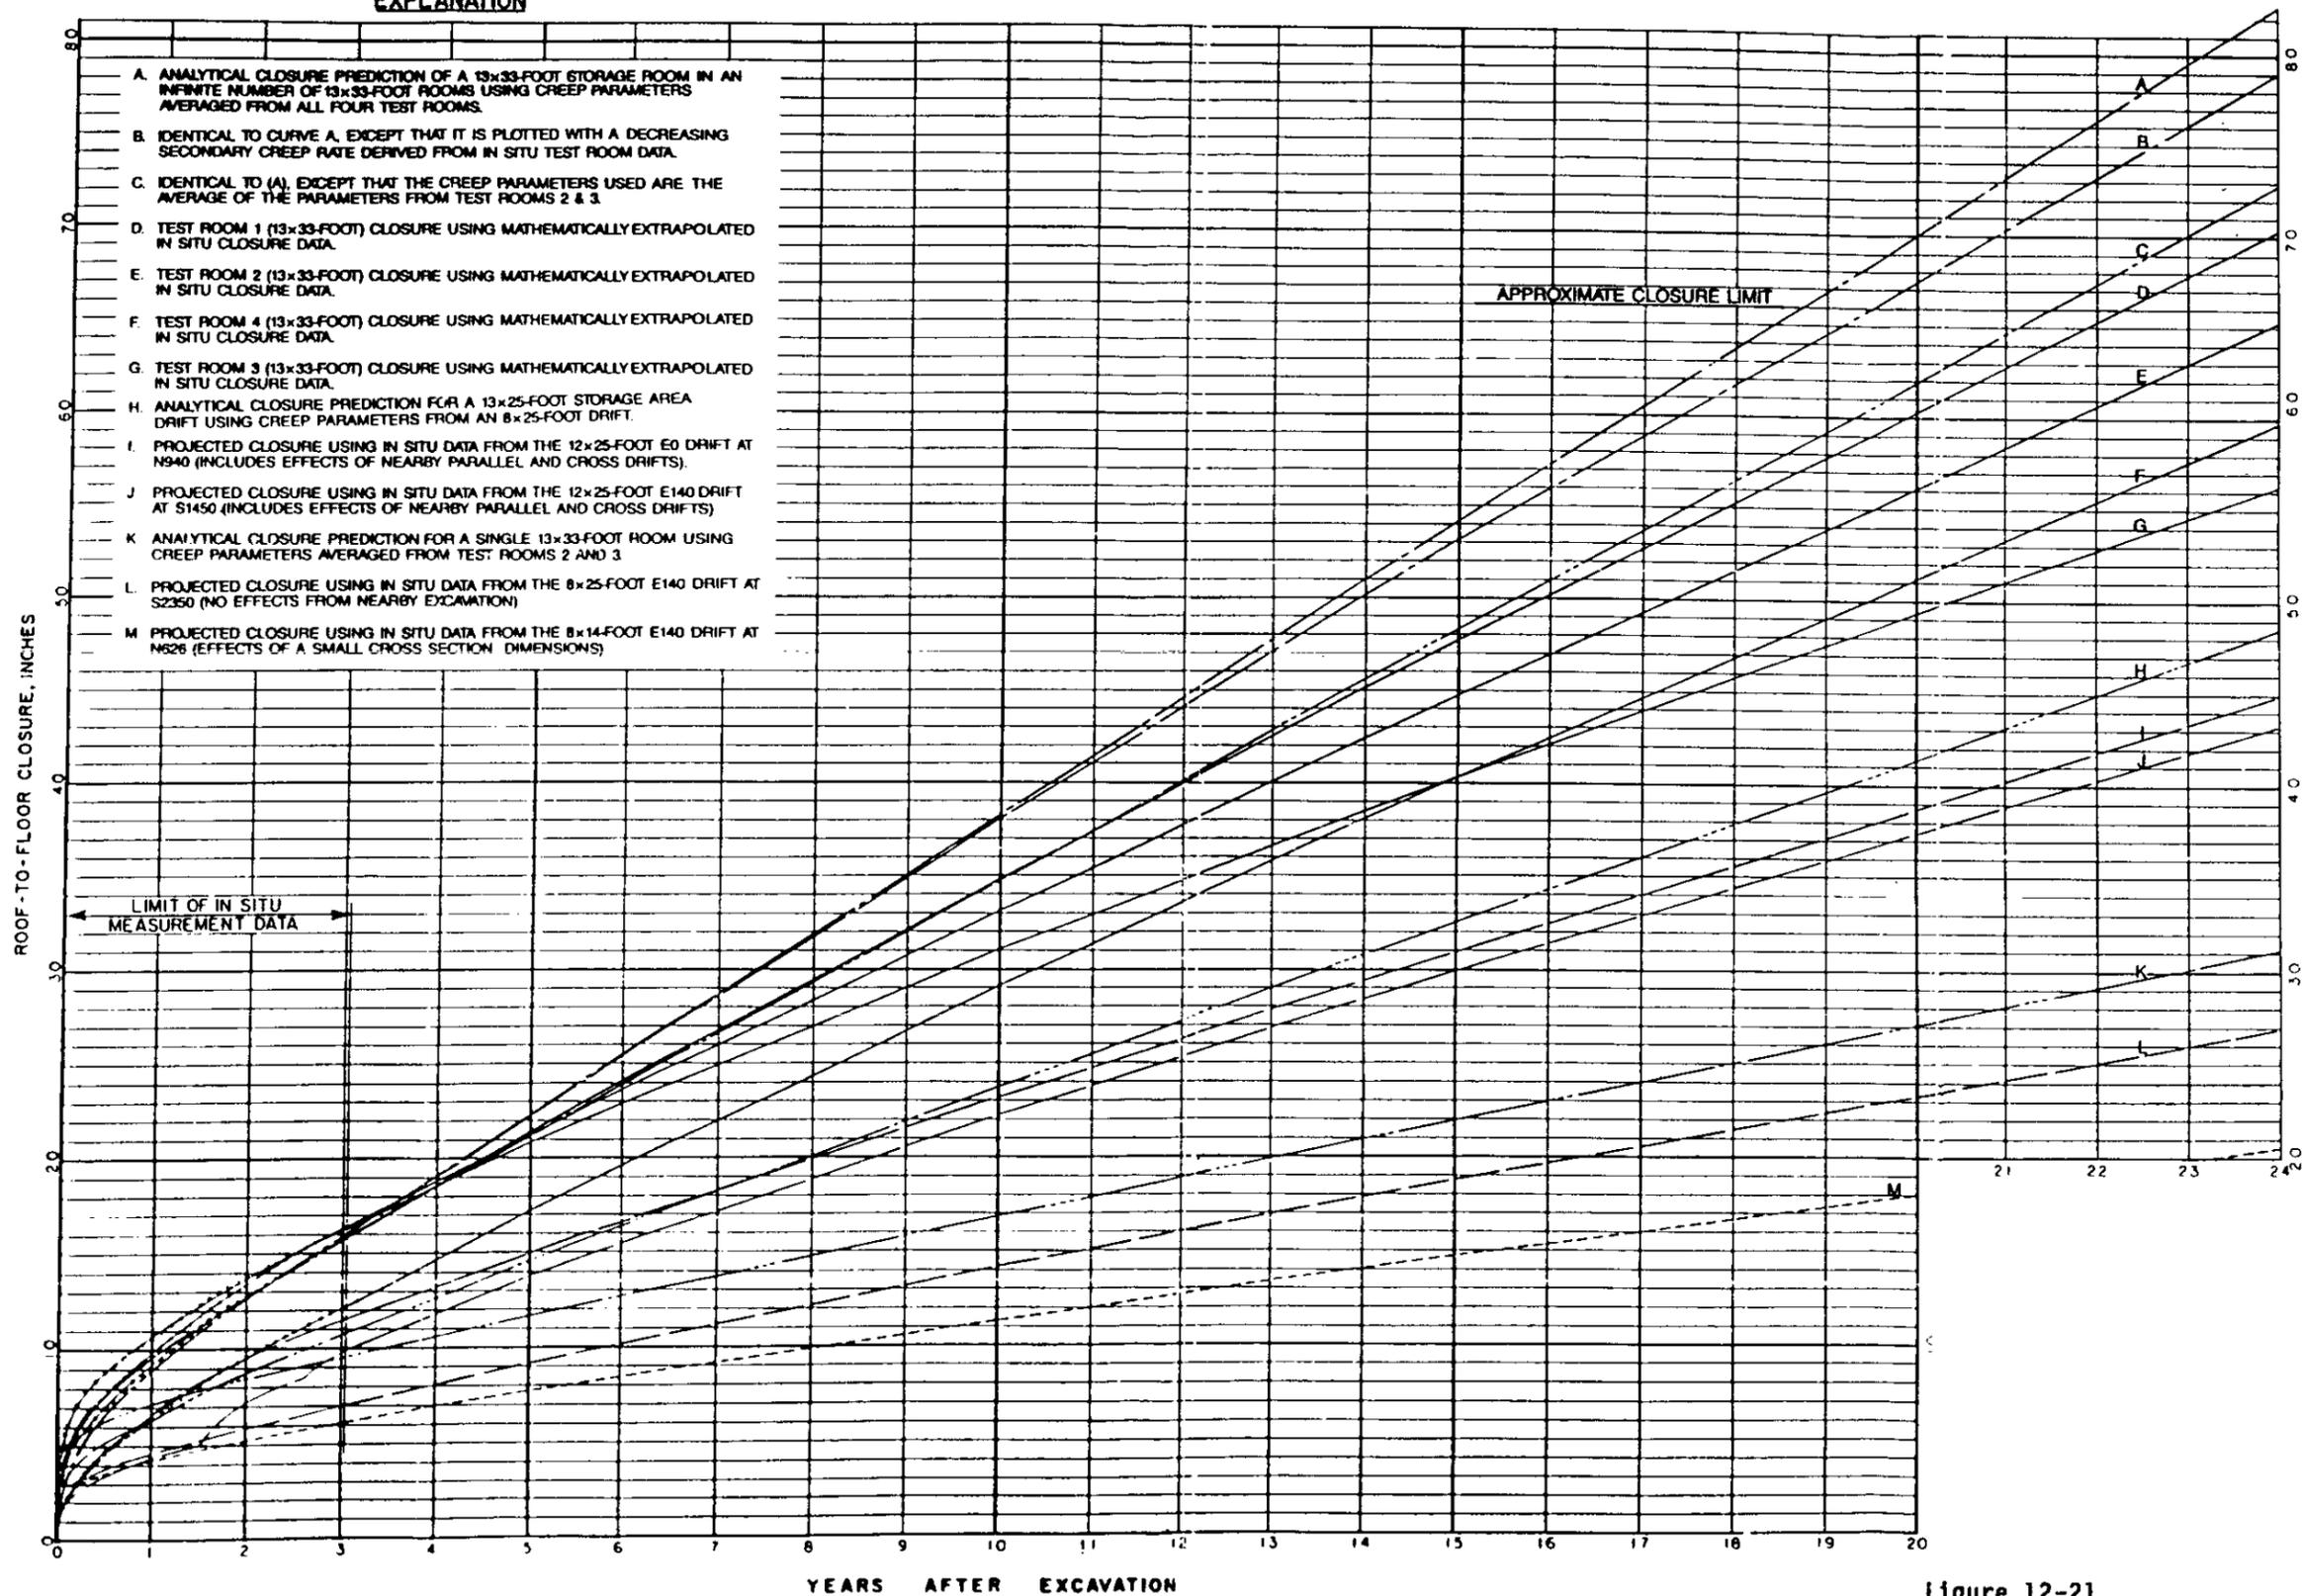
Figure 12-21

ROOF-TO-FLOOR CLOSURE  
GEOMETRY AND EXCAVATION EFFECTS

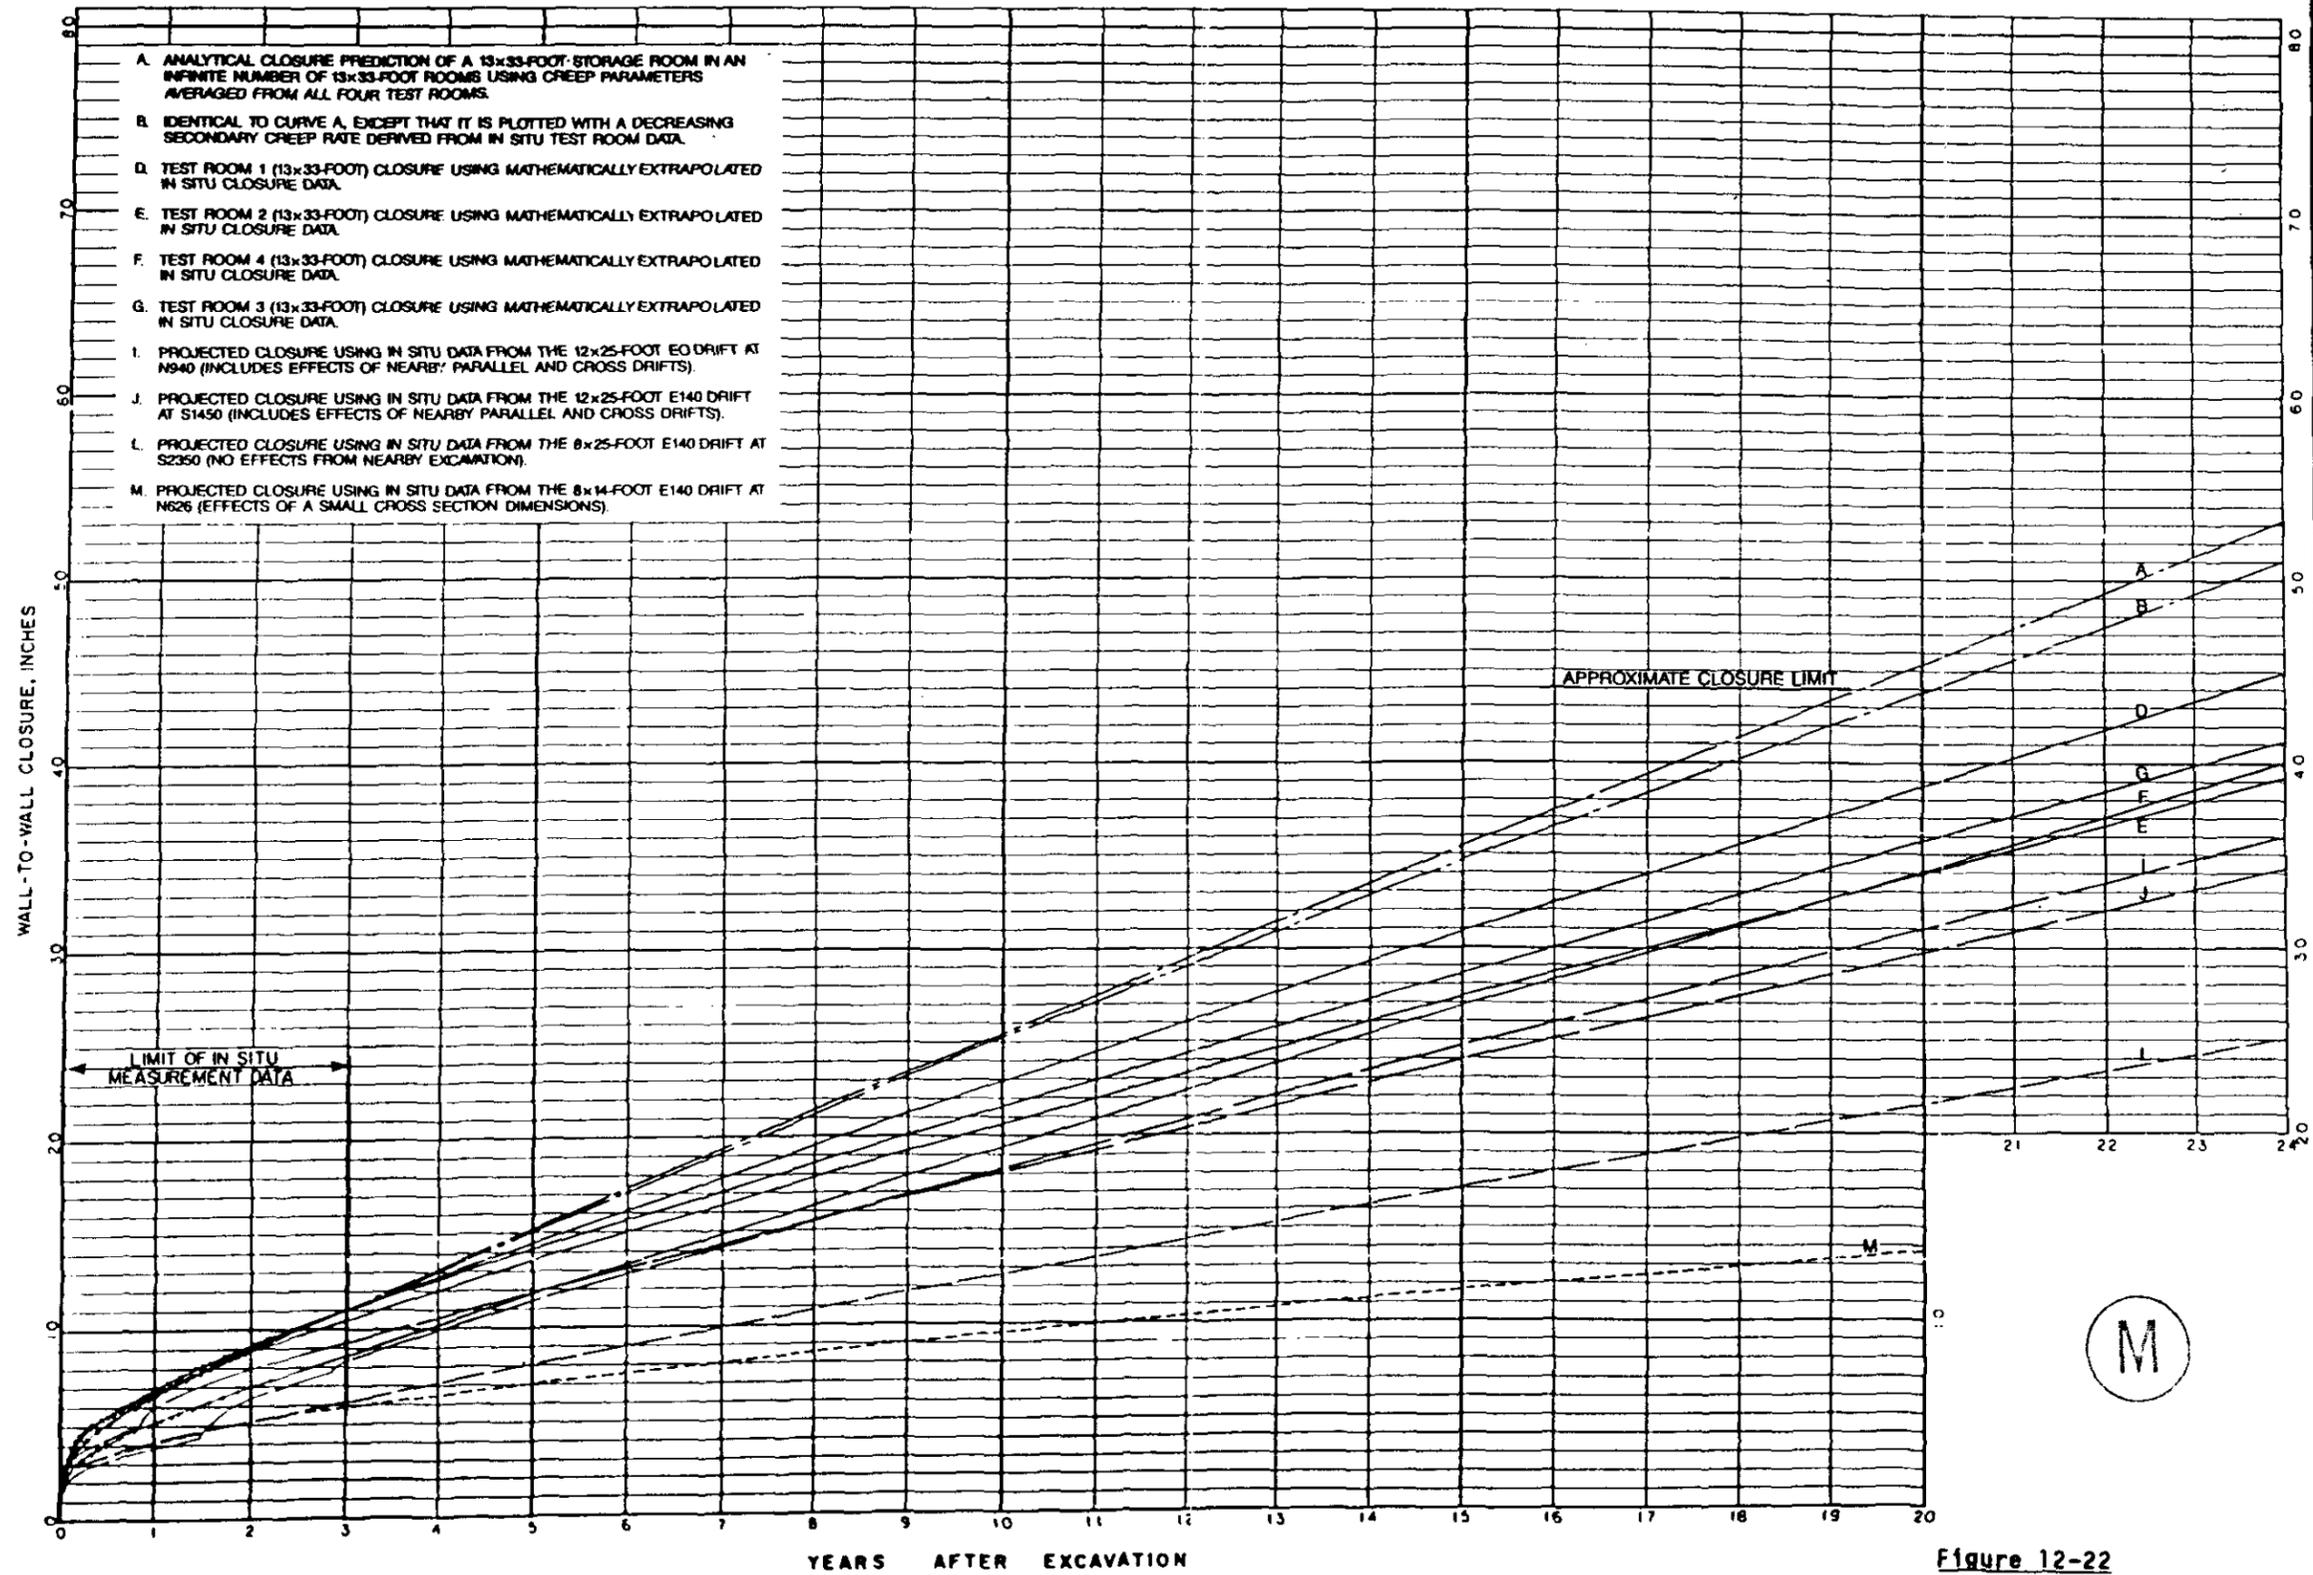
Figure 12-22

WALL-TO-WALL CLOSURE  
GEOMETRY AND EXCAVATION EFFECTS
