Waste Isolation Pilot Plant

Geotechnical Analysis Report For July 2010 – June 2011

**Geotechnical Analysis Report for July 2010 – June 2011
DOE/WIPP-12-3484, Vol. 1**

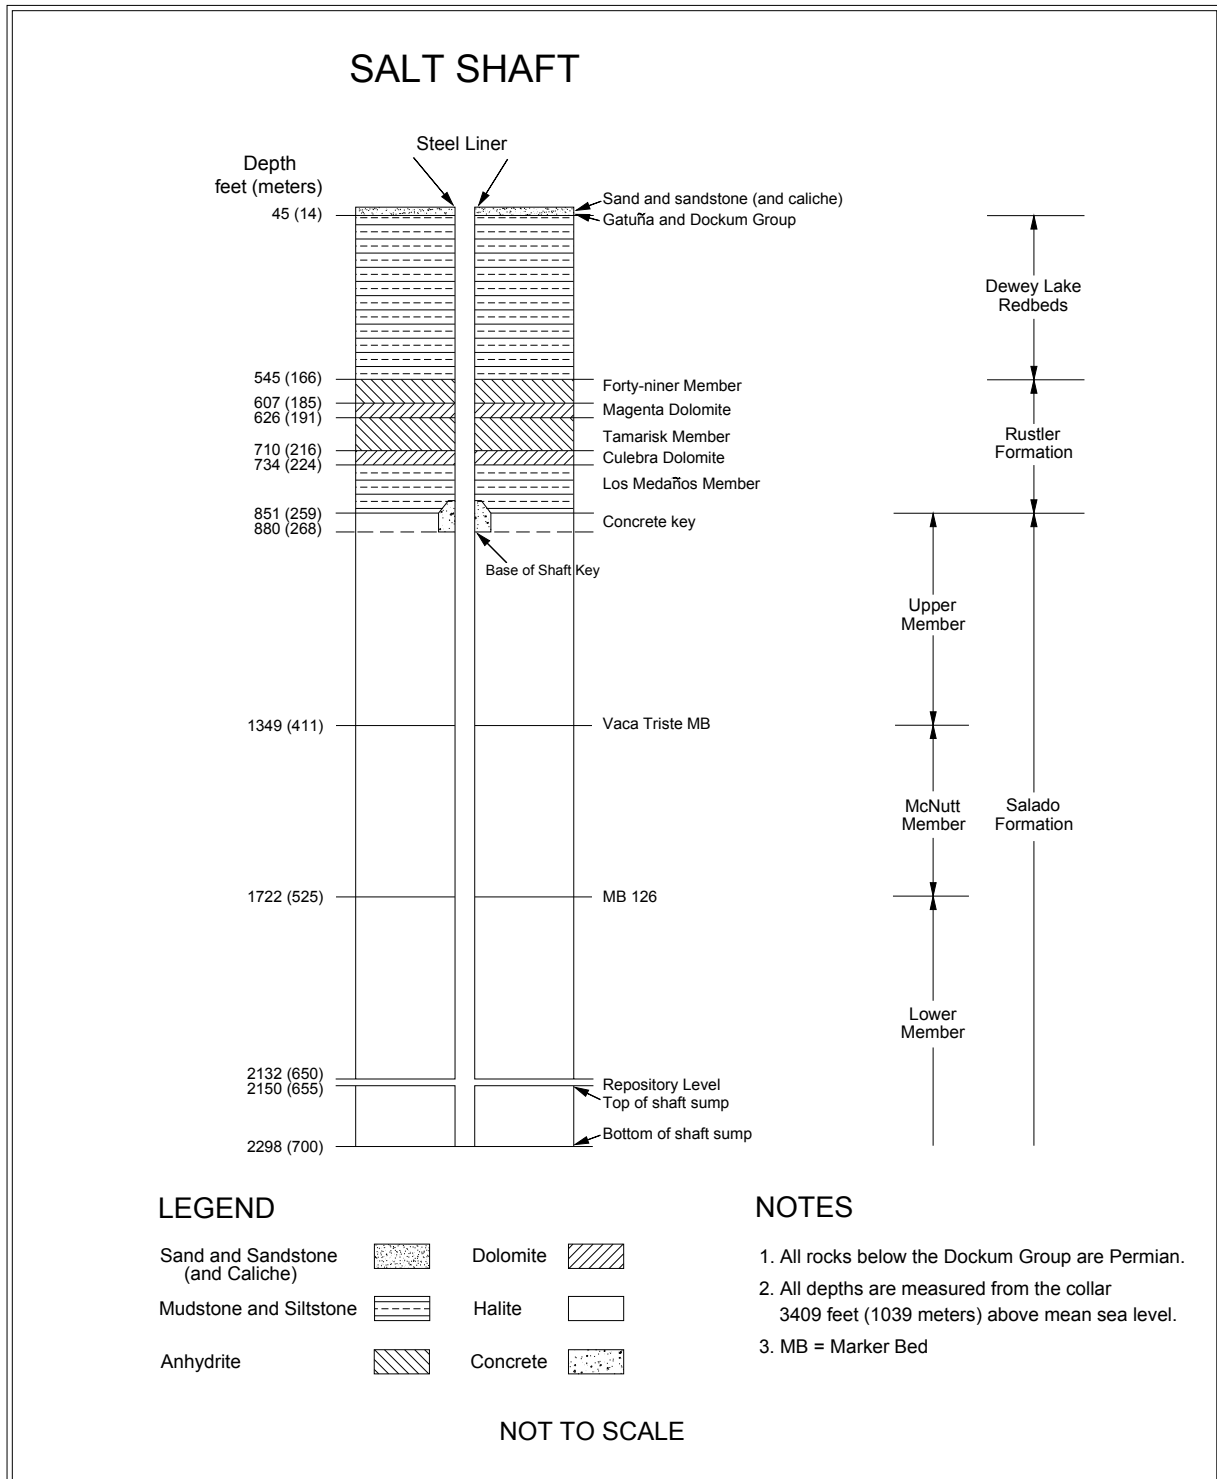
Figure 3-1 – Salt Shaft Stratigraphy

The first construction activity undertaken during the SPDV Program was the excavation of the Exploratory Shaft. This shaft was subsequently referred to as the Construction and Salt Shaft and is currently designated the Salt Shaft (see Figure 1-2). The shaft was drilled from July 4 to October 24, 1981, and geologically mapped in the spring of 1982 (DOE, 1983). Figure 3-1 presents the stratigraphy in the shaft.

The Salt Shaft is lined from the surface to 846 ft (258 m) with steel casing having an inside diameter of 10 ft (3-m). The thickness of the steel liner (including external stiffener rings) increases from 0.62 in (1.6 cm) at the top to 1.5 in (3.8 cm) at the key. Cement grout was placed between the liner and the rock face. The 10-ft (3-m) diameter extends through the concrete shaft key to 880 ft (268 m). The shaft key is a 37.5 ft (11.4-m) long, reinforced-concrete structure that begins 3.5 ft (1.07 m) above the bottom of the steel liner. From the key to the bottom at 2,298 ft (700 m), the shaft has a nominal diameter of 12 ft (4 m).

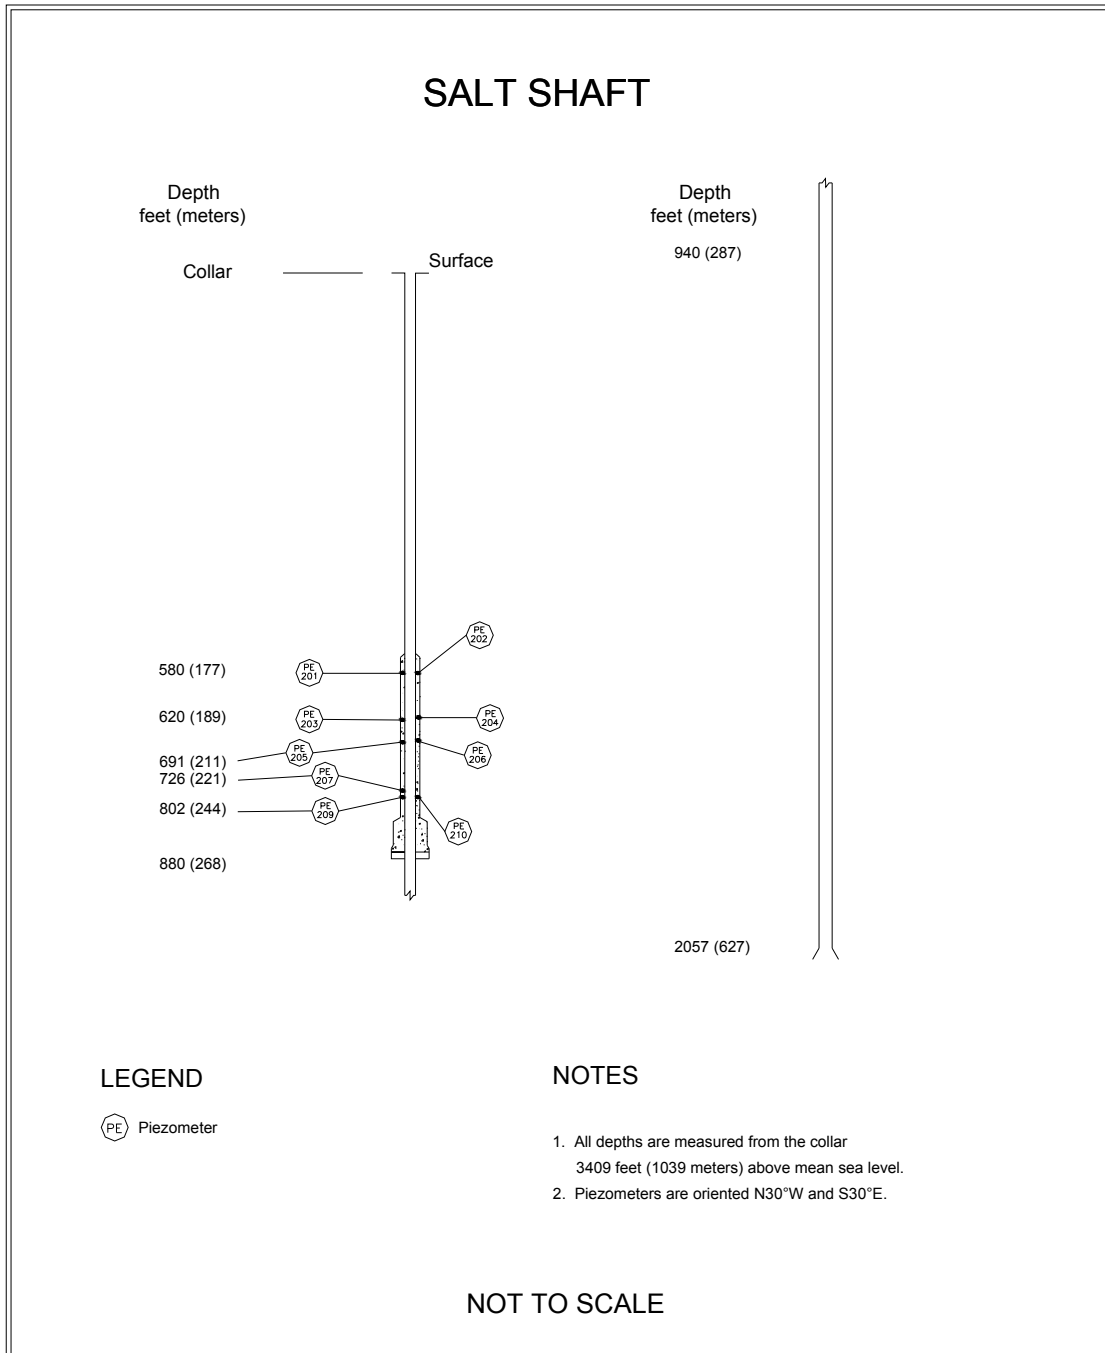
Figure 3-2 – Salt Shaft Instrumentation (Without Shaft Key)

Ten of the 12 piezometers continue to provide data. The fluid pressures recorded at the end of this reporting period range from approximately 60 pounds per square inch (psi) (414 kilopascals [kPa]) at the 802-ft (244-m) level in the Los Medaños Member to 188 psi (1,296 kPa) at the 691-ft (211-m) level in the Magenta Dolomite Member. The recorded pressures for this reporting period are generally consistent with the readings from the previous reporting period. The fluid pressure on the shaft liner will continue to be monitored on a regular basis.

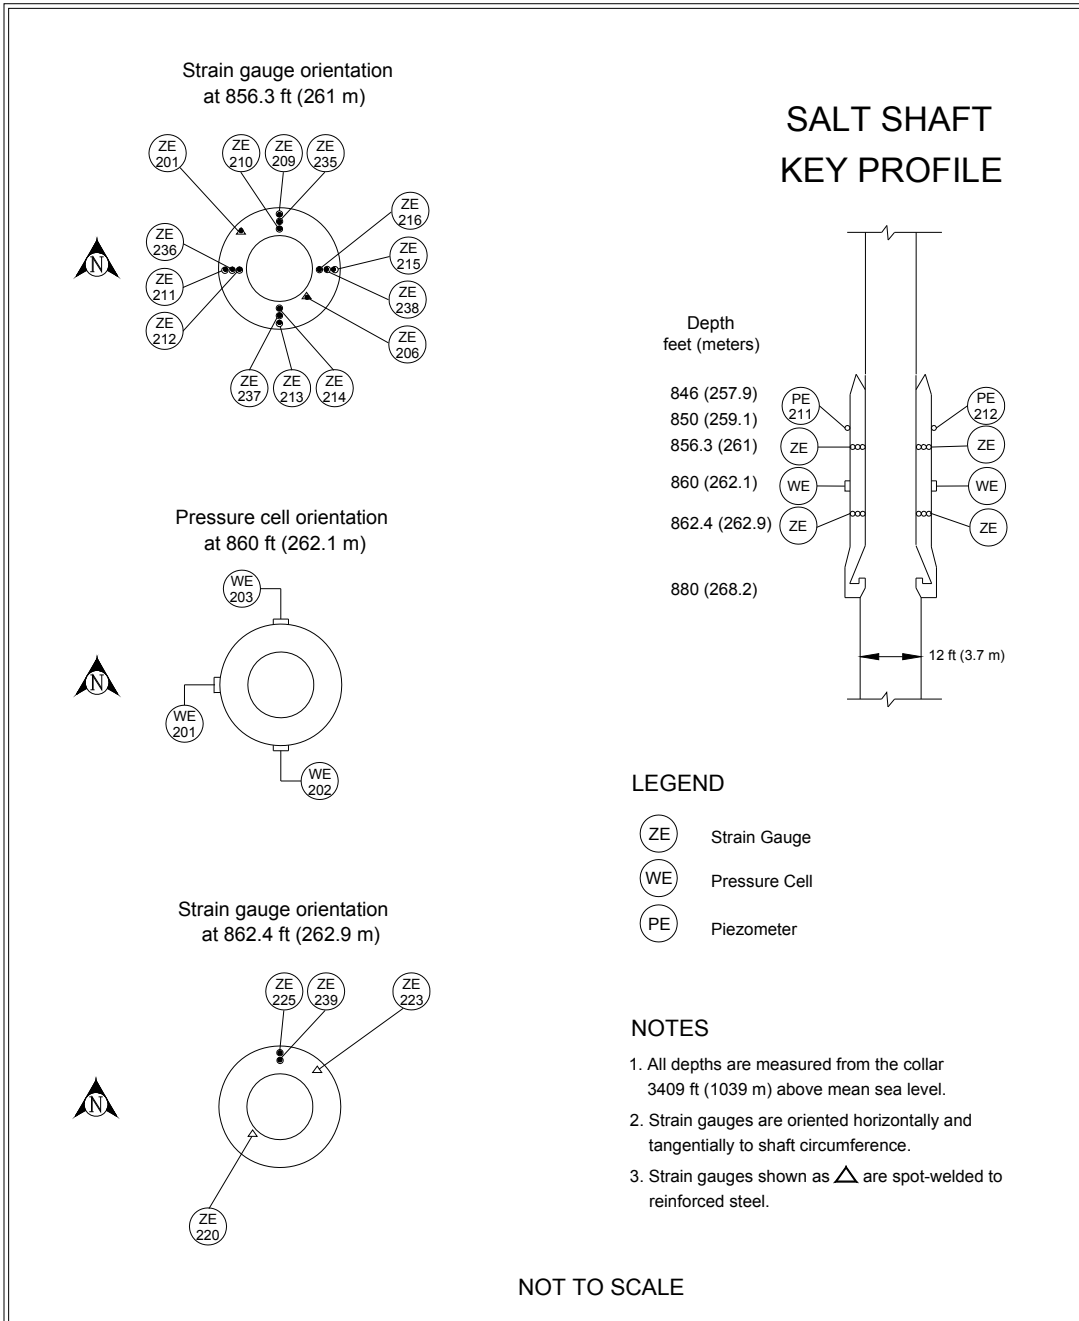
Figure 3-3 – Salt Shaft Key Instrumentation

Four earth pressure cells were installed in the key section during concrete emplacement at the 860-ft (262-m) level. These instruments measure the normal stress between the concrete key and the Salado Formation as salt creep loads up the key structure. Three of the four earth pressure cells continue to provide data. These instruments have indicated essentially no contact pressure since their installation (readings resemble instrument drift at a zero pressure). The maximum contact pressure recorded by the instruments for this reporting period is 7 psi (48 kPa).

Sixteen spot-welded and twenty-four embedment strain gauges were installed on and in the shaft key concrete at both the 856.3-ft (261-m) level and at the 862.4-ft (263-m) level. Four spot-welded strain gauges are still functioning at these levels. Strains at the 856.3-ft (261-m) level were 653 and 746 microstrain. Strains at the 862.4 ft (263 m) level were 705 and 906 microstrain. Fourteen embedment strain gauges are still functioning. The strains at the 856.3-ft (261-m) level ranged from -891 to 998 microstrain. The strains from the two embedment strain gauges at the 862.4 ft (263-m) level were 271 to 391 microstrain. The strains recorded by the spot-welded strain gauges and the embedment strain gauges during this reporting period are very similar to the strains recorded by these instruments at the end of the previous reporting period.

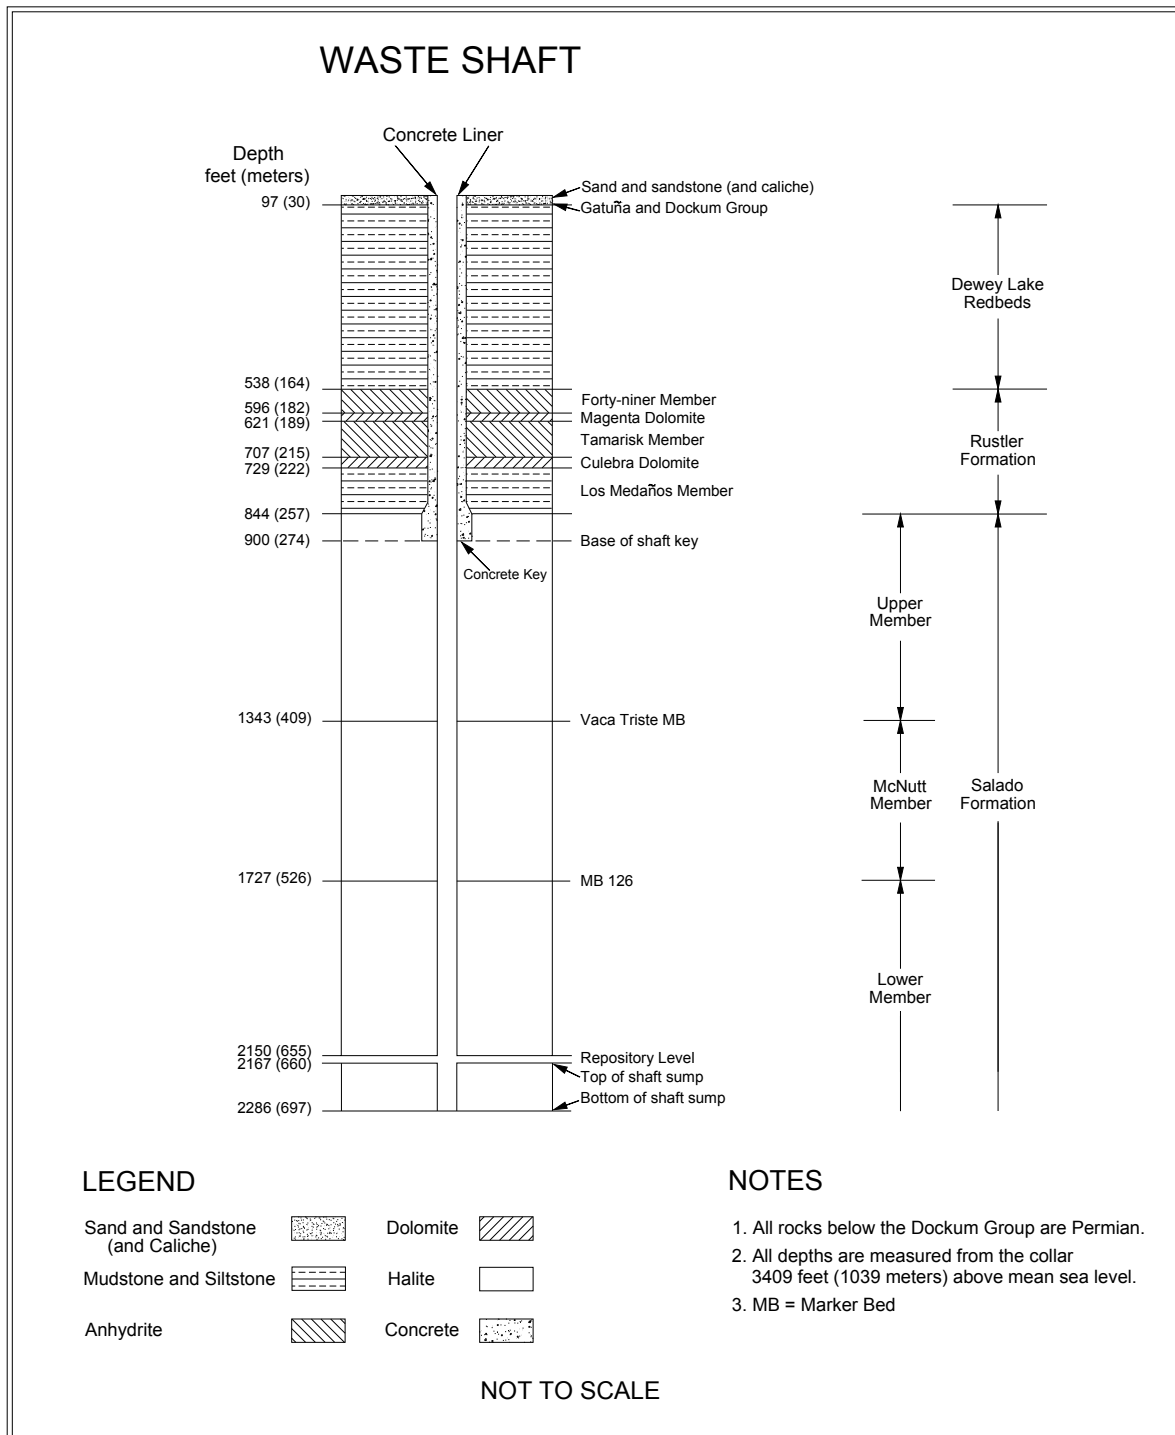
Figure 3-4 – Waste Shaft Stratigraphy

The Waste Shaft is lined with non-reinforced concrete having a 19 ft (6 m) inside diameter from the surface to the top of the key at 837 ft (255 m). Liner thickness increases from 10 in (25 cm) at the surface to 20 in (51 cm) at the key. The key is 63 ft (19 m) long and 4.25 ft (1.3 m) thick and is constructed of reinforced concrete. The bottom of the key is 900 ft (274 m) below the surface. The diameter of the shaft is 20 ft (6 m) at the bottom of the key and increases to 23 ft (7 m) just above the shaft station. The shaft below the key is lined with wire mesh anchored by rock bolts. The diameter of 23 ft (7 m) extends to a depth of approximately 2,286 ft (697 m), with the shaft sump comprising the lower 119 ft (36 m) of that interval.

As part of the SPDV Program, a 6-ft (2-m) diameter ventilation shaft, now referred to as the Waste Shaft, was excavated from December 1981 through February 1982 (see Figure 1-2). This shaft, in combination with the Salt Shaft, provided a two-shaft underground air circulation system. From October 11, 1983, to June 11, 1984, the shaft was enlarged to a diameter of 20 to 23 ft (6 to 7 m) and lined above the key. Stratigraphic mapping (Figure 3-4) was conducted during shaft enlargement from December 9, 1983, to June 5, 1984 (Holt and Powers, 1984).

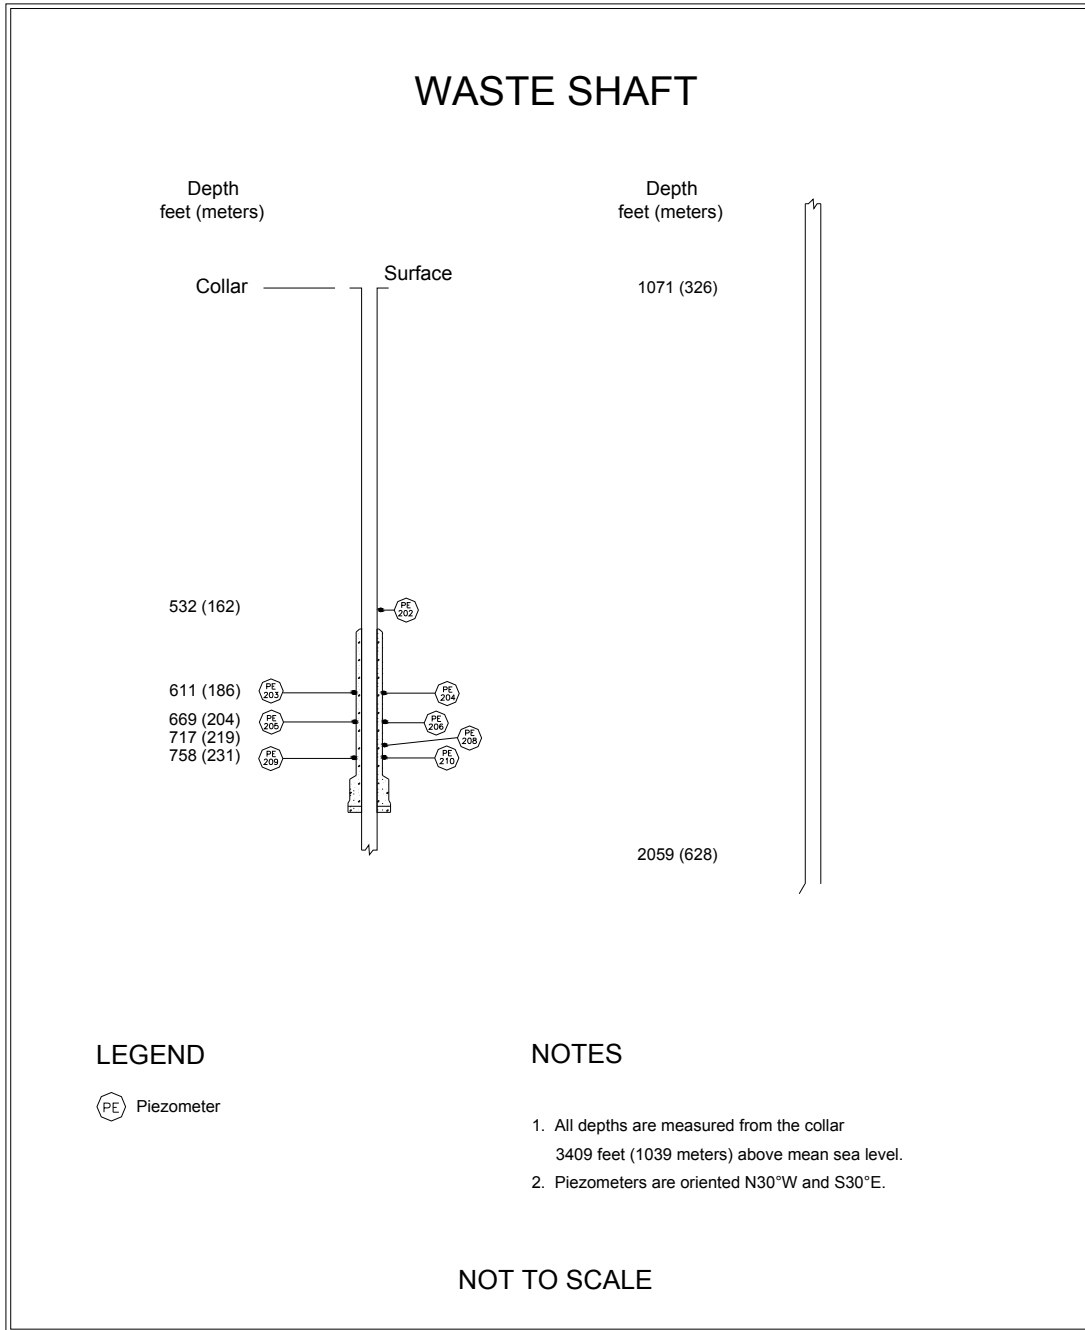
Figure 3-5 – Waste Shaft Instrumentation (Without Shaft Key)

Twelve piezometers were installed in the lined section of the Waste Shaft on September 7 and 8, 1984, to monitor fluid pressure behind the shaft liner and the key section. Data continue to be received from 4 piezometers. The maximum recorded fluid pressure during this reporting period was 138 psi (951 kPa) at the 717-ft (219-m) level. The pressure readings during this reporting period were consistent with the readings from the previous reporting period with a mean change in pressures of 5 psi (34 kPa).

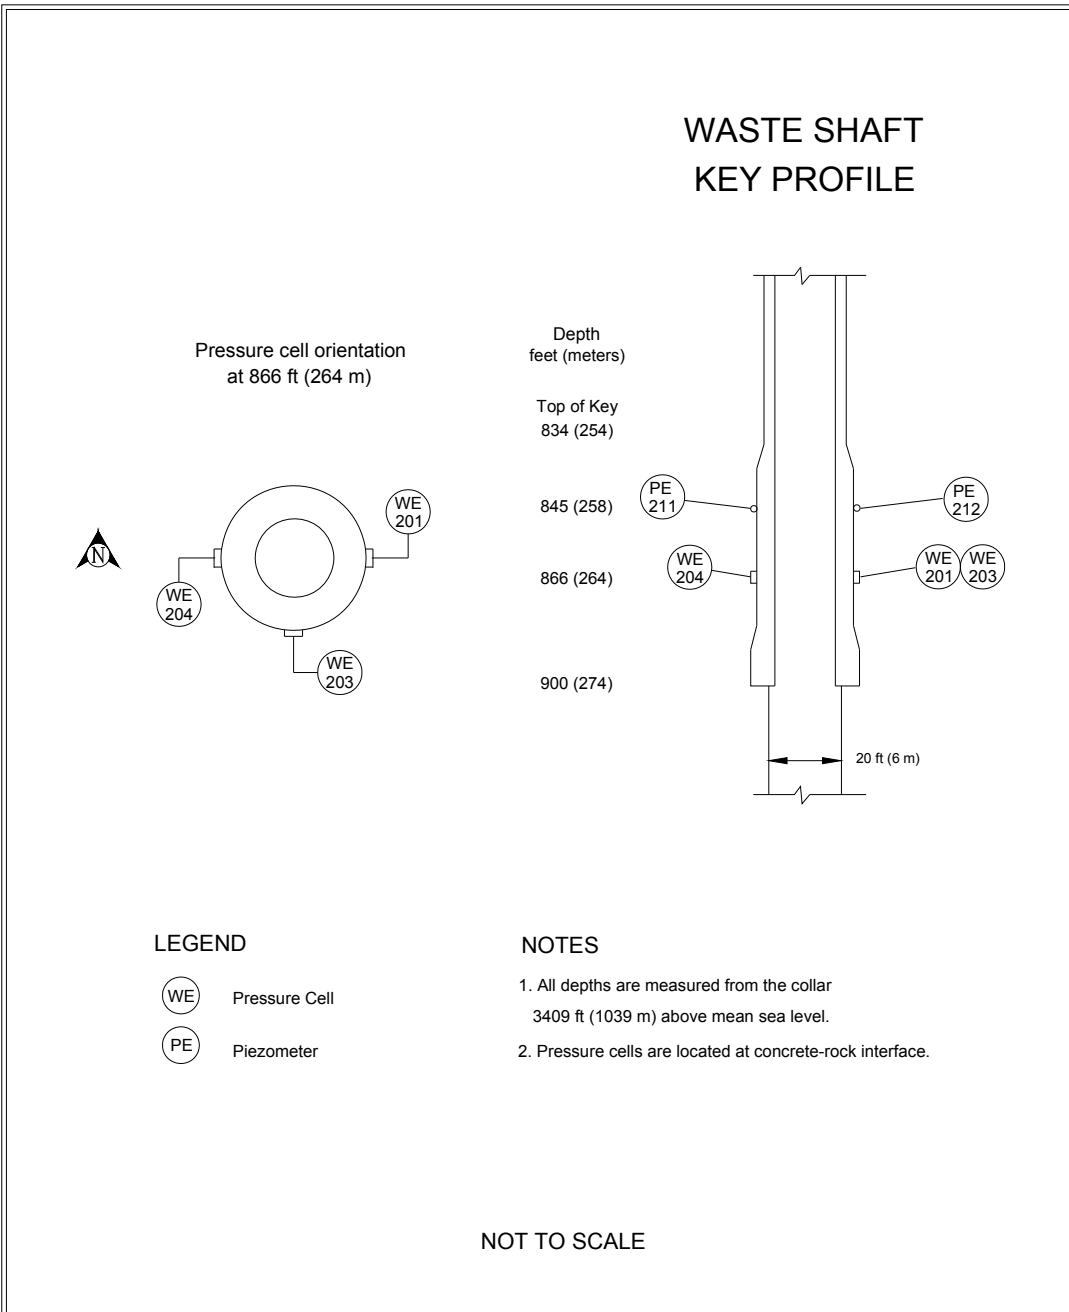
Figure 3-6 – Waste Shaft Key Instrumentation

Four earth pressure cells were installed in the key section of the Waste Shaft during concrete emplacement between March 23 and April 3, 1984. One is still working. Earth pressure cells measure the normal stress between the concrete key and the Salado Formation as salt creep loads the key structure. The contact pressure recorded by the instrument during this reporting period was 118 psi (814 kPa) at the 866 ft (264 m) level.

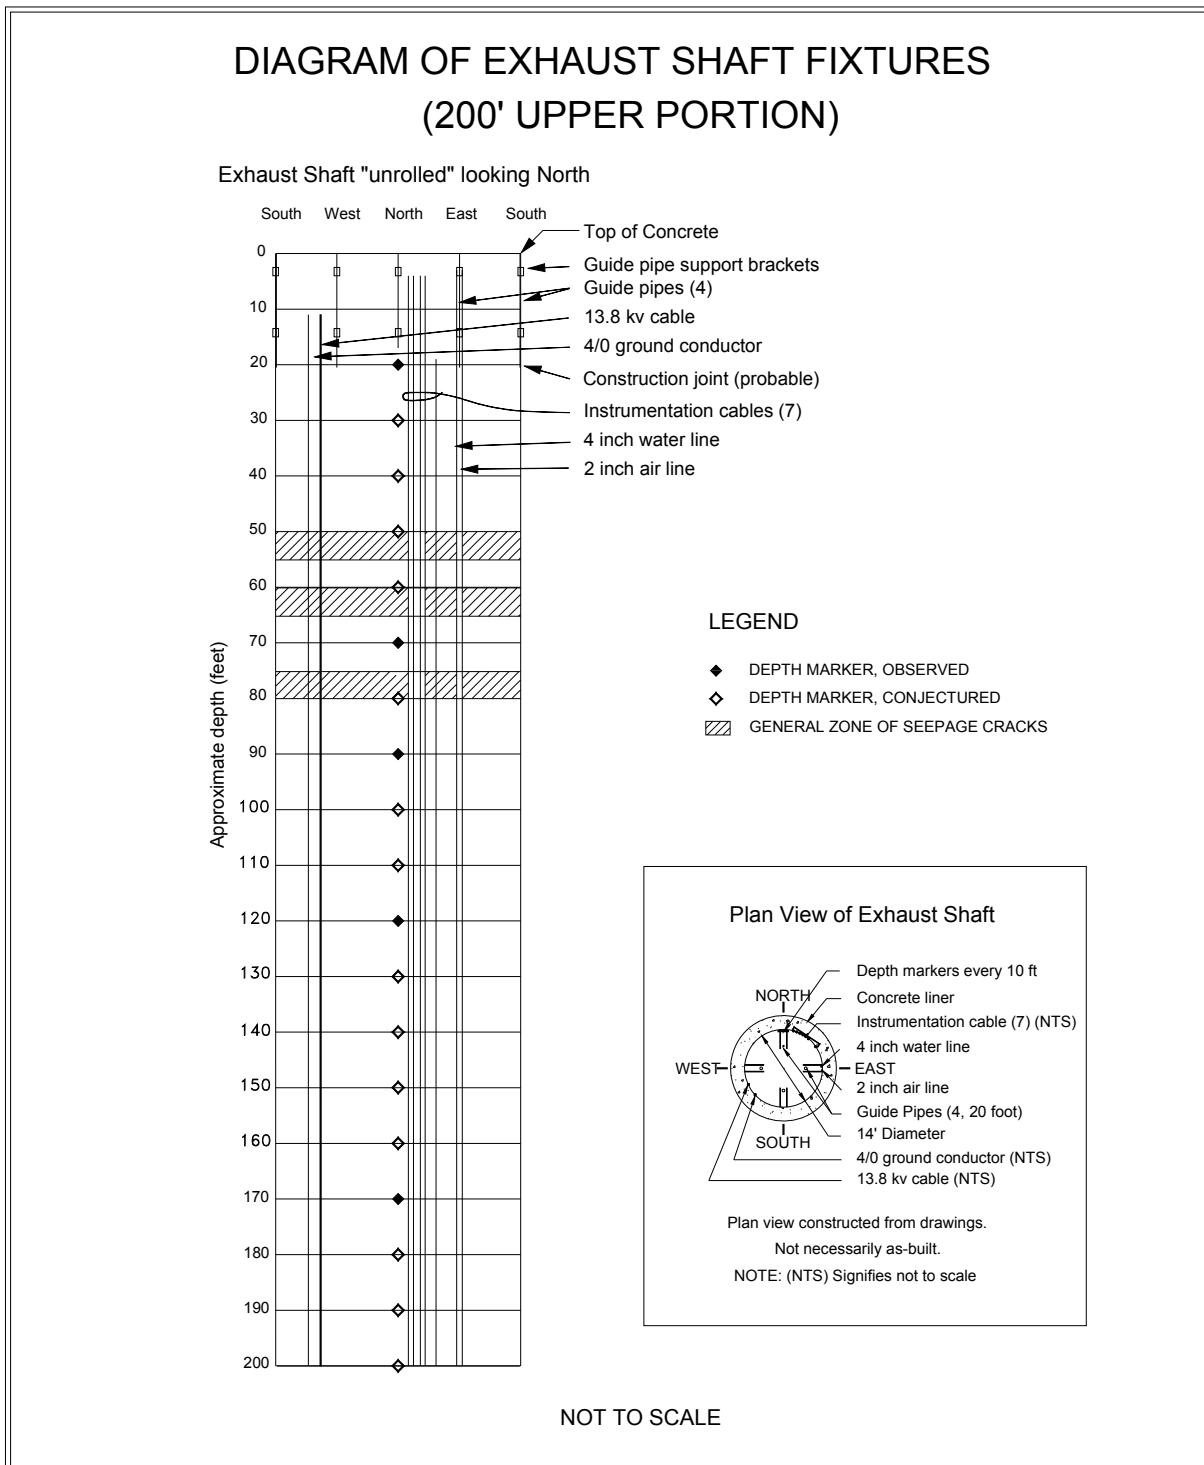
Figure 3-9 – Diagram of Exhaust Shaft Fixtures and Seepage Zones (Upper 200 ft)

The Exhaust Shaft liner is examined for cracks, seepage, and general shaft stability. Currently, there are three principal zones of seepage in the shaft. The first is about 50 to 55 ft below the shaft collar (bsc). The second is about 60 to 65 ft bsc. The third is

about 75 to 80 ft bsc, as shown in Figure 3-9. Monitoring of seepage horizons started before 1995. Water entering the shaft through these cracks is believed to originate from a perched aquifer at the base of the Santa Rosa Formation that is being recharged as the result of surface modifications at the site. The fluid level in the Santa Rosa near the shaft is about 46 to 47 ft below the surface. Based on examination of inspection videos, the flow rate into the shaft during this reporting period is estimated at about 1 to 1 1/2 gallons per minute, most of which is carried out of the shaft by the exhaust air. Seepage cracks are confined primarily to the eastern side of the shaft wall.

Though the Magenta and Culebra water rings are encrusted with salt buildup, no water appears to originate from the liner or water rings. Most of the seepage was observed along the east face of the shaft wall near the instrumentation cables and the air lines and water-lines in the upper section of the shaft. Though the presence of water is an inconvenience requiring periodic disposal, at this time it does not appear to have created any hazard or affected the structural integrity of the shaft. However, brine increases the probability of corrosion and deterioration of utility hangers and brackets. There are no visible signs of dissolution of the salt below the key.

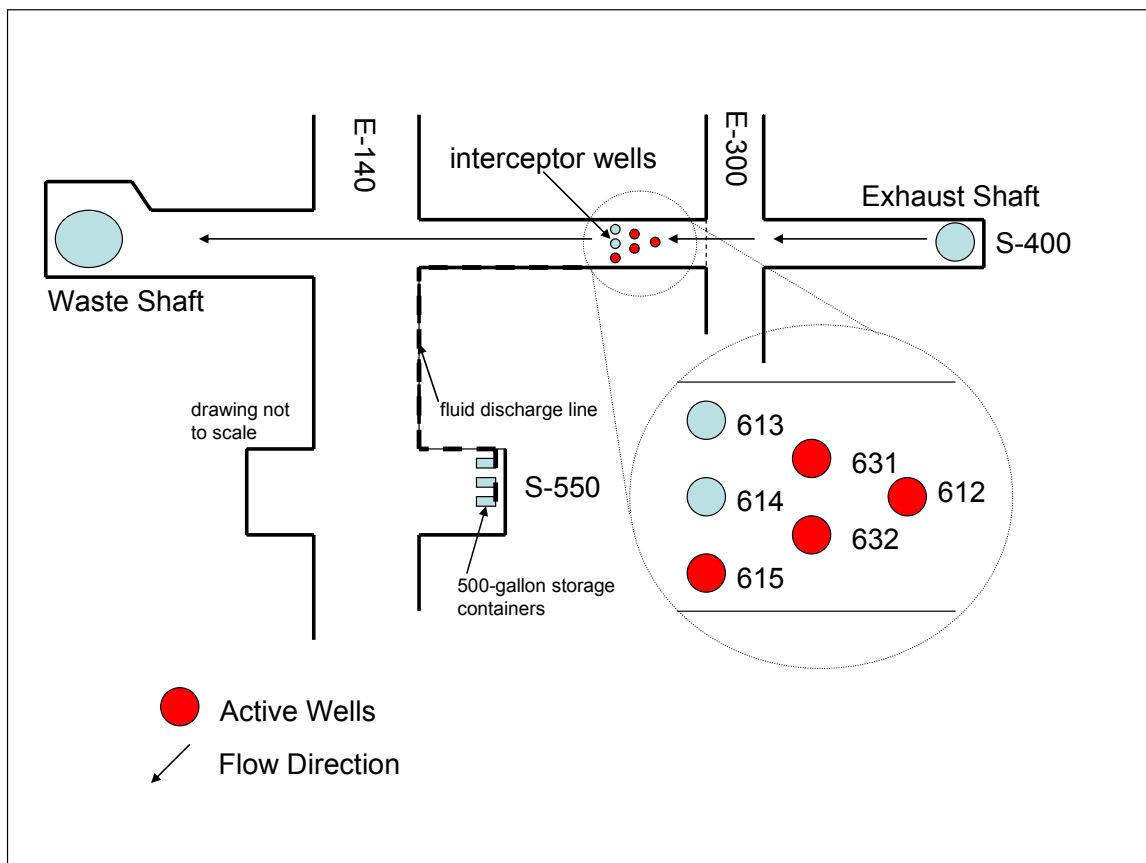
Figure 3-10 – Location of Interception Wells and Storage Containers

Between February 2 and 6, 2008, two additional fluid collection holes, OH631 and OH632, were drilled in S-400 to improve the total volume of fluid recovered by the interception well system. They replaced OH613 and OH614 which generated little fluid. As with the previous four holes, the additional holes were drilled at 9-7/8-inch diameter to a total depth of 30 feet. Pumps were pulled from OH613 and OH614 and installed in OH631 and OH632. Figure 3-10 shows the location of the interception wells system and the 500-gallons storage containers.

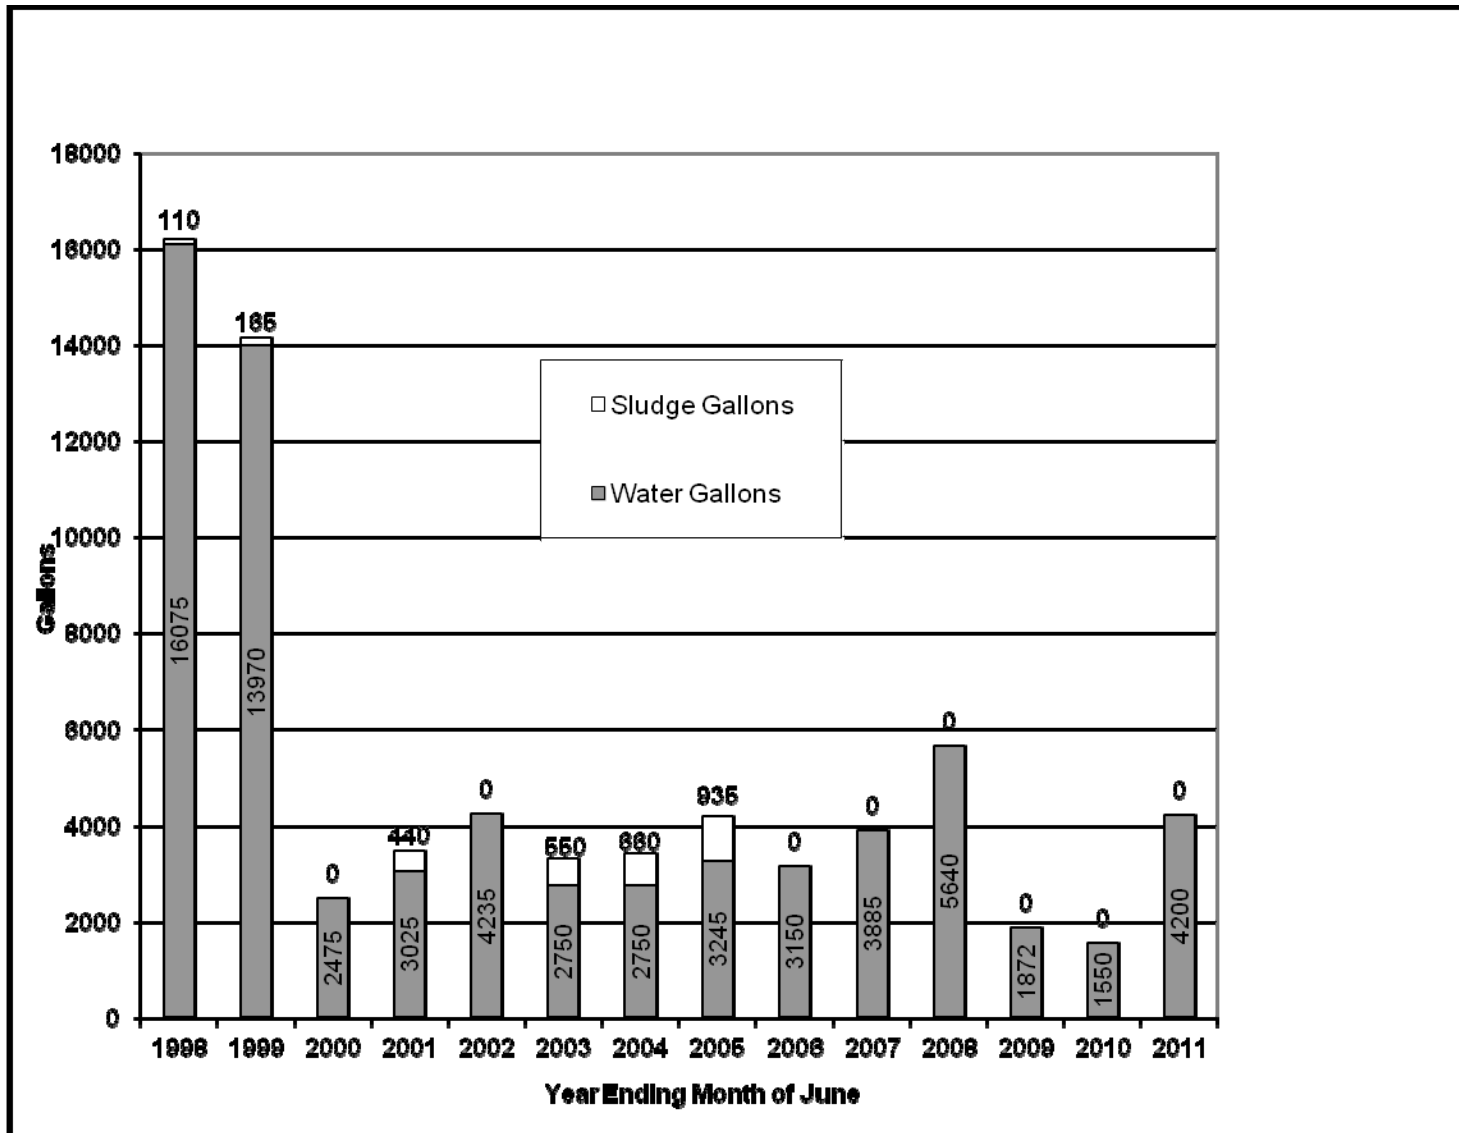
Figure 3-11 – Water Removed from the Exhaust Shaft Catch Basin and the Interception Well System

Table 3-1 and Figure 3-11 present the volume of fluid removed from the catch basin from July 1997 through June 2006, and by the interception well system from July 2006 through June 2011. The largest reported volumes are typically associated with periods of reduced ventilation and increased humidity. For a discussion of the factors affecting the quantity of fluid produced in the Exhaust Shaft, refer to DOE/WIPP 00-2000, *Brine Generation Study*.

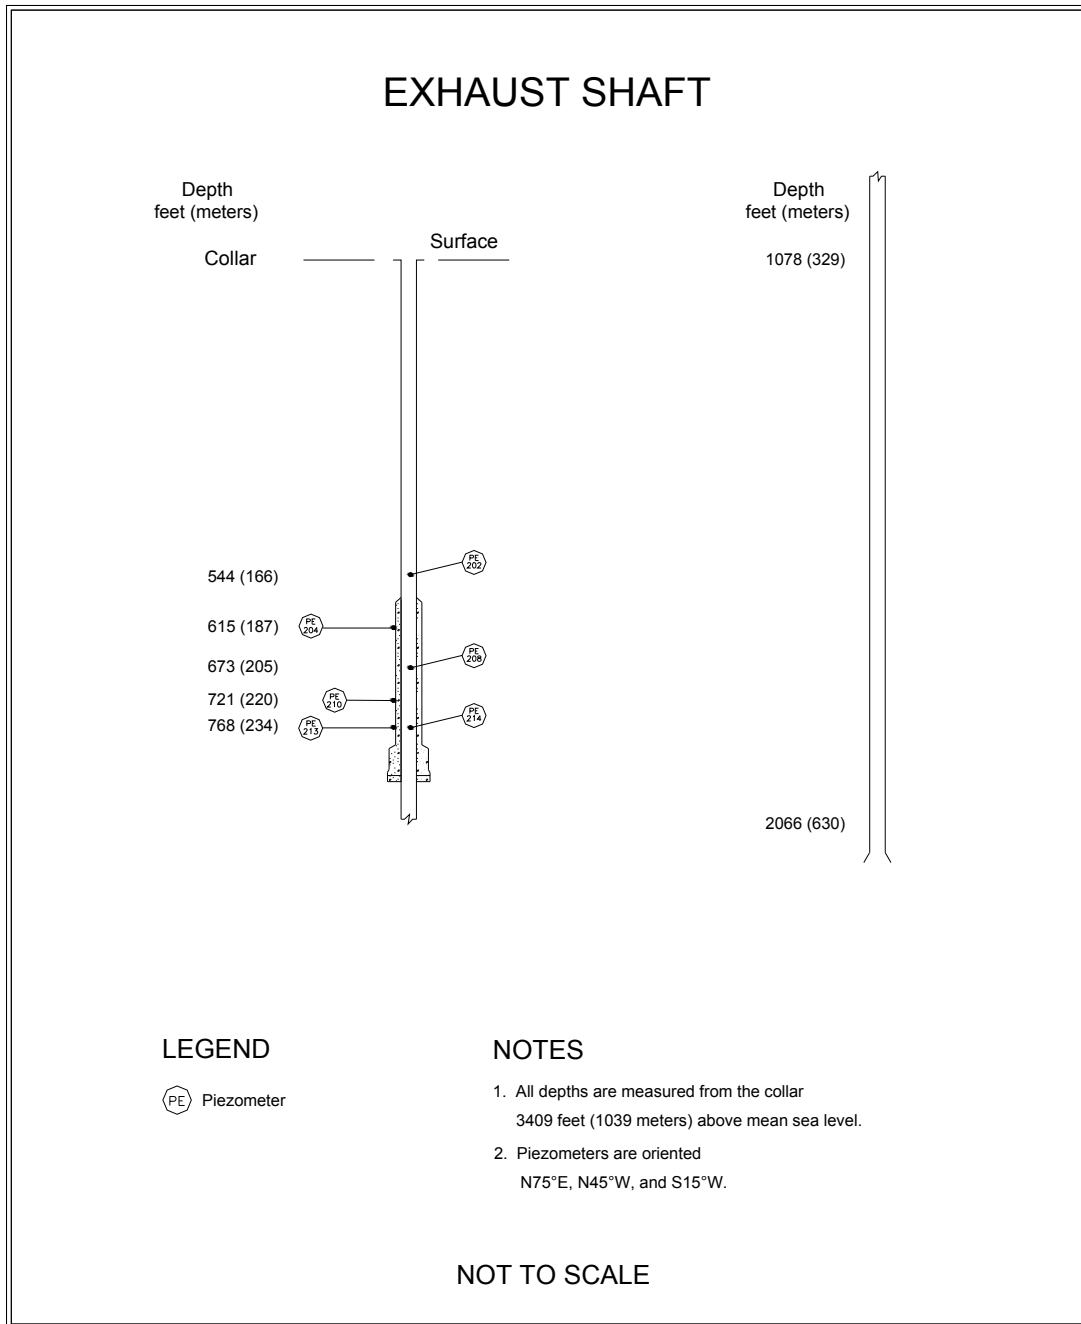
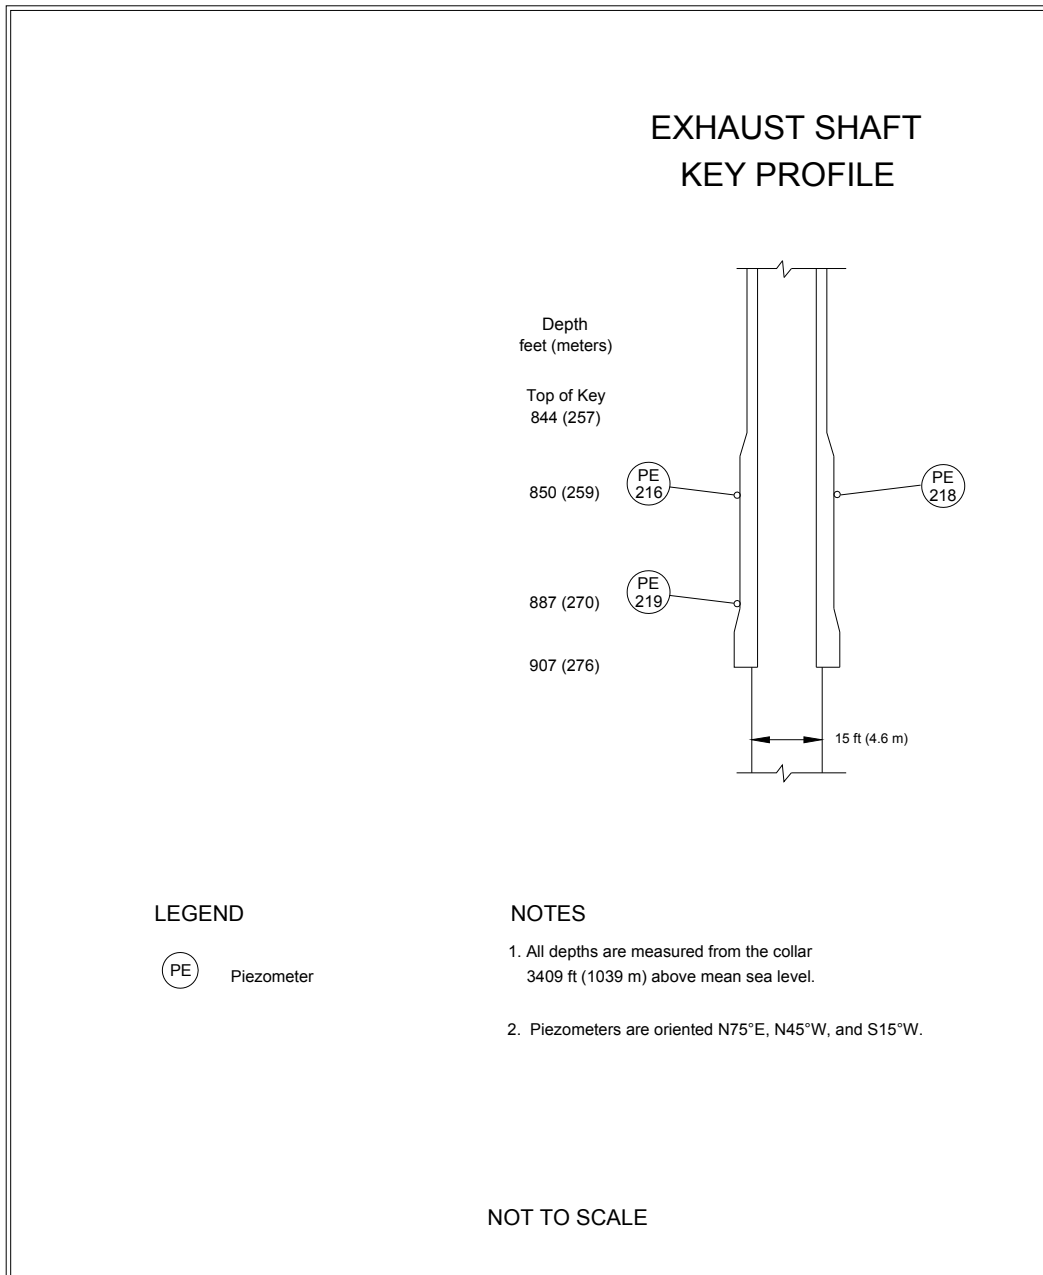
The Exhaust Shaft was equipped with geomechanical instrumentation in two stages. Earth pressure cells were installed behind the liner key in November 1984. Piezometers and nine multi-position extensometers were installed during November and December 1985. Figure 3-12 and Figure 3-13 show the instrument locations.

Eight piezometers remain in working condition. The fluid pressure readings from the working piezometers at the end of the reporting period range from -3 psi (-21 kPa) at 544 ft (166 m) to 141 psi (972 kPa) at 721 ft (220 m). Maximum pressure readings from the working piezometers during this reporting period were consistent with maximum readings from the previous reporting period.

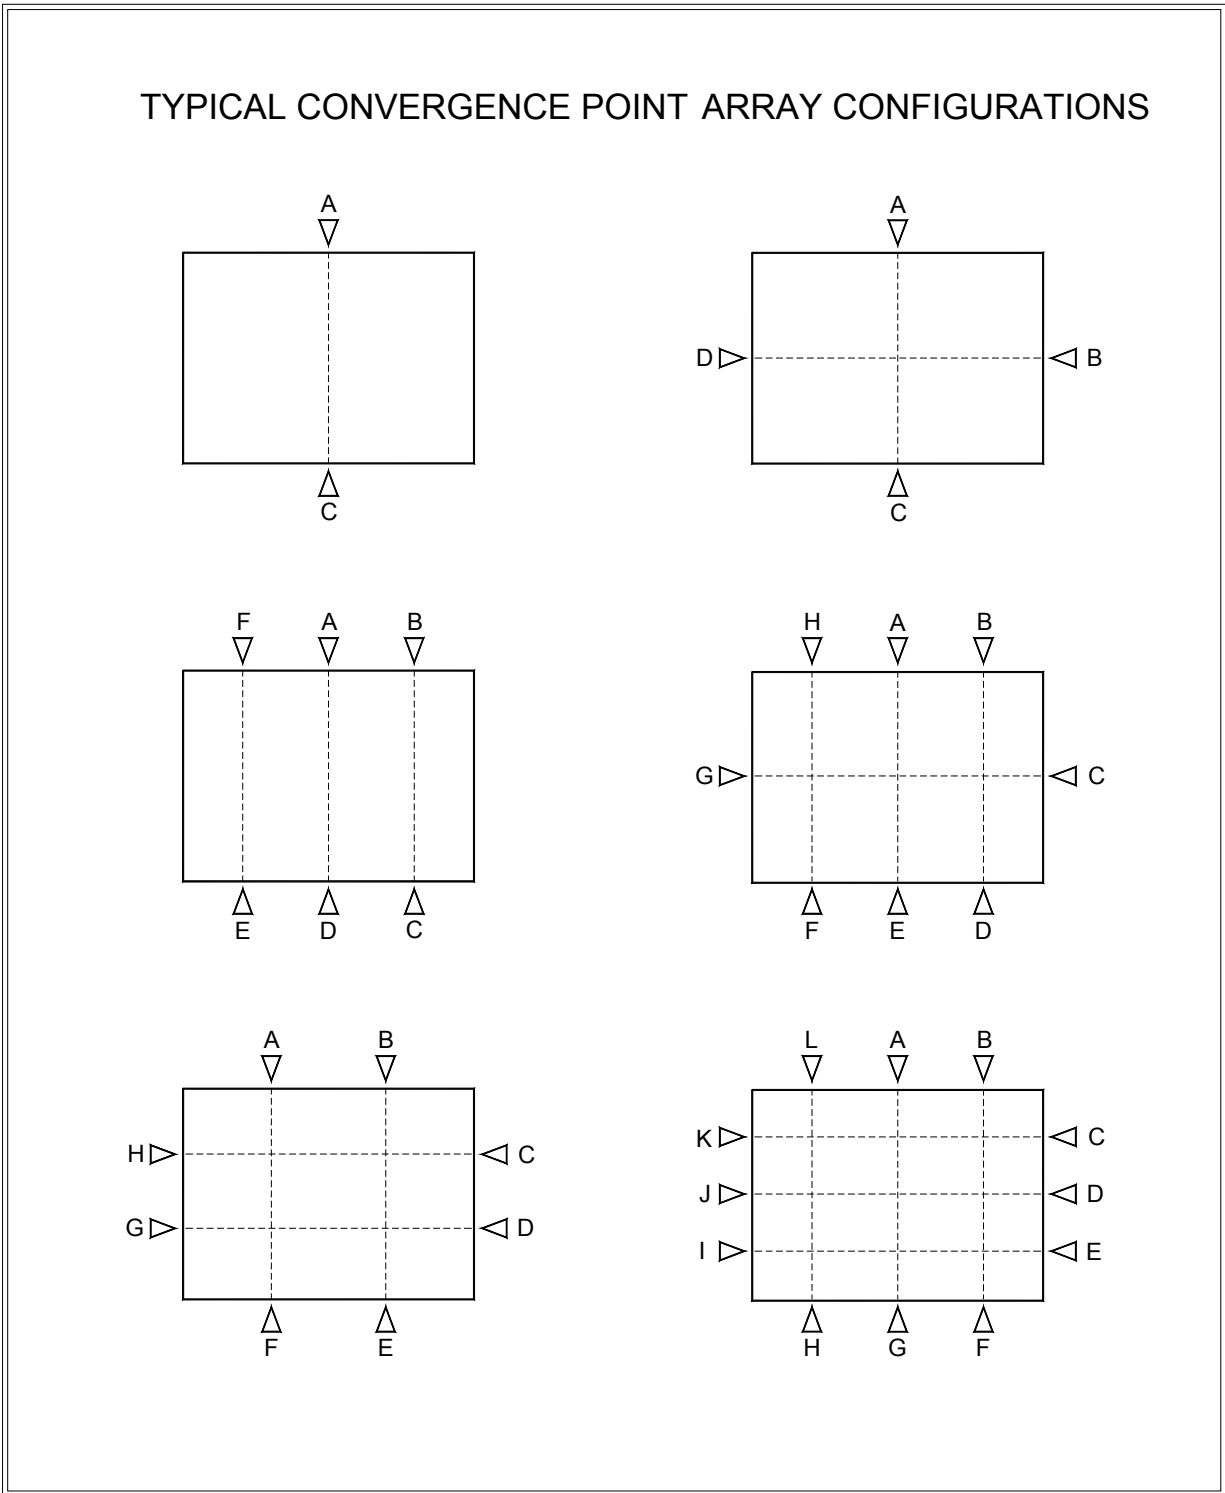
Figure 5-1 – Typical Convergence Point Array Configurations Showing Anchor Designations

Where possible, annual closure rates were calculated from convergence point array data gathered in the access drifts. A complete tabulation of these convergence point data and calculated closure rates is presented in the supporting data document for this report. Locations with increases in annual vertical closure rates of greater than 10 percent are shown in Table 5-3.

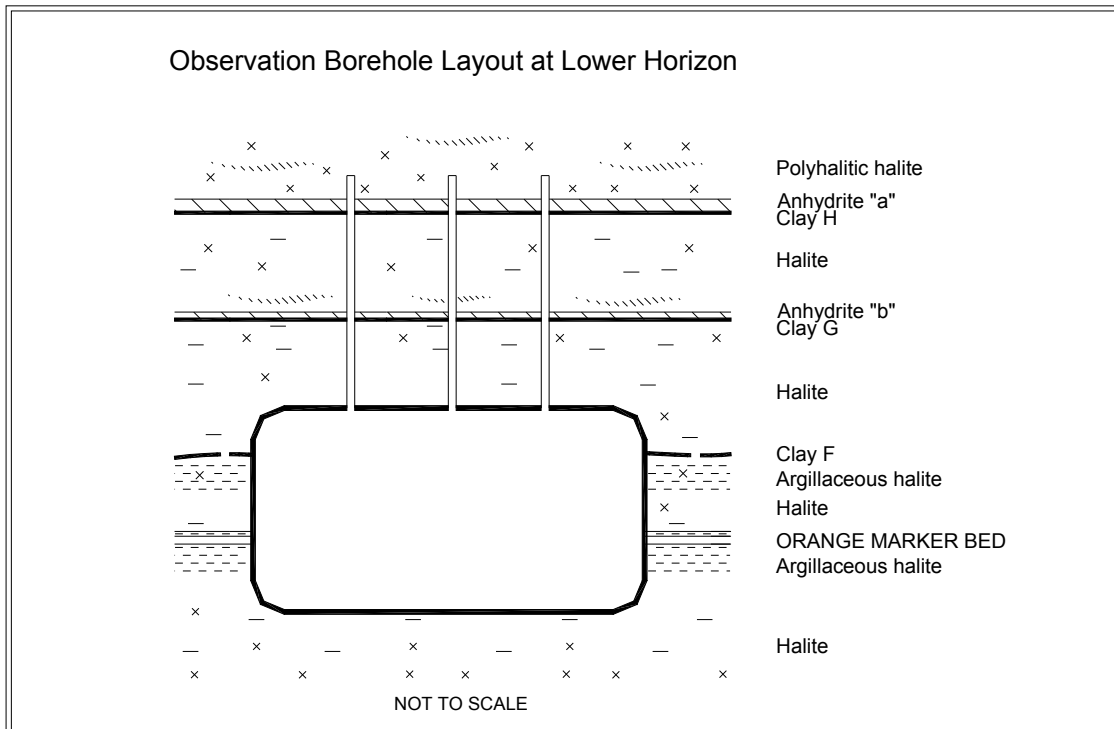
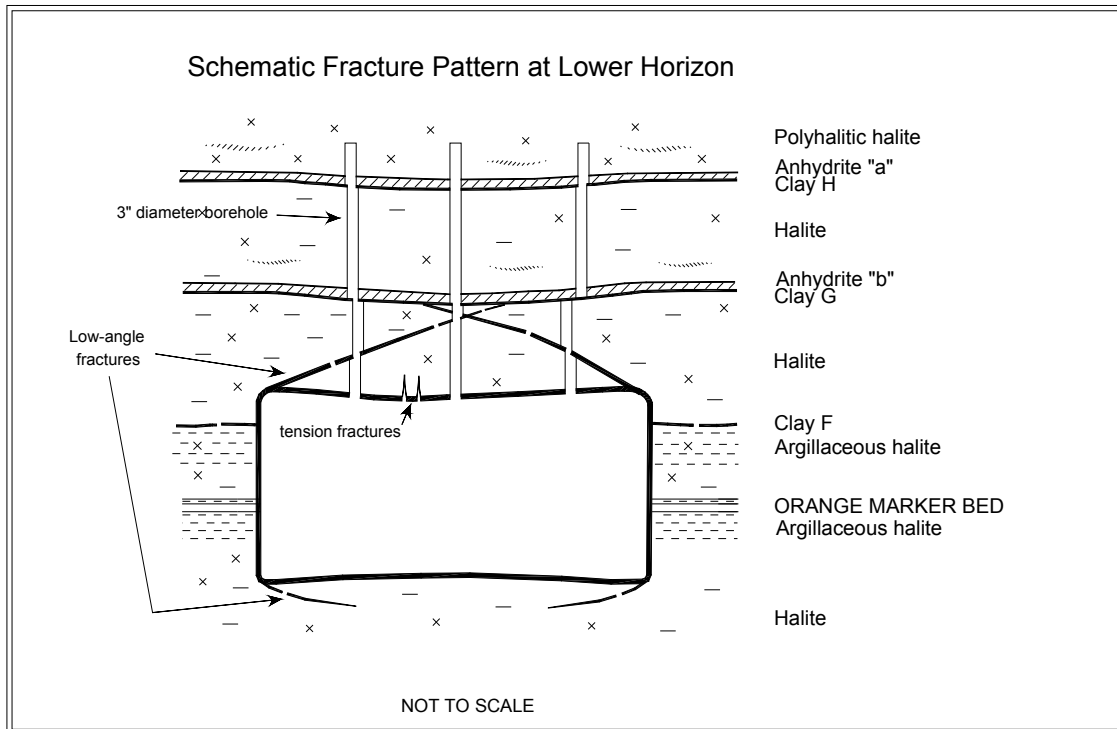
Observation holes are inspected for fractures, using an aluminum rod with a flattened steel wire probe attached to one end perpendicular to the rod (referred to as a "scratch rod"). Fractures and clay seams are located by moving the probe along the inside of the hole until it is snagged in one of these features. Depth to each feature is recorded, as is the magnitude of separations encountered. A fiber scope camera is occasionally used in addition to the scratch rod to visually document features of interest in a hole.
