Waste Isolation Pilot Plant

Geotechnical Analysis Report For July 2010 – June 2011

**Geotechnical Analysis Report for July 2010 – June 2011
DOE/WIPP-12-3484, Vol. 1**

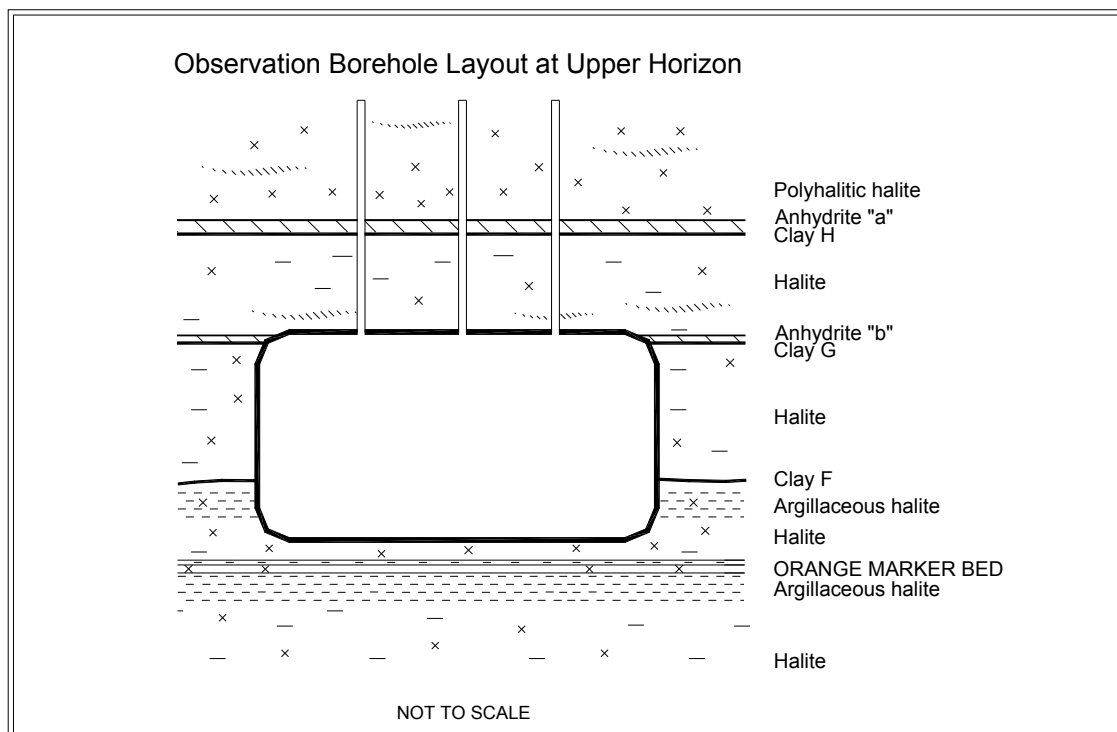
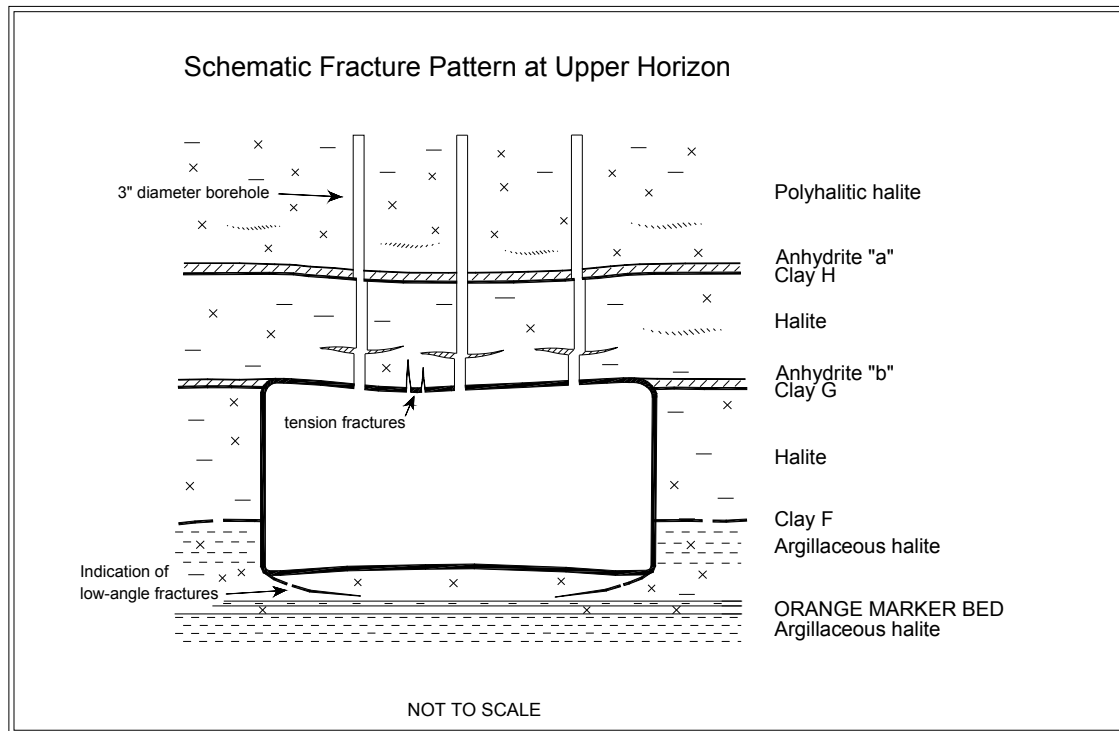
holes located near ribs than in those located along excavation centerlines. Offsetting along the clay layers is observable until total offset is reached or visibility is obstructed by intervening offsets at other clay seams or fractures.
