**Waste Isolation Pilot Plant**

**Geotechnical Analysis**  
**Report**  
**For**  
**July 2005 – June 2006**

**Geotechnical Analysis Report for July 2005 – June 2006**  
**DOE/WIPP 07-3177, Vol. 1**

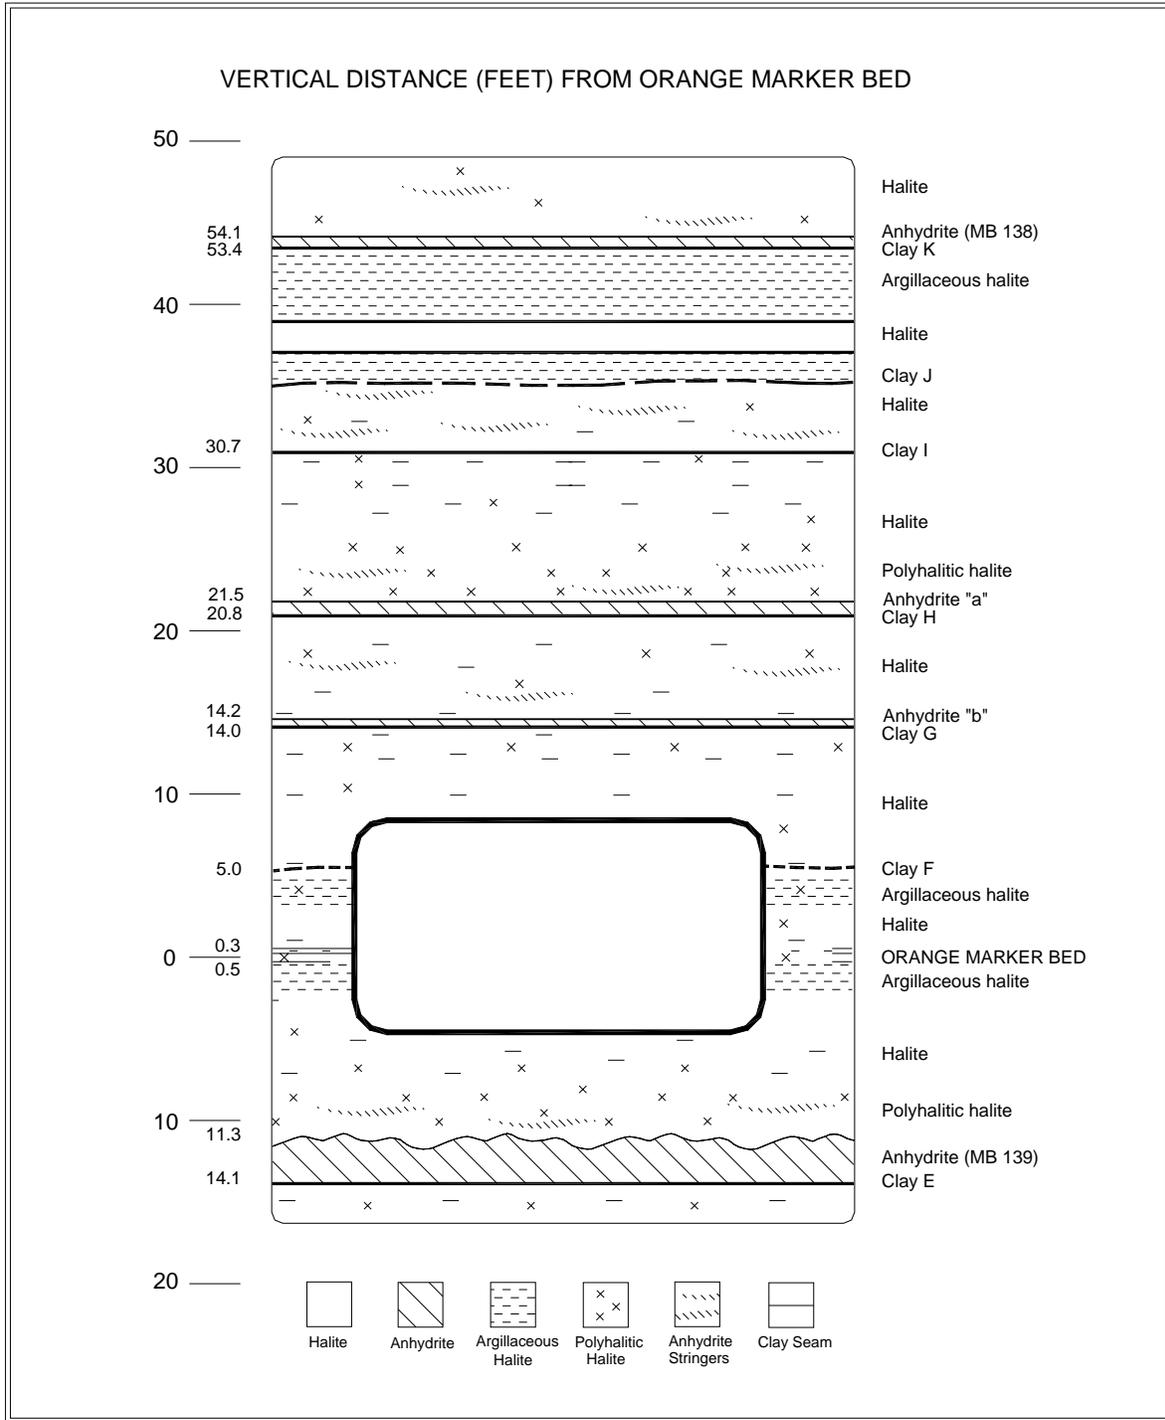
**Figure 2-2 – Repository Level Stratigraphy of Panels 1, 2, 7, and 8**

Field observations and computer modeling indicated that moving the disposal horizon stratigraphically upwards (so that the roof was located at clay "G") would improve long-term ground conditions and provide a more stable roof configuration without significantly impacting repository performance. In 2000, the decision was made to implement this change by moving the mining horizon up approximately six feet. Subsequently, in 2000 and 2001, ramps were mined in the W-170, W-30, E-140, and E-300 drifts between S-2620 and S-2750 (Figure 1-2). As a result, the disposal horizon for Panels 3, 4, 5, and 6, and the associated connecting drifts, lies above the horizon for the other panels. Panels 5 and 6 are not yet excavated.

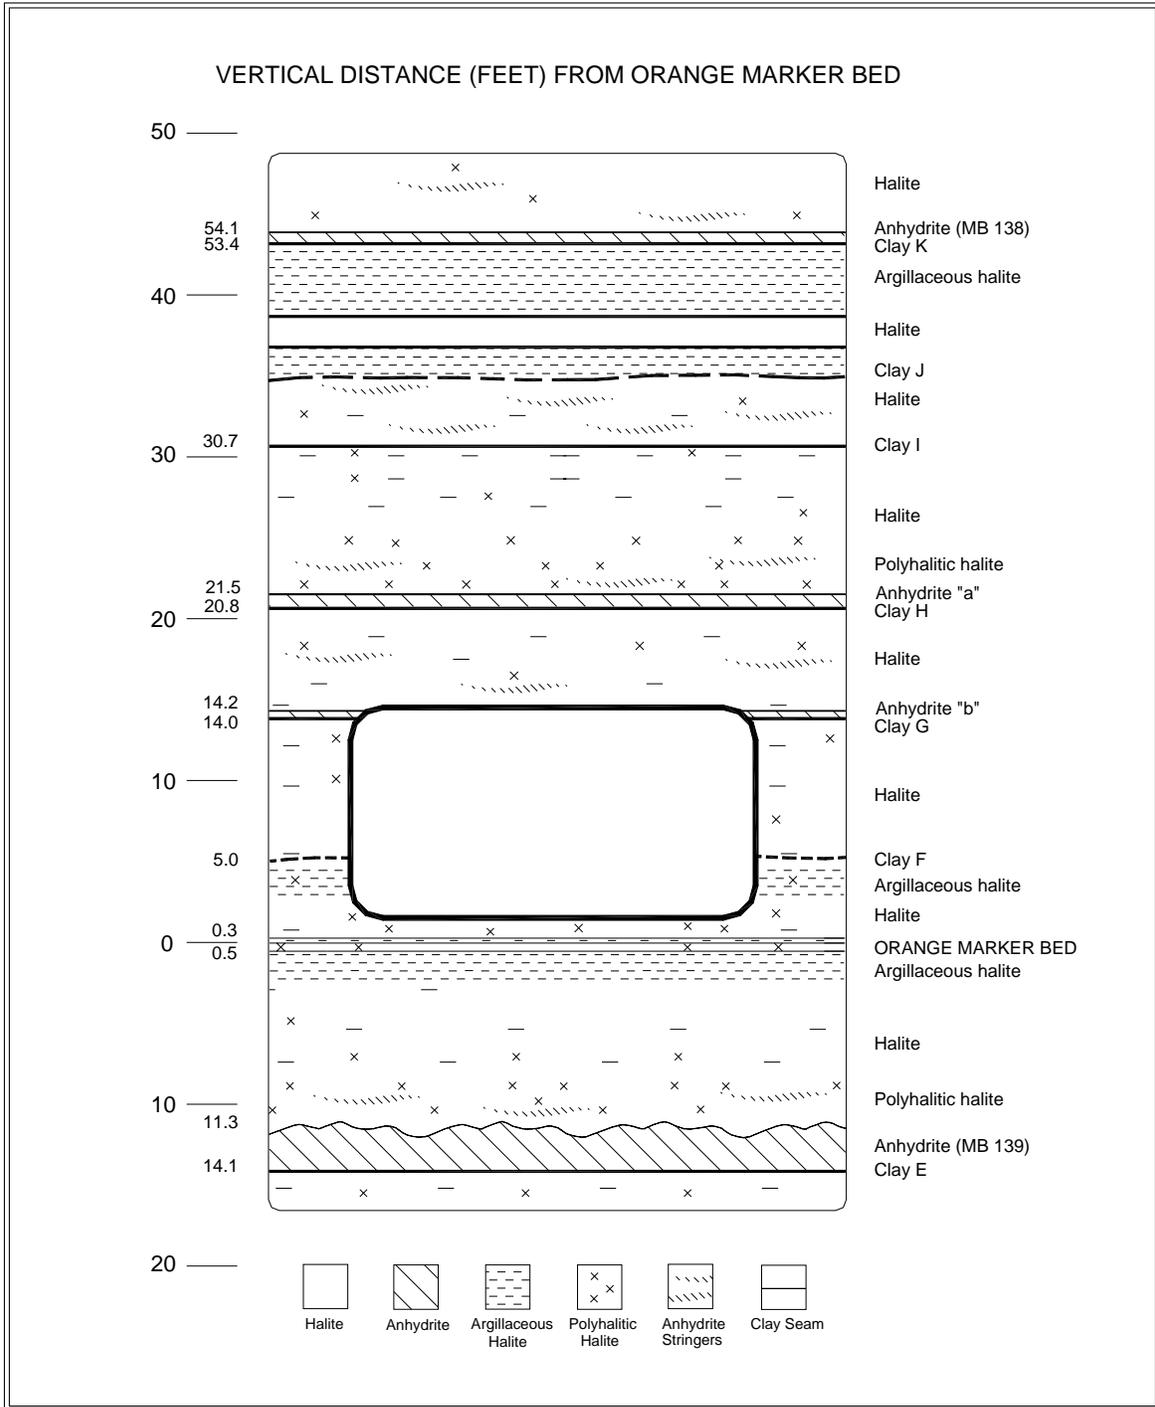
**Figure 2-3 – Repository Level Stratigraphy of Panels 3, 4, 5, and 6**

In this horizon (see Figure 2-3), the OMB lies at or below the floor. MB139 lies about 12 ft (3.7 m) below the floor. The roof is immediately above Anhydrite "b". Clay "G"/ Anhydrite "b" is used as the mining reference during excavation of this disposal horizon.

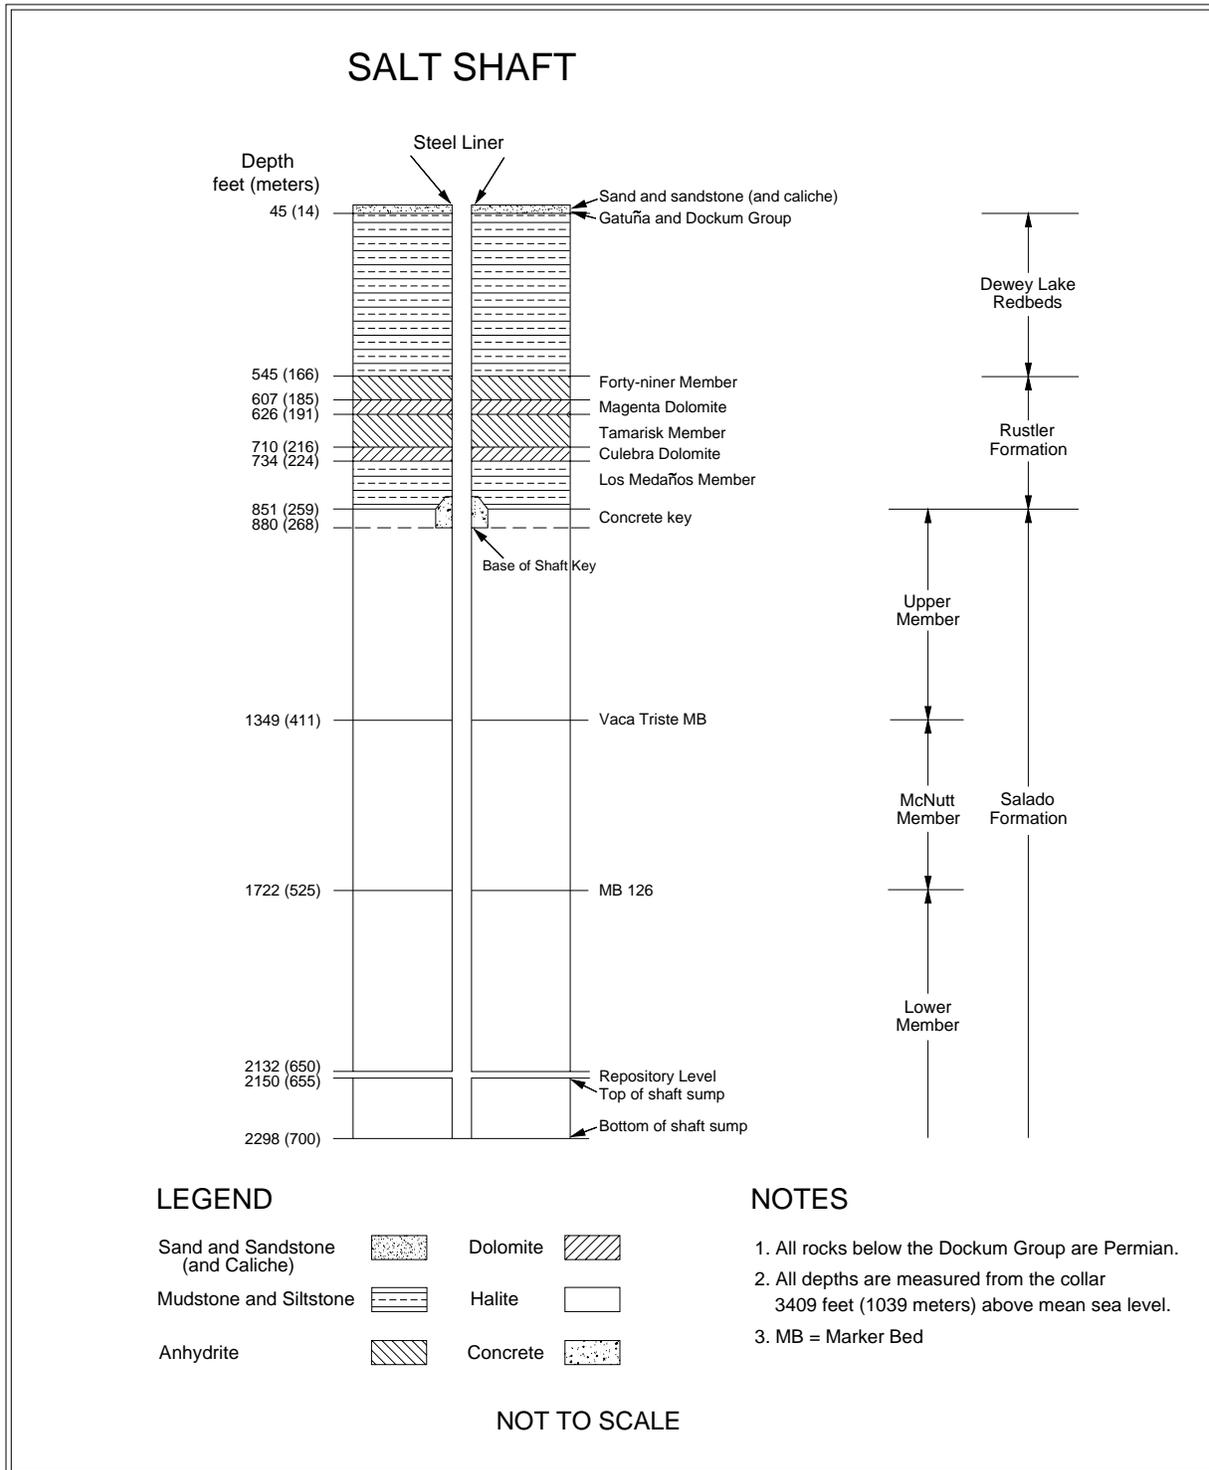
**Figure 3-1 – Salt Shaft Stratigraphy**

The first construction activity undertaken during the SPDV Program was the excavation of the Exploratory Shaft. This shaft was subsequently referred to as the Construction and Salt Shaft and is currently designated the Salt Shaft (see Figure 1-2). The shaft was drilled from July 4 to October 24, 1981, and geologically mapped in the spring of 1982 (DOE, 1983). Figure 3-1 presents the stratigraphy in the Salt Shaft.

The Salt Shaft is lined from the surface to 846 ft (258 m) with steel casing having an inside diameter of 10-ft (3-m). The thickness of the steel liner (including external stiffener rings) increases from 0.62 in (1.6 cm) at the top to 1.5 in (3.8 cm) at the key. Cement grout was placed between the liner and rock face. The 10-ft (3-m) diameter extends through the concrete shaft key to 880 ft (268 m). The shaft key is a 37.5-ft (11.4-m) long, reinforced-concrete structure that begins 3.5 ft (1.07 m) above the bottom of the steel liner. From the key to the bottom at 2,298 ft (700 m), the shaft has a nominal diameter of 12 ft (4 m).

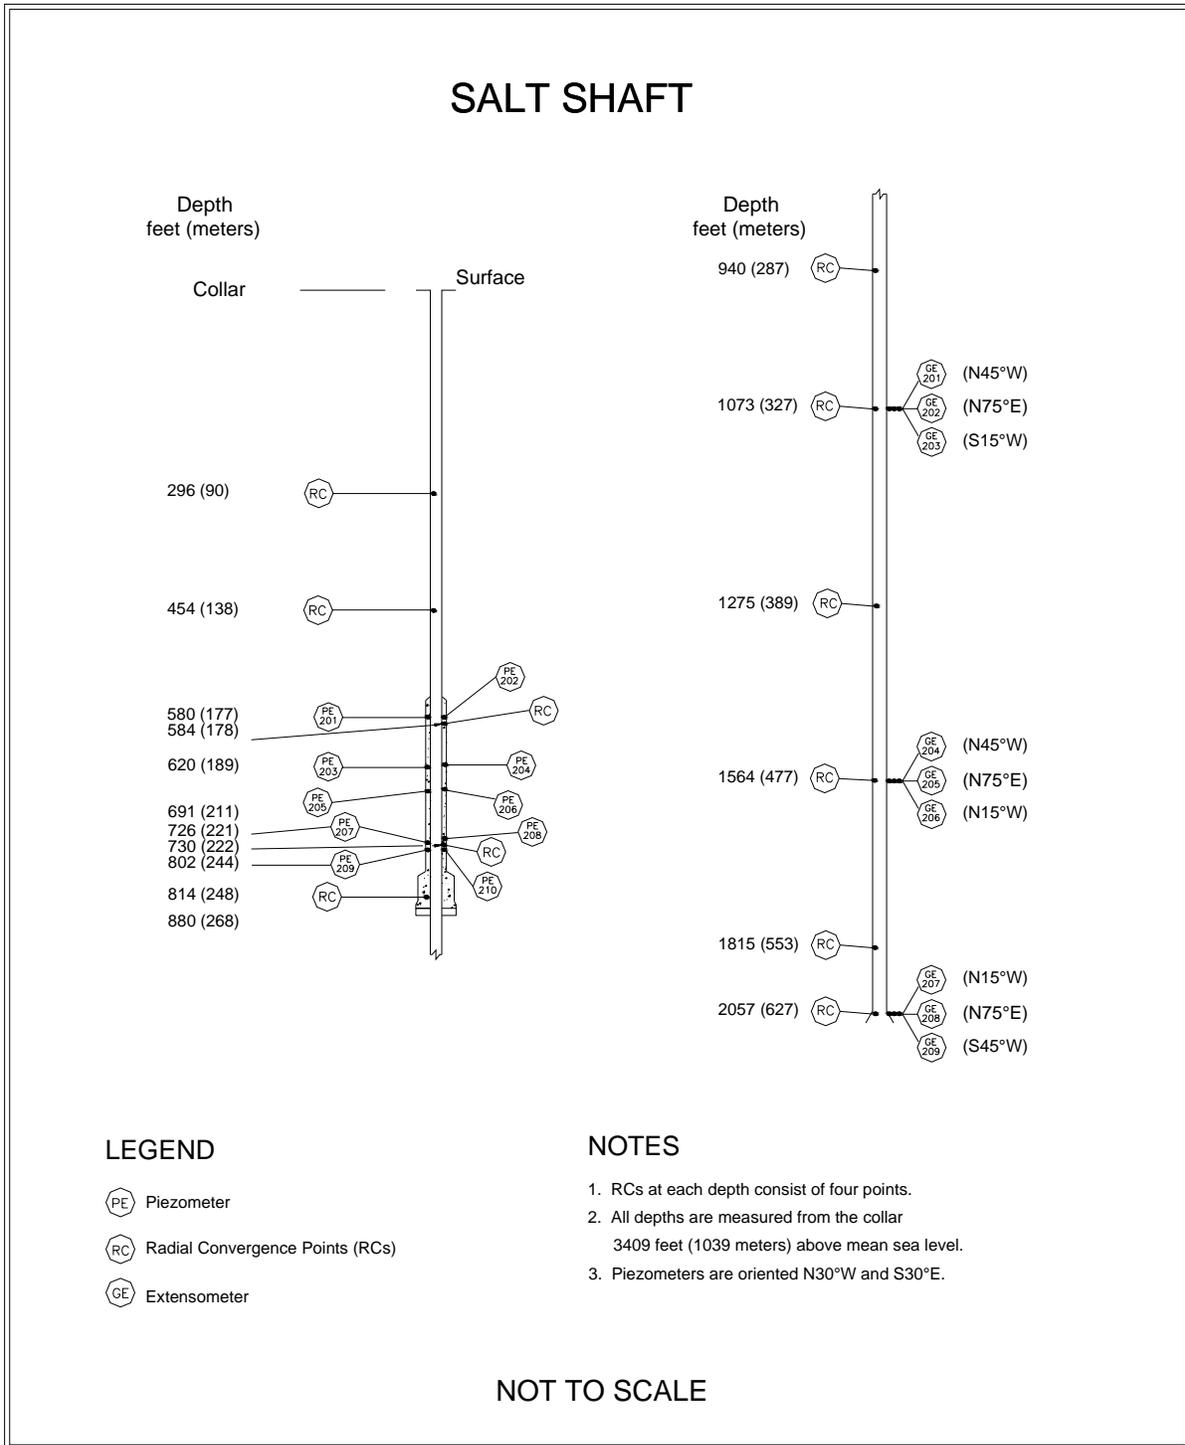
**Figure 3-2 – Salt Shaft Instrumentation (Without Shaft Key)**

All 12 piezometers continue to provide data. The fluid pressures recorded at the end of this reporting period range from approximately 74 pounds per square inch (psi) (510 kilopascals [kPa]) at the 802-ft (244-m) level in the Los Medanos Member to 229 psi (1,579 kPa) at the 620-ft (189-m) level in the Magenta Dolomite Member. The recorded pressures for this reporting period are generally consistent with the readings from the previous reporting period. The fluid pressure on the shaft liner will continue to be monitored on a regular basis.

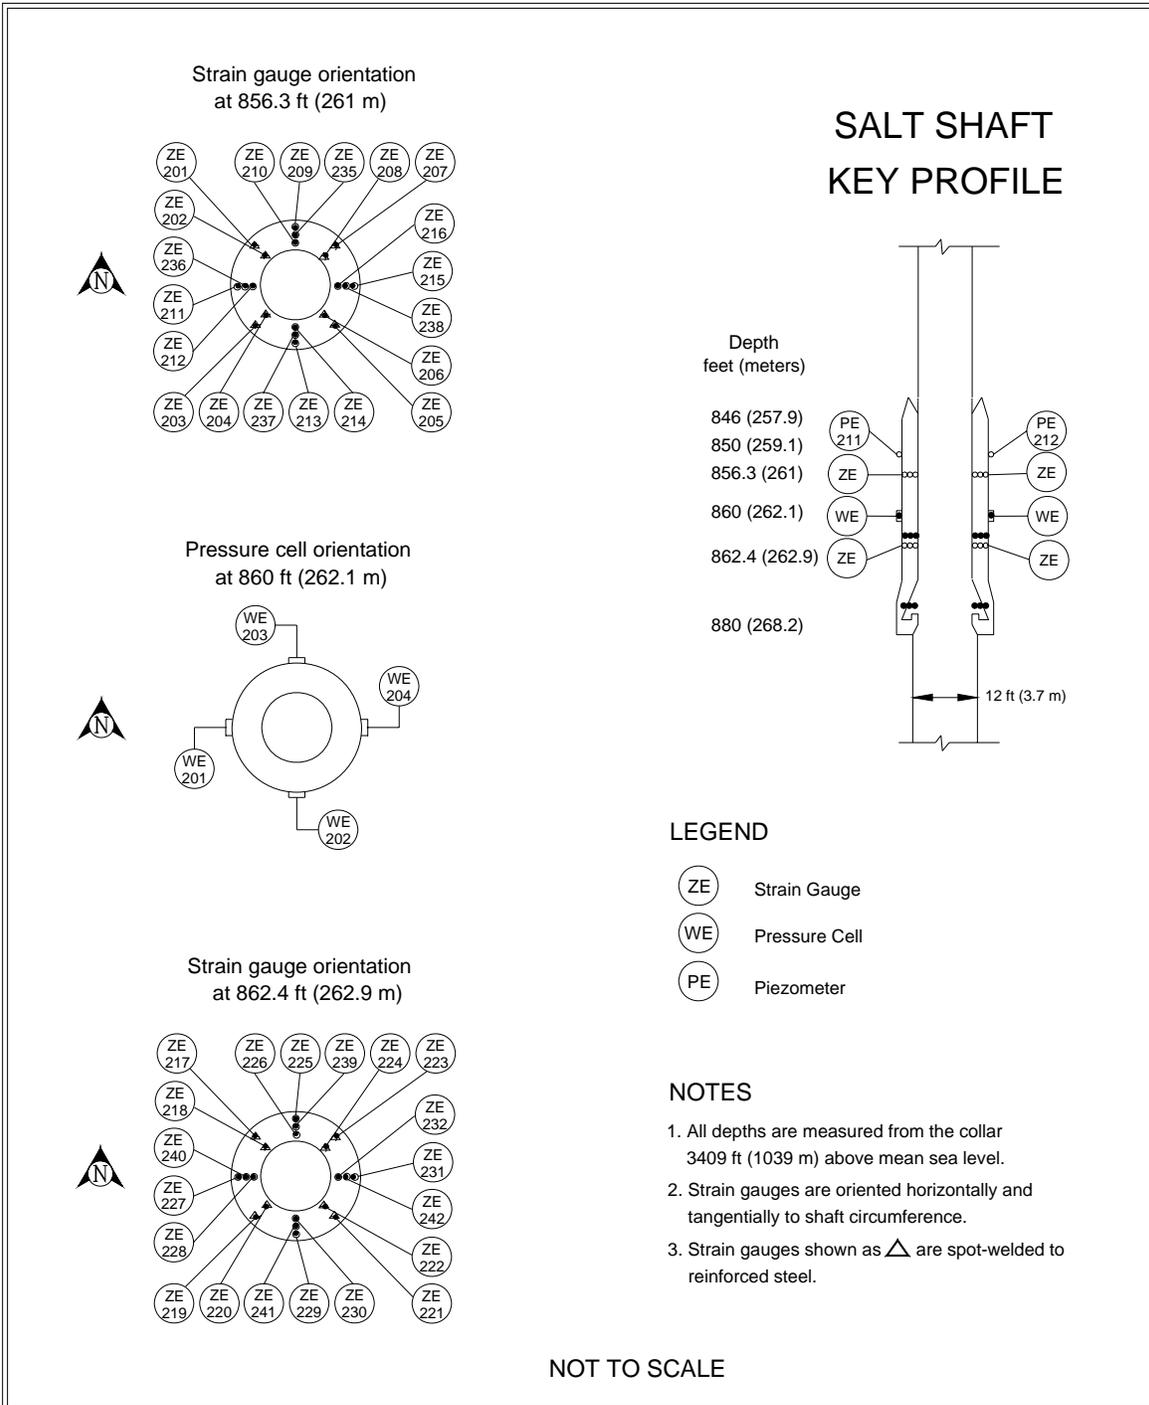
**Figure 3-3 – Salt Shaft Key Instrumentation**

Four earth pressure cells were installed in the key section of the Salt Shaft during concrete emplacement at the 860-ft (262-m) level. These instruments measure the normal stress between the concrete key and the Salado Formation as salt creep loads up the key structure. Three of the four earth pressure cells continue to provide data. These instruments have indicated essentially no contact pressure since their installation (readings resemble instrument drift at a zero pressure). The contact pressures recorded by the instruments for this reporting period ranged from -22 to 3 psi (-152 to 21 kPa).

Sixteen spot-welded and twenty-four embedment strain gauges were installed on and in the shaft key concrete at both the 856.3-ft (261-m) level and at the 862.4-ft (263-m) level. Four spot-welded strain gauges are still functioning at these levels. Maximum strains at the 856.3-ft (261-m) level were 668 and 748 microstrain. Strains at the 862.4-ft (262.9-m) level were 591 and 829 microstrain. The strains from the twelve embedment strain gauges at the 856.3-ft (261-m) level ranged from -810 to 984 microstrain. The strains from the two embedment strain gauges at the 862.4-ft (263-m) level were 200 to 340 microstrain. The strains recorded by the spot-welded strain gauges and the embedment strain gauges during this reporting period are very similar to the strains recorded by these instruments at the end of the previous reporting period.

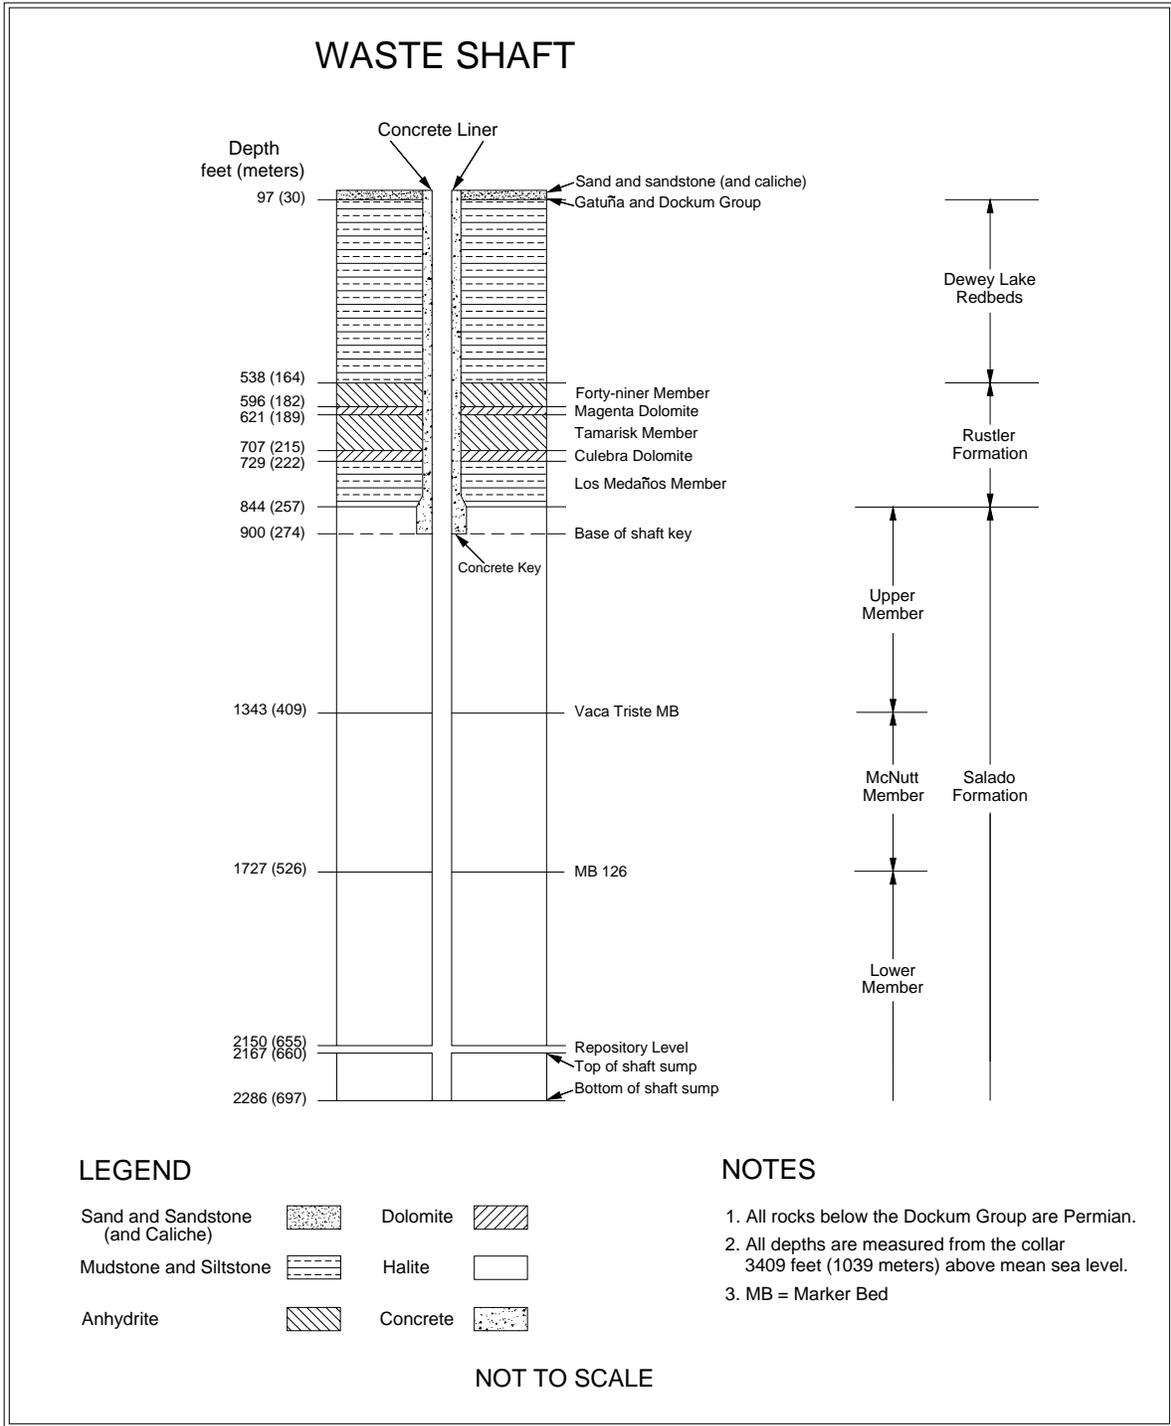
**Figure 3-4 – Waste Shaft Stratigraphy**

The Waste Shaft is lined with nonreinforced concrete having a 19 ft (6 m) inside diameter from the surface to the top of the key at 837 ft (255 m). Liner thickness increases from 10 in. (25 cm) at the surface to 20 in. (51 cm) at the key. The key is 63 ft (19 m) long and 4.25 ft (1.3 m) thick and is constructed of reinforced concrete. The bottom of the key is 900 ft (274 m) below the surface. The diameter of the shaft is 20 ft (6 m) at the bottom of the key and increases to 23 ft (7 m) just above the shaft station. The shaft below the key is lined with wire mesh anchored by rock bolts. The diameter of 23 ft (7 m) extends to a depth of approximately 2,286 ft (697 m), with the shaft sump comprising the lower 119 ft (36 m) of that interval.

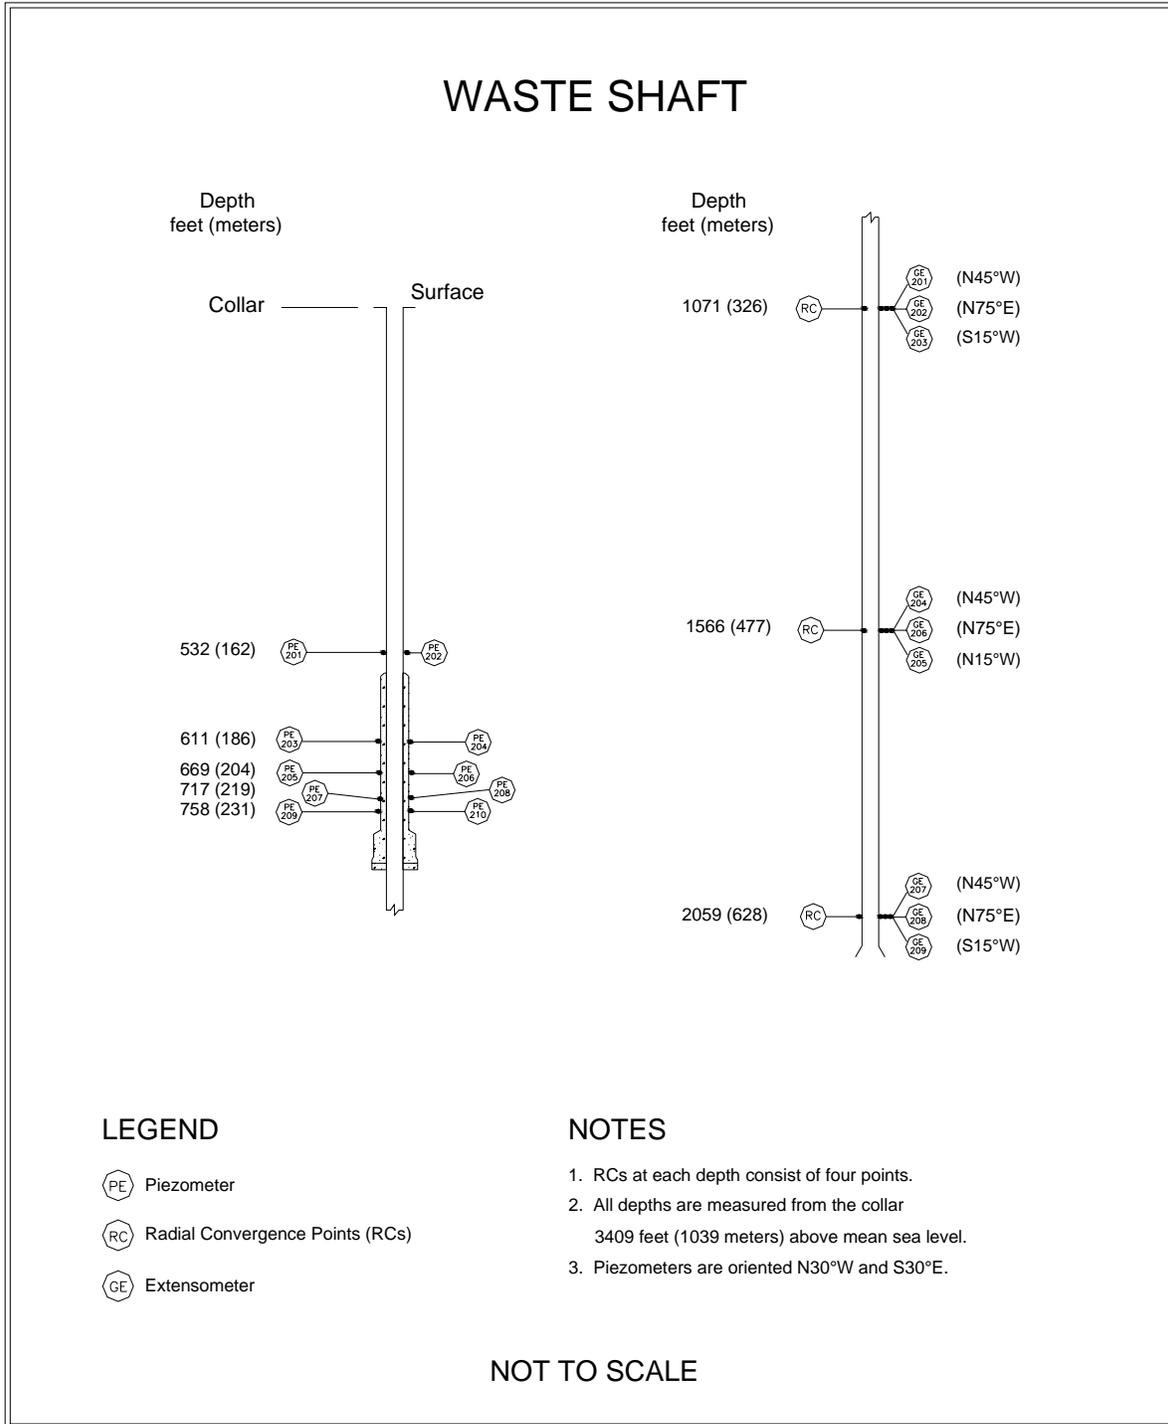
**Figure 3-5 – Waste Shaft Instrumentation (Without Shaft Key)**

Twelve piezometers were installed in the lined section of the Waste Shaft on September 7 and 8, 1984, to monitor fluid pressure behind the shaft liner and key section. Data continue to be received from 10 piezometers. The maximum recorded fluid pressure during this reporting period was 138 psi (951 kPa) at the 717-ft (219-m) level. The pressure readings during this reporting period were consistent with readings from the previous reporting period, with a mean change in pressure of less than 5 psi (34n kPa).

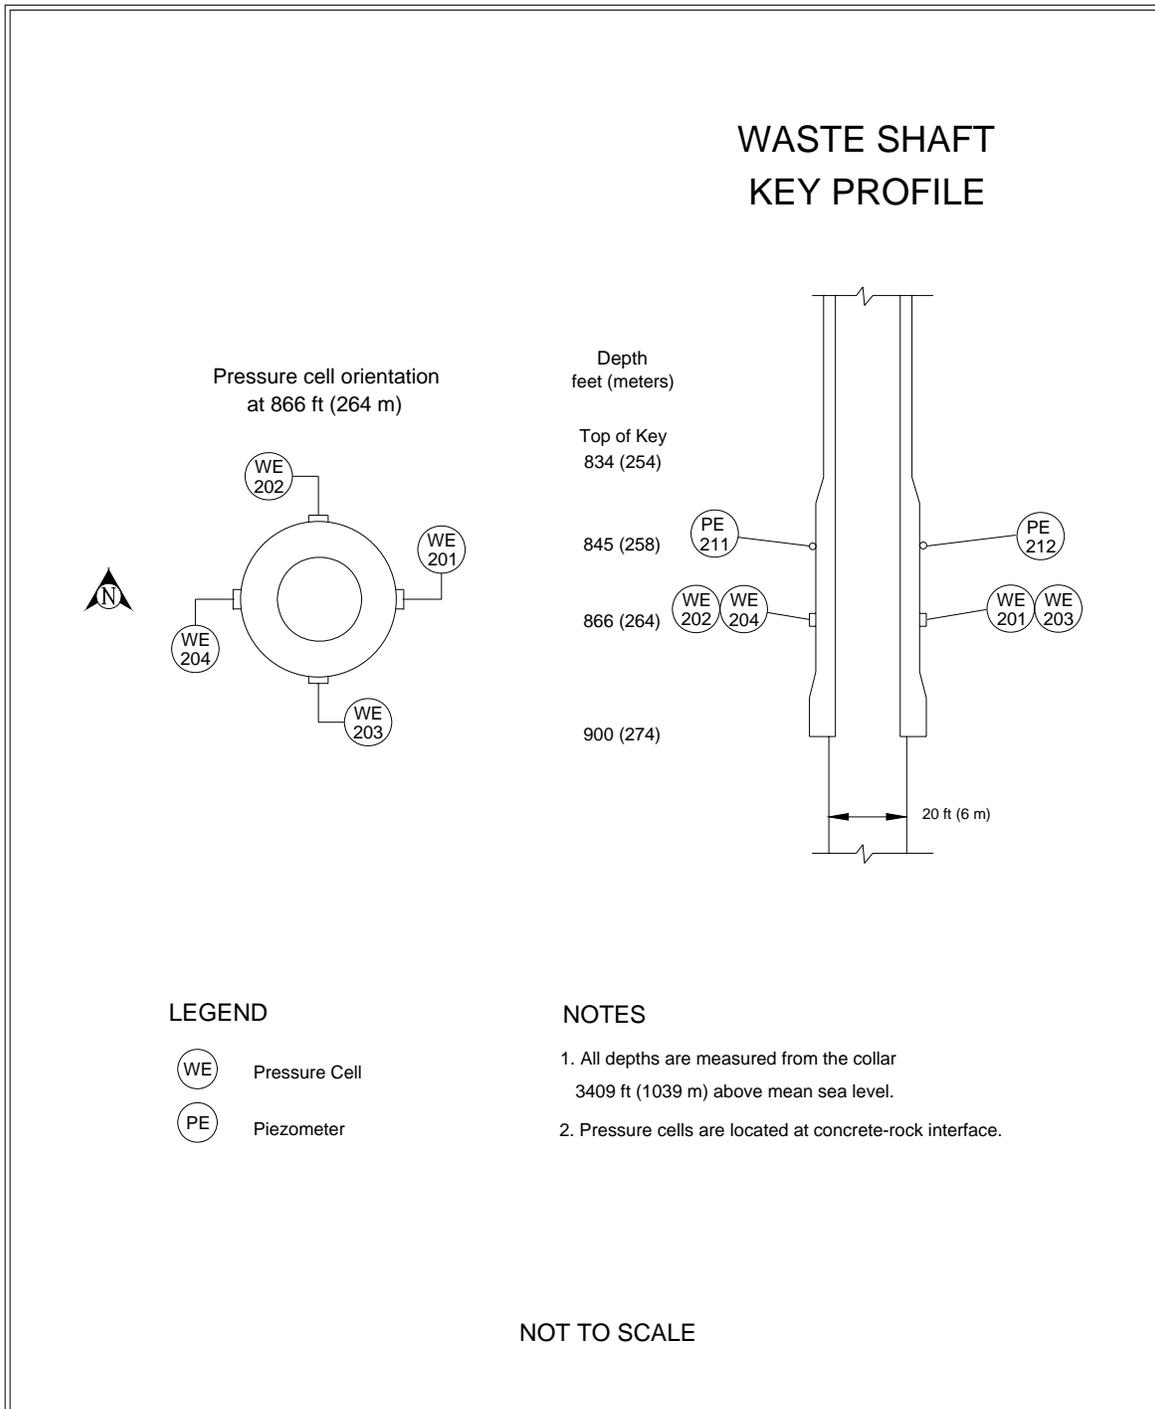
**Figure 3-6 – Waste Shaft Key Instrumentation**

Four earth pressure cells were installed in the key section of the Waste Shaft during concrete emplacement between March 23 and April 3, 1984. These instruments measure the normal stress between the concrete key and the Salado Formation as salt creep loads the key structure. The contact pressures recorded by the instruments during this reporting period ranged from 84 to 110 psi (579 to 758 kPa).

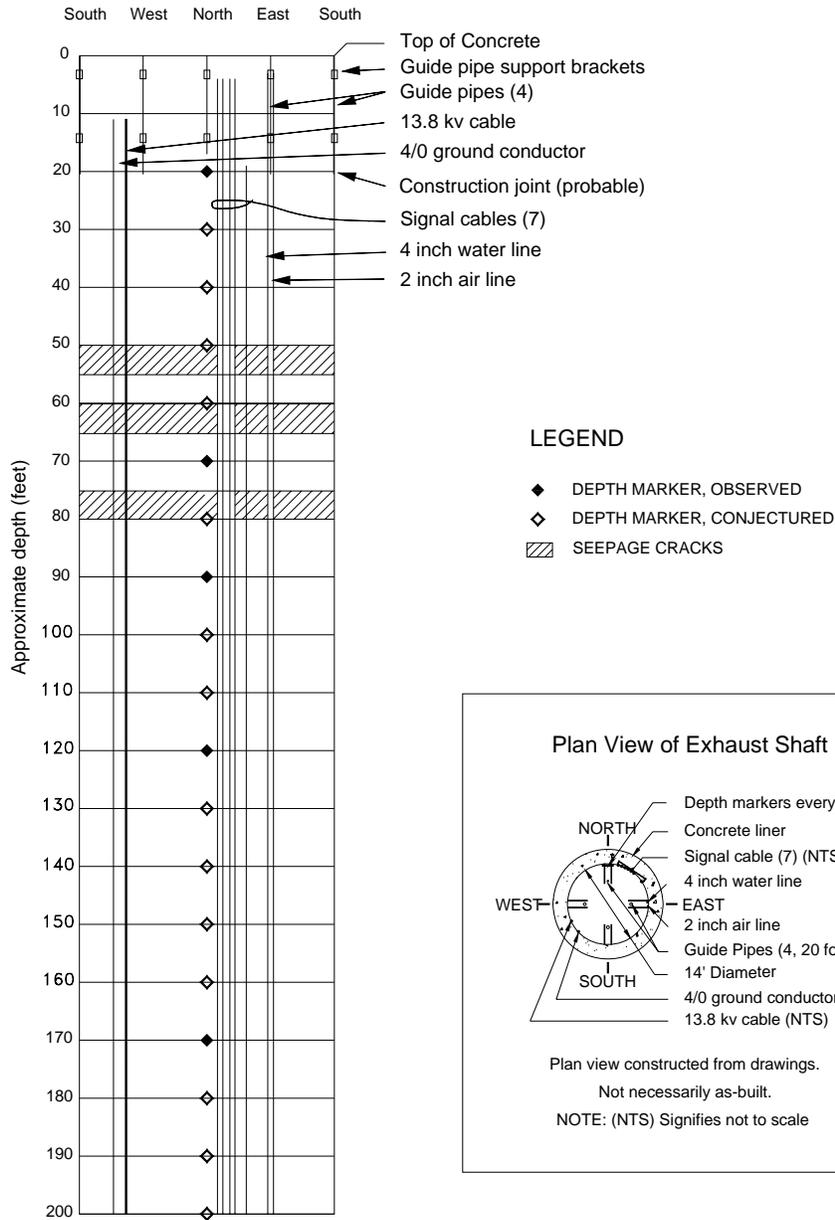
**Figure 3-9 – Diagram of Exhaust Shaft Fixtures and Seepage Zones (Upper 200 ft)**

The Exhaust Shaft liner is examined for cracks, seepage, and general shaft stability. Currently, there are three principal zones of seepage in the shaft. The first is about 50 to 55 ft below the shaft collar (bsc). The second is about 60 to 65 ft bsc. The third is about 75 to 80 ft bsc, as shown in Figure 3-9. Monitoring of seepage horizons started before 1995. Water entering the shaft through these cracks is believed to originate from a perched aquifer at the base of the Santa Rosa Formation that is being re-charged as the result of surface modifications at the site. The fluid level in the Santa Rosa near the shaft is about 43 to 44 ft below the surface. Based on examination of inspection videos,

the flow rate into the shaft is estimated at about 1 to 3 gallons per minute, most of which is carried out of the shaft with the exhaust air. Seepage cracks are confined primarily to the eastern side of the shaft wall.

Though the Magenta and Culebra water rings are encrusted with salt buildup, no water appears to emanate from the liner or water rings. Most of the seepage was observed along the east face of the shaft wall near the instrumentation cables and the air- and water-lines in the upper section of the shaft. Though the presence of water is an inconvenience requiring periodic disposal, at this time it does not appear to have created any hazard or affected the structural integrity of the shaft. However, brine increases the probability of corrosion and deterioration of utility hangers and brackets. There are no visible signs of dissolution of the salt below the key.

The video inspection also focused on the installed utilities and support brackets. These include the 13.8 kVA power cable and the grounding cable on the west wall of the shaft, the instrumentation cables on the northeast wall of the shaft, and the 4-in. air-line and the 2-in. water-line on the east wall of the shaft. In the August 19, 2006, video, salt buildups 6-12 inches thick were noted about 112 to 150 feet bsc or higher on the west wall associated with the 13.8 kVA cable. Examination of the shaft video suggests that a slab of salt broke off from about 90 to 112 feet bsc, possibly associated with the damage that occurred to the power cable noted in Section 3.3.1. Later video inspections show that salt crust sloughing extended to about 135 feet bsc between the August and November inspections.

Sporadic salt buildup continues on all cables. The long-term implication of salt buildup is increased loading on cables and cable hangers, accompanied by intermittent falls of debris. The 4-in. compressed air-line and the 2-in. water-line extend from the surface to the bottom of the shaft. At present, neither line is being used. The integrity of the brackets holding the air-line and water-line was difficult to assess because of salt buildup; however, there was no indication that the brackets were broken. Instrumentation cable breaks were observed in the shaft; however, most of these breaks affected abandoned cables, with negligible impact on shaft monitoring and operations.

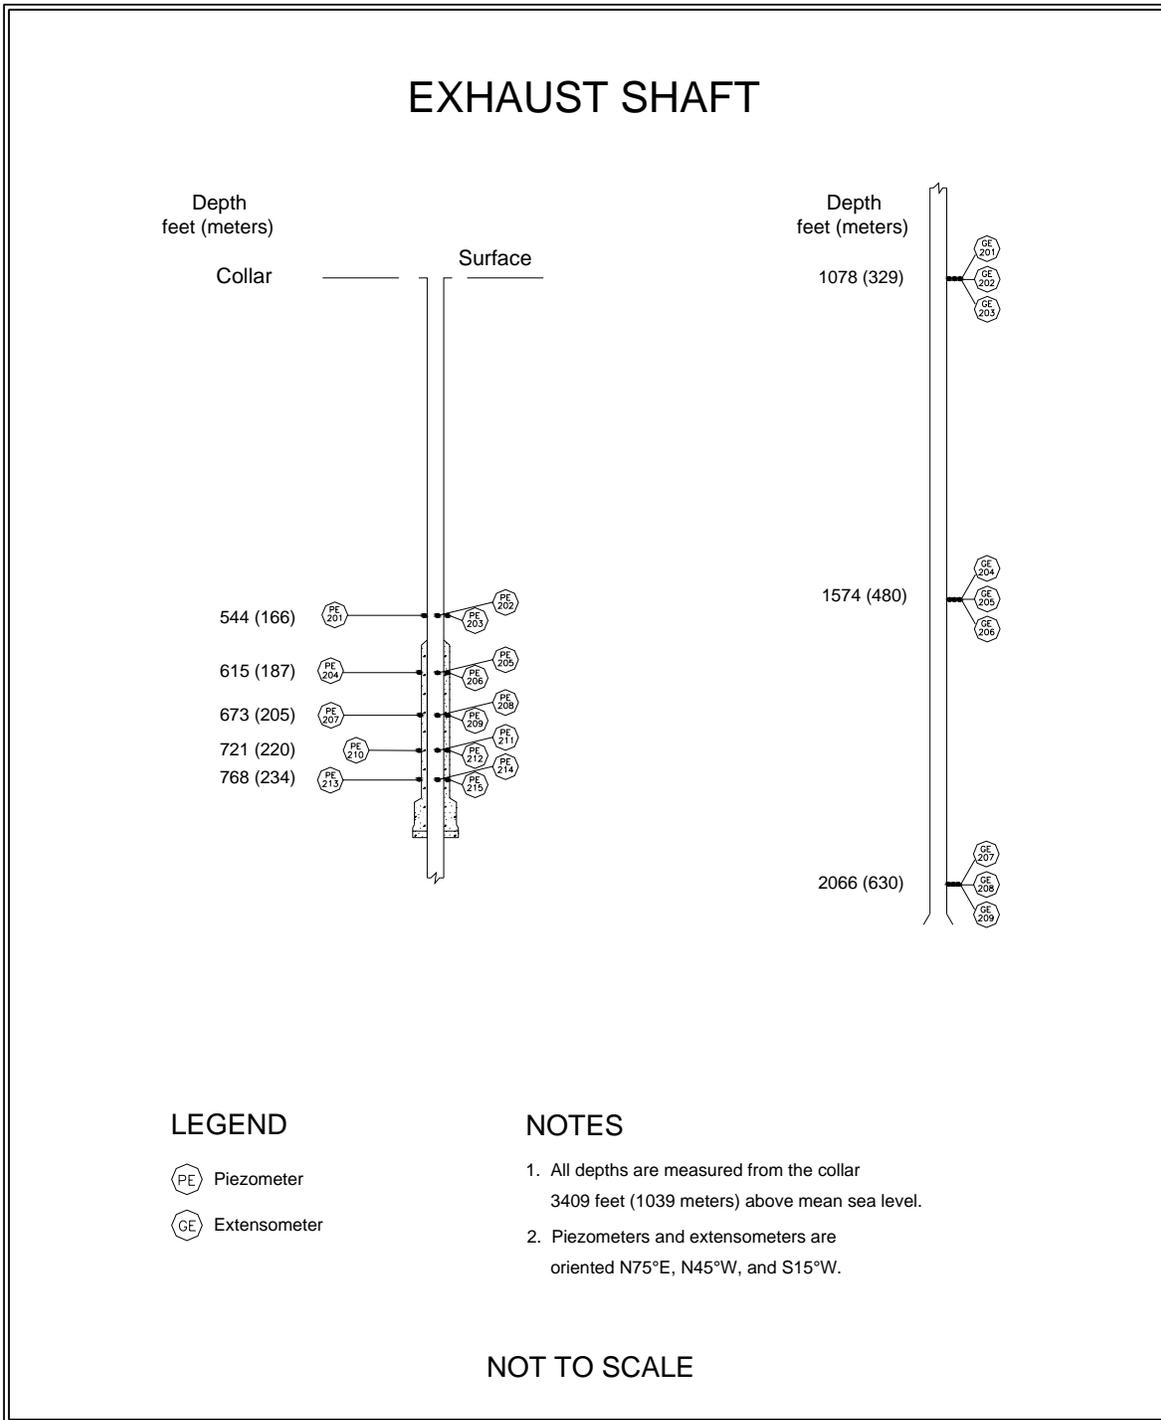
**Figure 3-10 – Exhaust Shaft Instrumentation (Without Shaft Key)**

Ten of the 21 piezometers remain in working condition. The fluid pressure readings from the working piezometers at the end of the reporting period range from -2 psi (-14 kPa) at 544-ft (166-m) to 141 psi (972 kPa) at 721-ft (220-m). Maximum pressure readings from the working piezometers during this reporting period were consistent with maximum readings from the previous reporting period.

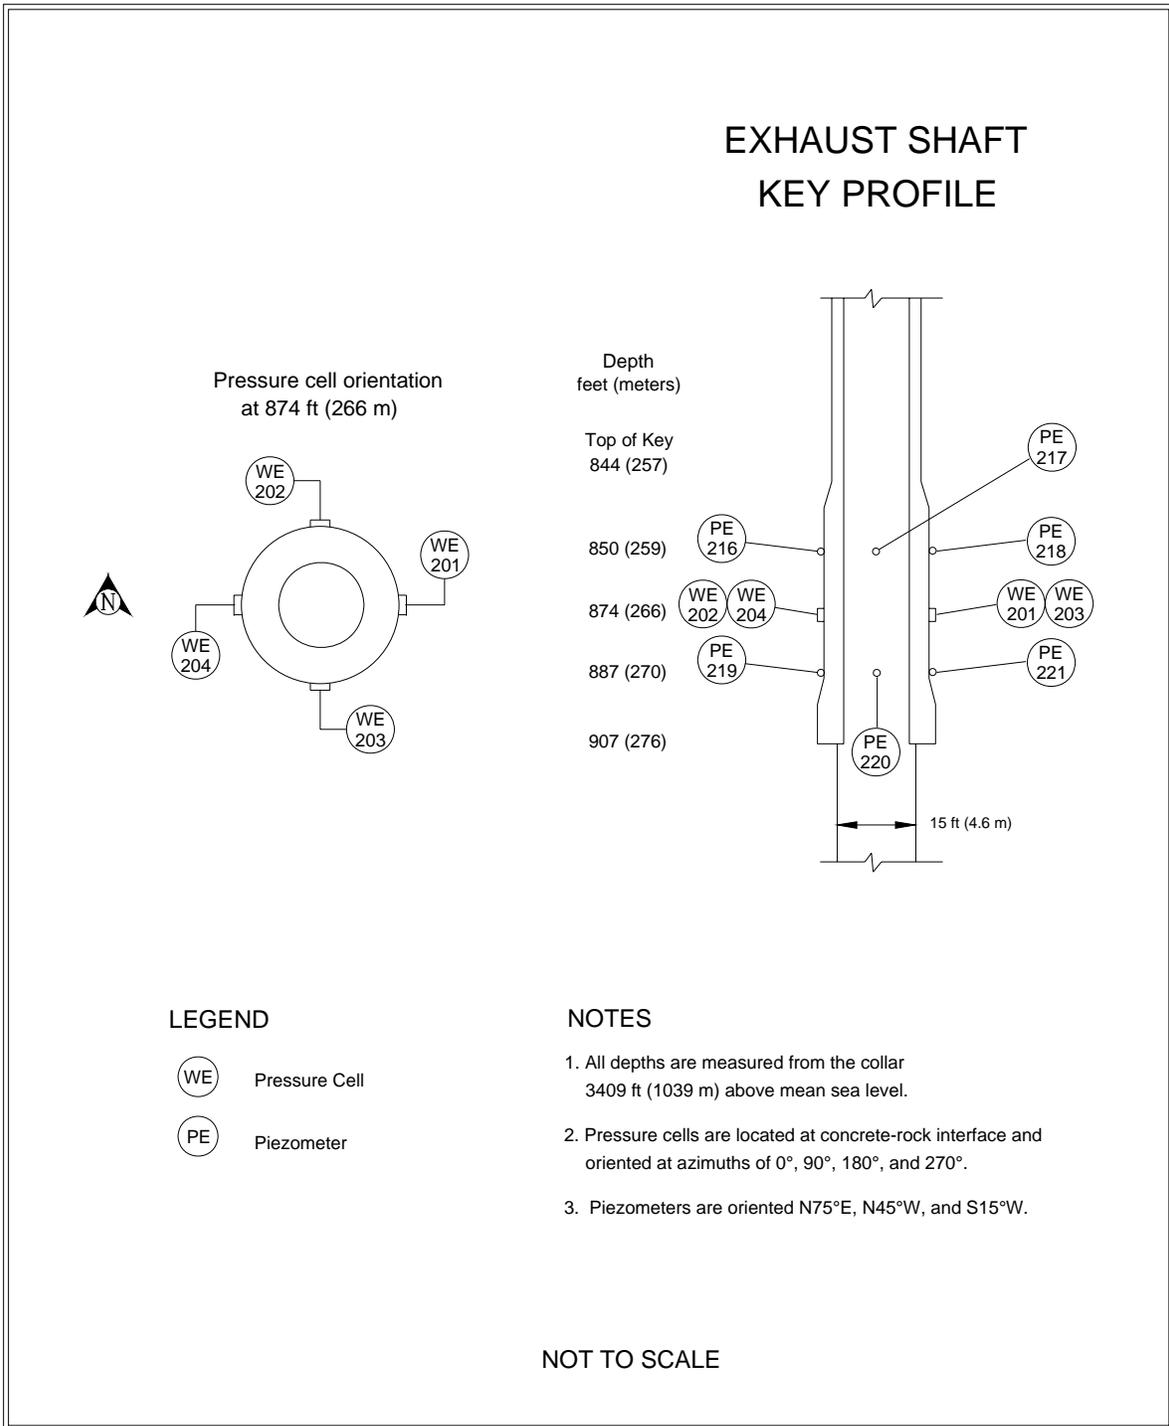
**Figure 3-11 – Exhaust Shaft Key Instrumentation**

Four earth pressure cells were installed in the key section of the Exhaust Shaft during concrete emplacement. Only two of these earth pressure cells are still functional. During this reporting period, the pressure cell readings indicated less than three psi

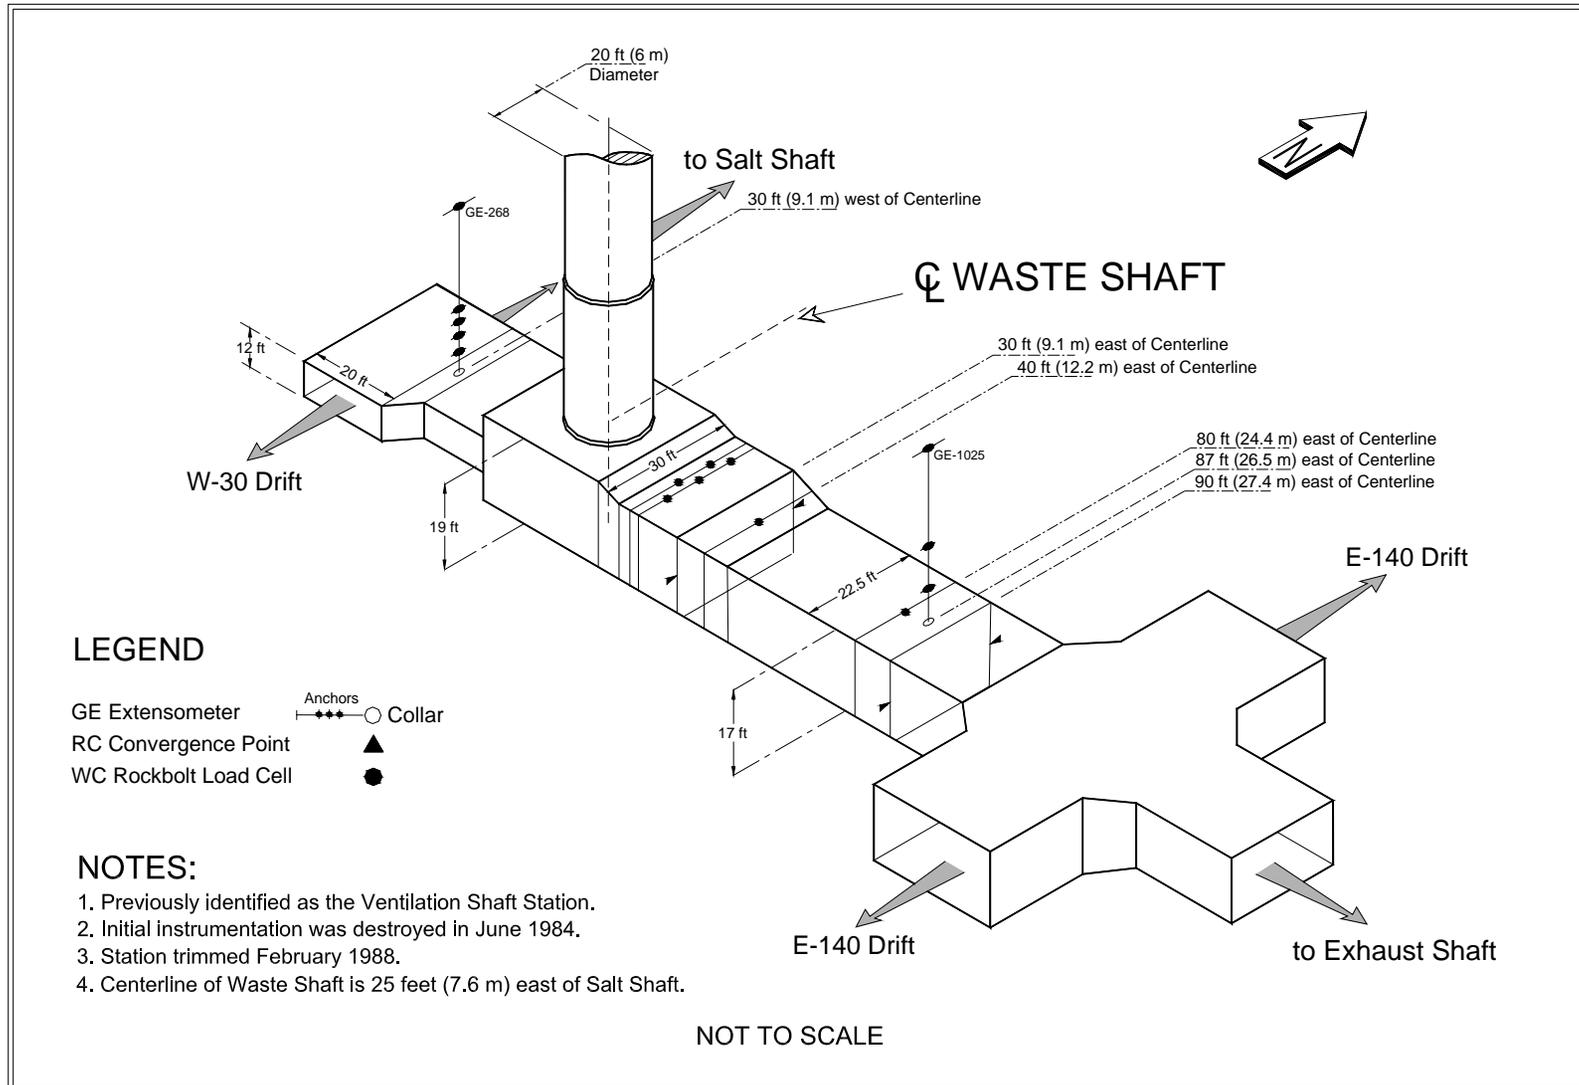
**Figure 4-4 – Waste Shaft Station Instrumentation after Wall Trimming**

Table 4-2 summarizes the recent history of the roof extensometers in the Waste Shaft Station. Extensometers 51X-GE-00268 (W-30) and 51X-GE-01025 (E-87) are installed in boreholes drilled into the roof of the station. Extensometers 51X-GE-00356 and 51X-GE-00357 monitor fracture dilation along the shaft wall above the east brow.

Table 4-3 summarizes the annual horizontal closure rates calculated from convergence point data for this reporting period. The data indicate an increase in the horizontal closure rate at E-30 of 1 percent and an increase at E-90 of 7 percent relative to the previous annual closure rates.
