**Waste Isolation Pilot Plant**

**Geotechnical Analysis**  
**Report**  
**For**  
**July 2005 – June 2006**

**Geotechnical Analysis Report for July 2005 – June 2006**  
**DOE/WIPP 07-3177, Vol. 1**

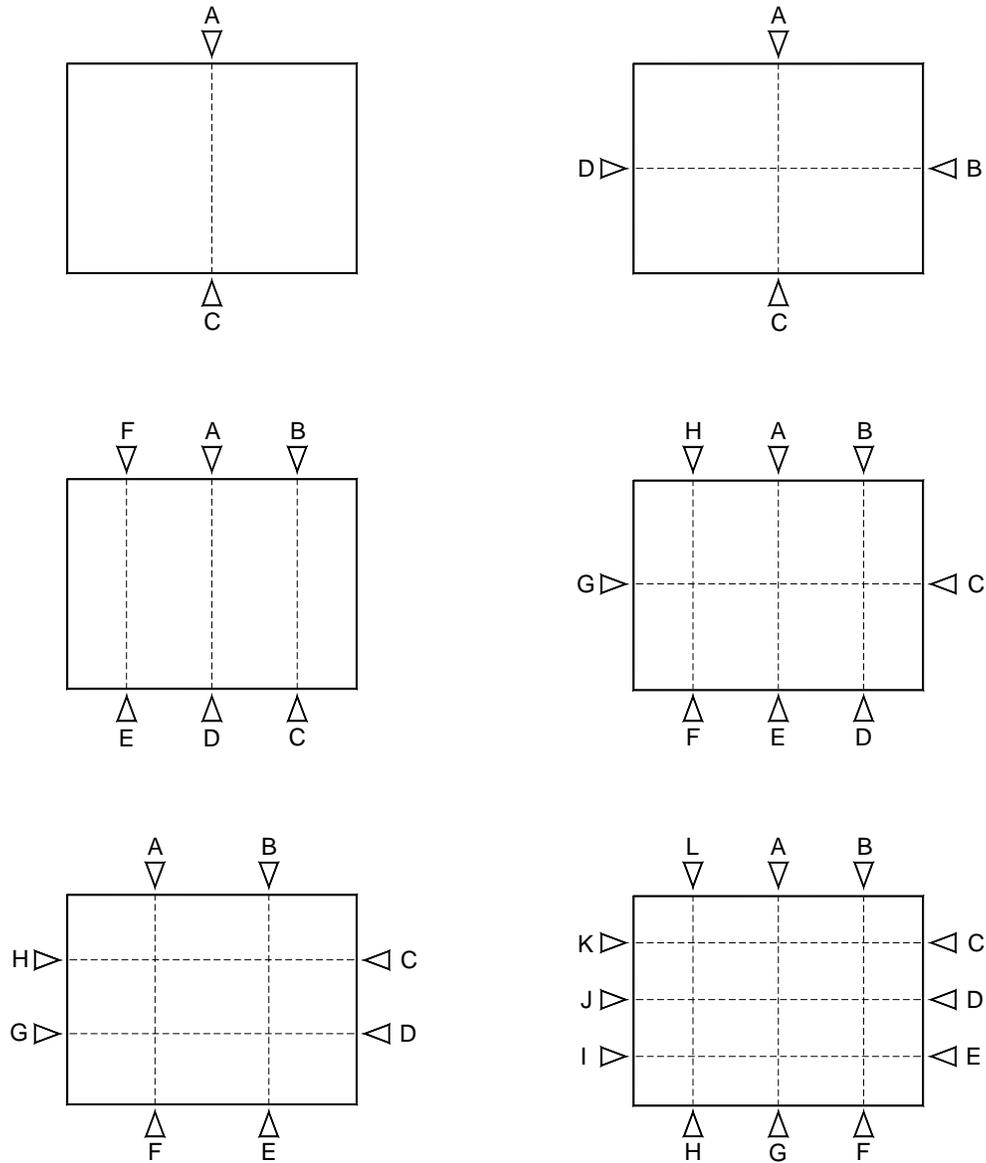
Figure 5-1 – Typical Convergence Point Array Configurations Showing Anchor Designations

Figure 5-1 shows typical convergence point array configurations. Instrumentation installed during this reporting period was limited to the replacement of convergence point arrays in previously mined areas and the installation of new monitoring arrays in the newly mined areas. New and replacement convergence points were installed in 21 locations throughout the WIPP underground access drifts because of mining and trimming activities. Horizontal and vertical convergence point arrays were installed at various locations. Most of these installations were located in the southern access drifts. Convergence points within the access drifts are read manually at least every two months, with more frequent monitoring in some areas. Table 5-2 lists the new and replacement convergence points that were installed during this reporting period.

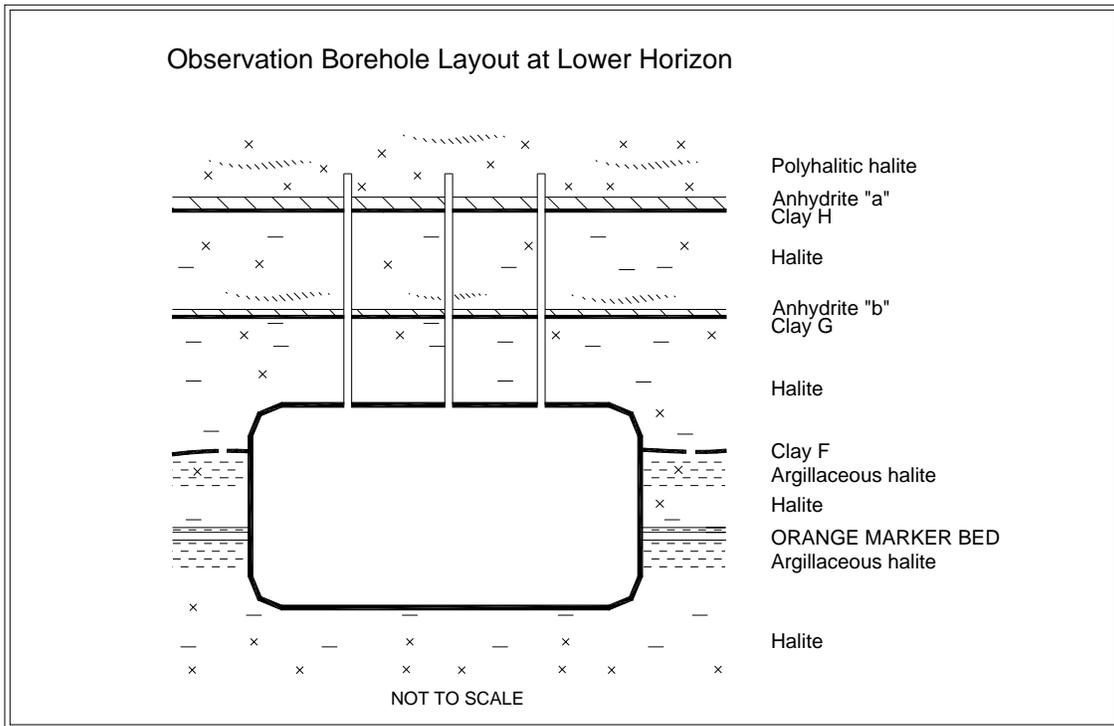
**Figure 7-1 – Example of Observation Borehole Layout at Lower Horizon**

The clay seams nearest the excavation surfaces define the immediate roof beam. The roof beam is bounded by clay "G" in most of the access drifts and Panels 1 and 2. Some areas, such as the Salt Shaft Station, portions of the E-0 and E-140 drifts, the south mains south of S-2620, and Panels 3 and 4 are excavated to clay "G" and so have roof beams bounded by clay "H".

The offset in a borehole is determined by visually estimating the degree of borehole occlusion. The direction of offset along clay seams is observed as the movement of the strata nearer to the observer relative to the strata farther away. Typically, the nearer strata move toward the center of the excavation (Figures 7-3 and 7-4). Based on previous observations in the underground, the magnitude of offset is usually greater in boreholes located near ribs than in those located along excavation centerlines. Offsetting along the clay layers is observable until the total borehole offset is reached or visibility is obstructed by intervening offsets at other clay seams or fractures. Boreholes are inspected for fractures, using an aluminum rod with a flattened steel wire probe attached to one end perpendicular to the rod (referred to as a "scratcher rod"). Fractures and clay seams are located by moving the probe along the inside of the borehole until it is snagged in one of these features. Depth to each feature is recorded, as is the magnitude of separations encountered. In addition, during this reporting period, the use of a borehole camera has been introduced in conjunction with the scratch rod.
