Waste Isolation Pilot Plant
Geotechnical Analysis
Report
For
July 2007 – June 2008

March 2009

Geotechnical Analysis Report for July 2007 – June 2008
DOE/WIPP-09-3177, Vol. 1

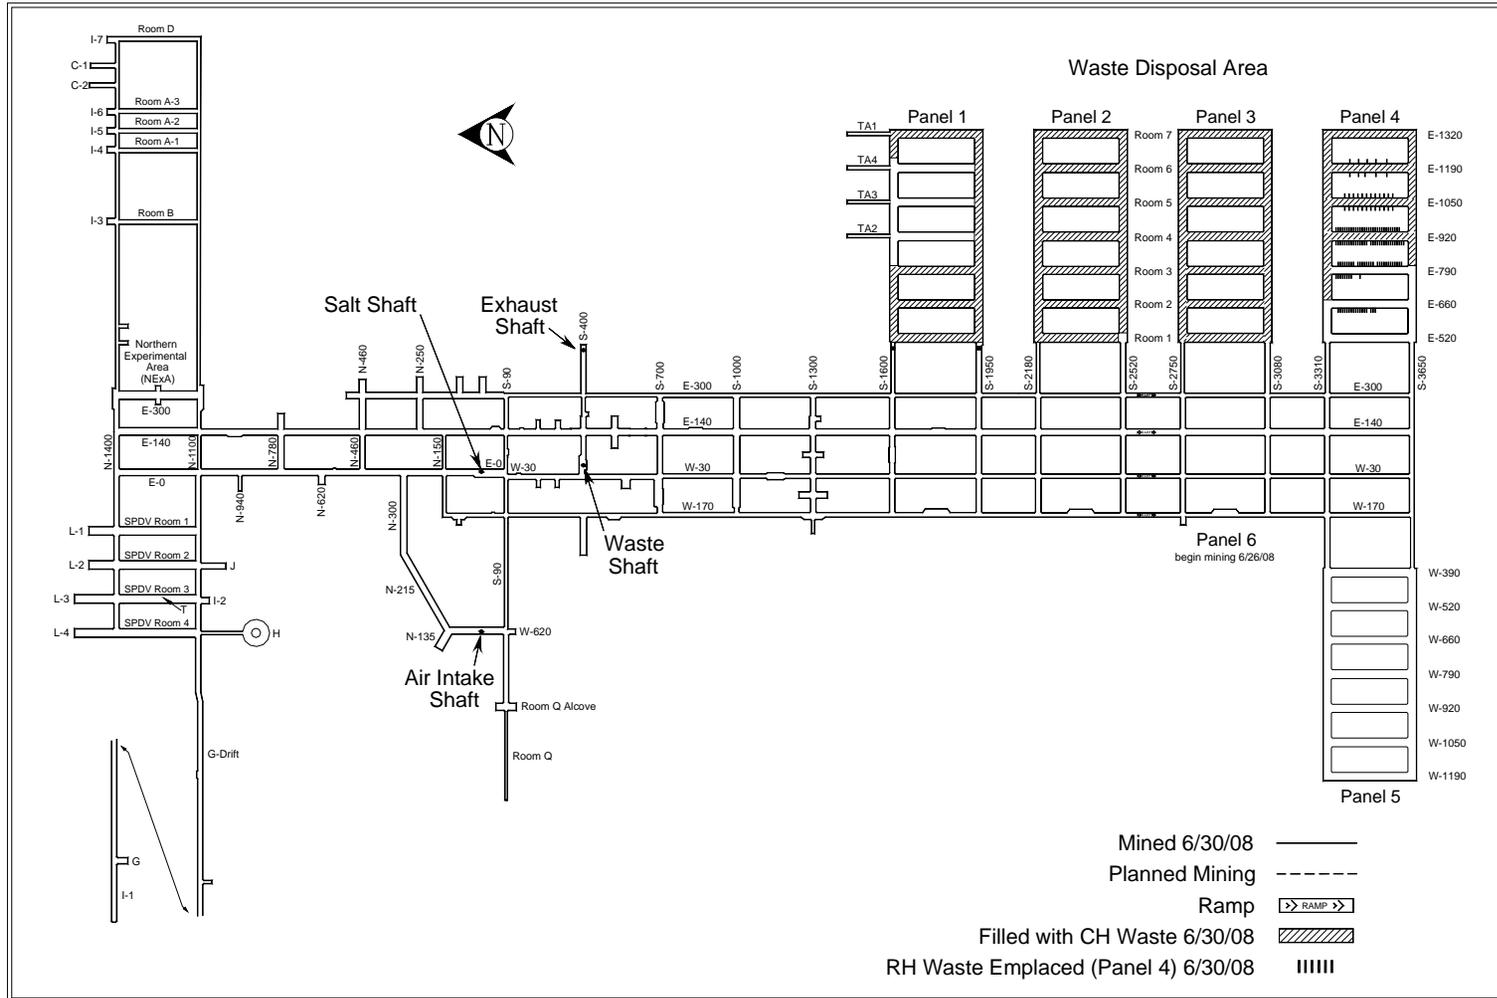
Figure 1-2 – Underground Mining and Waste Disposal Configuration as of June 30, 2008

WIPP is located in southeastern New Mexico, 26 miles (42 kilometers [km]) east of Carlsbad (Figure 1-1). The surface facilities were built on the flat to gently rolling terrain that is characteristic of the Los Medaños area. The underground facility is being excavated approximately 2,150 feet (ft) (655 meters [m]) beneath the surface in the Salado Formation. Figure 1-2 shows a plan view of the underground configuration of WIPP as of June 30, 2008.

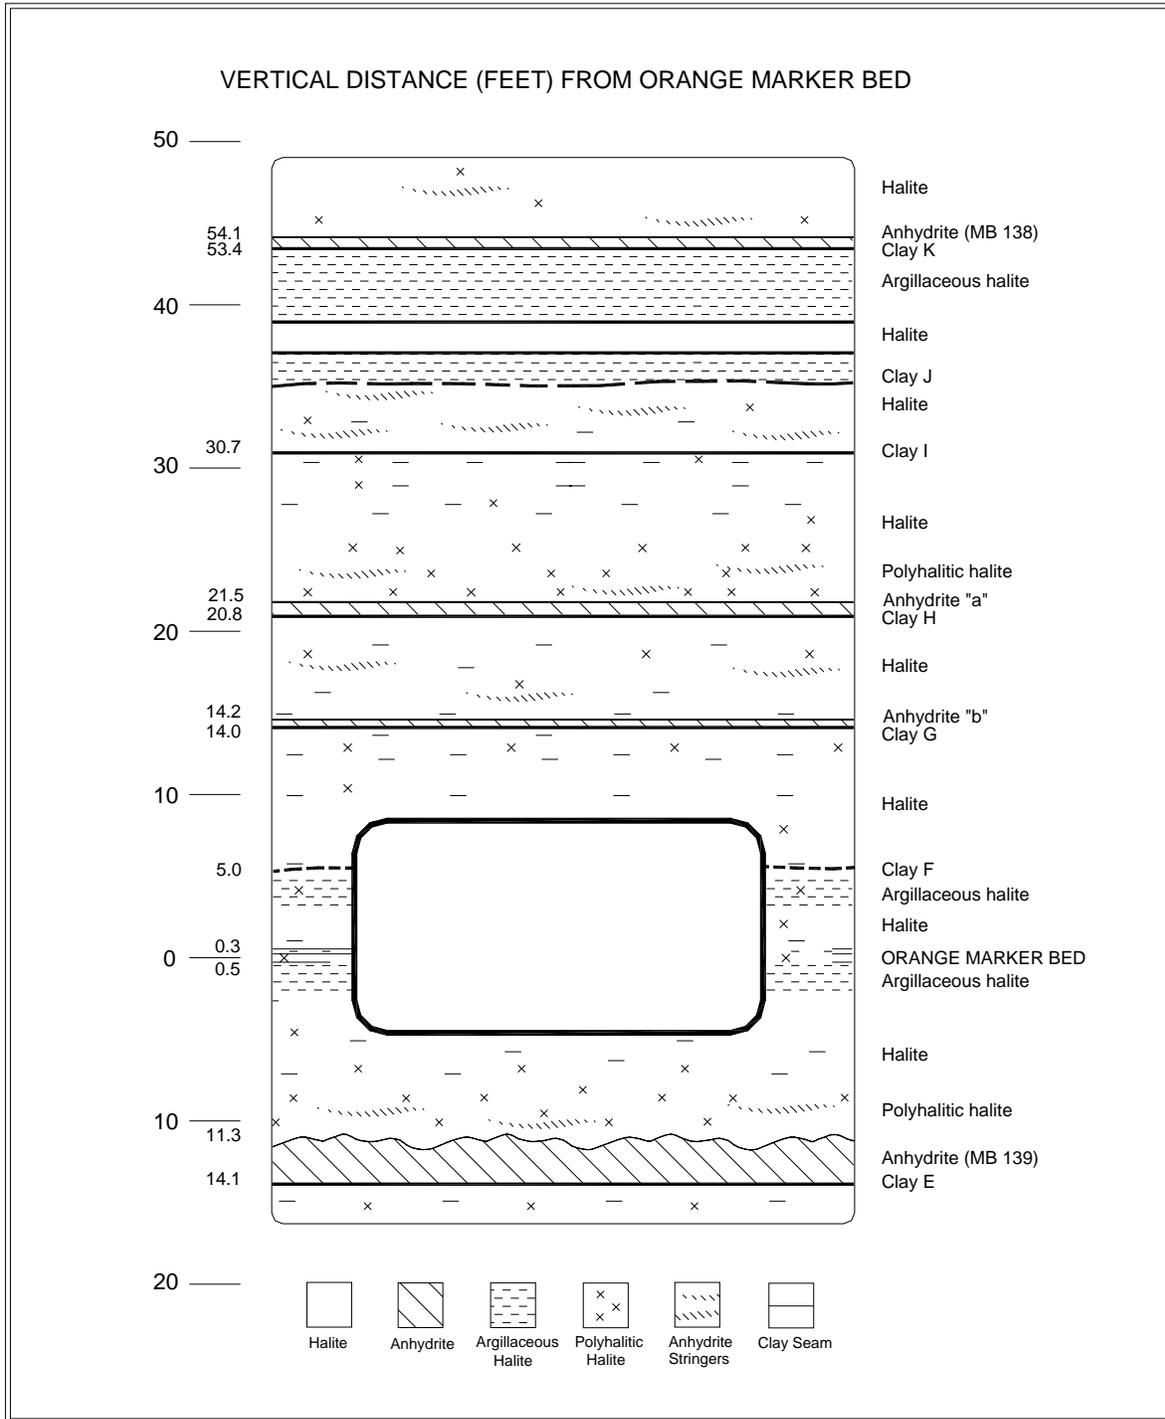
Figure 2-2 – Repository Level Stratigraphy of Panels 1, 2, 7, and 8

Field observations and computer modeling indicated that moving the disposal horizon stratigraphically upwards (so that the roof was located at Clay G) would improve long-term ground conditions and provide a more stable roof configuration without significantly impacting repository performance. In 2000, the decision was made to implement this change by moving the mining horizon up approximately six feet. Subsequently, in 2000 and 2001, ramps were mined in the W-170, W-30, E-140, and E-300 drifts between S-2620 and S-2750 (Figure 1-2). As a result, the disposal horizon for Panels 3, 4, 5, and 6, and the associated connecting drifts, lies above the horizon for the other panels (Figure 2-3). Panel 5 excavation is complete, but outfitting was not yet completed.

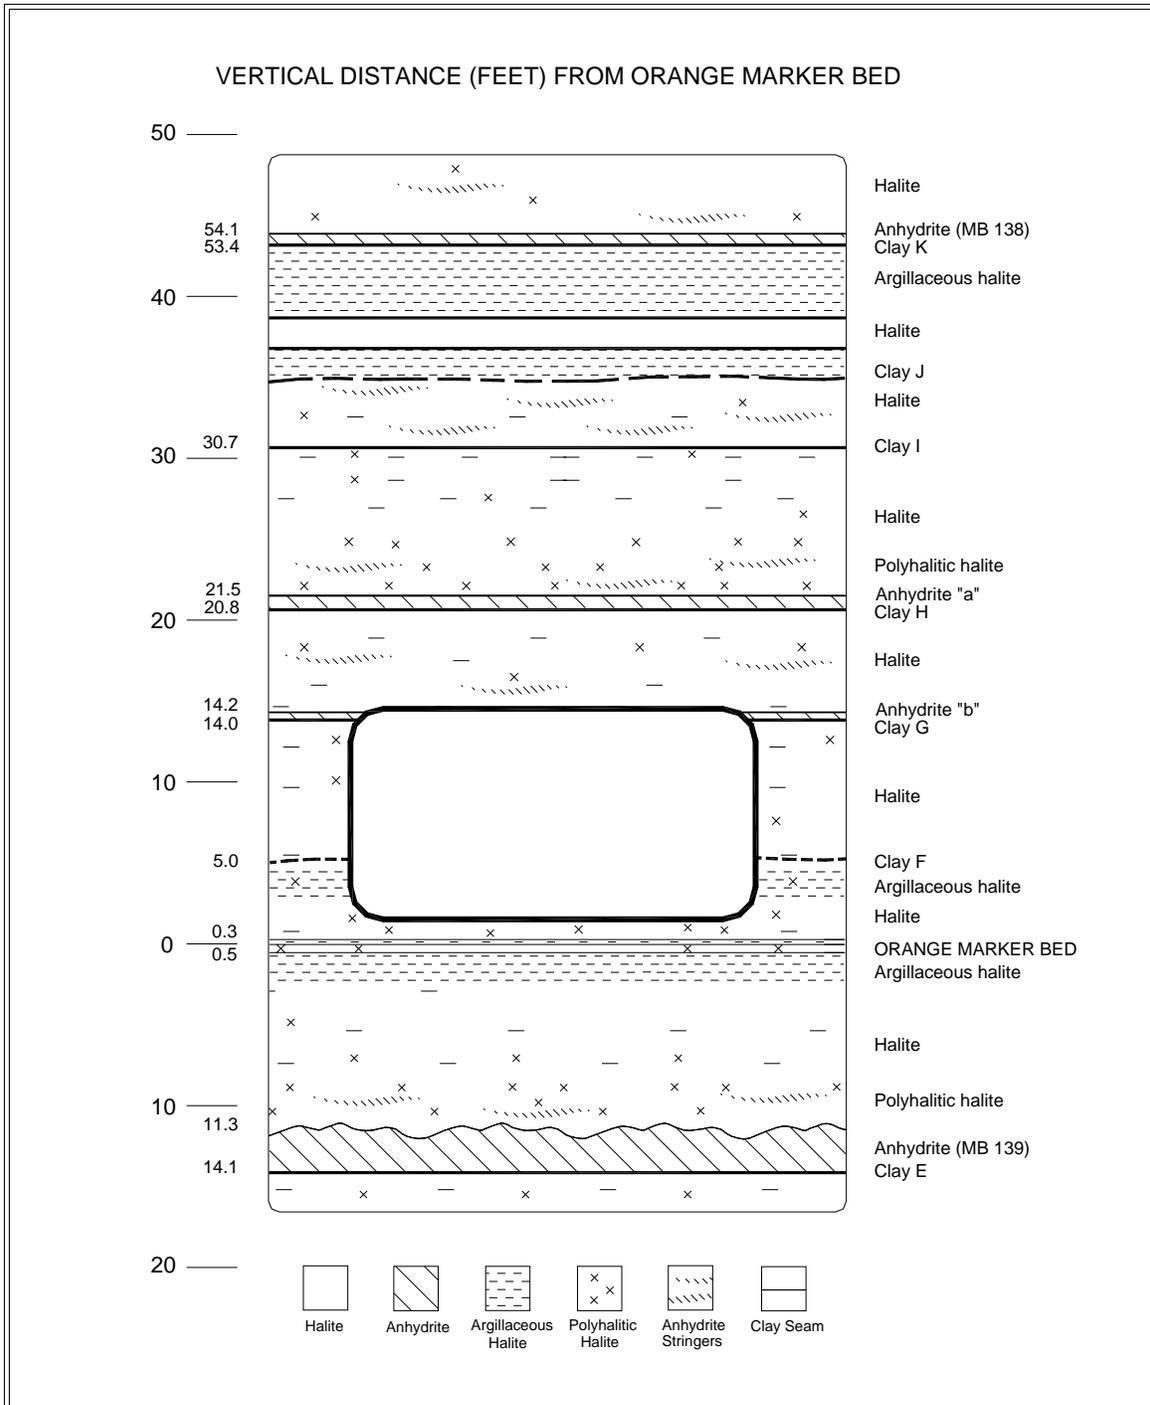
Figure 2-3 – Repository Level Stratigraphy of Panels 3, 4, 5, and 6

In this horizon (see Figure 2-3), the OMB lies at or below the floor. MB139 lies about 12 ft (3.7 m) below the floor. The roof is immediately above Anhydrite "b". Clay G/ Anhydrite "b" is used as the mining reference during excavation of this disposal horizon.

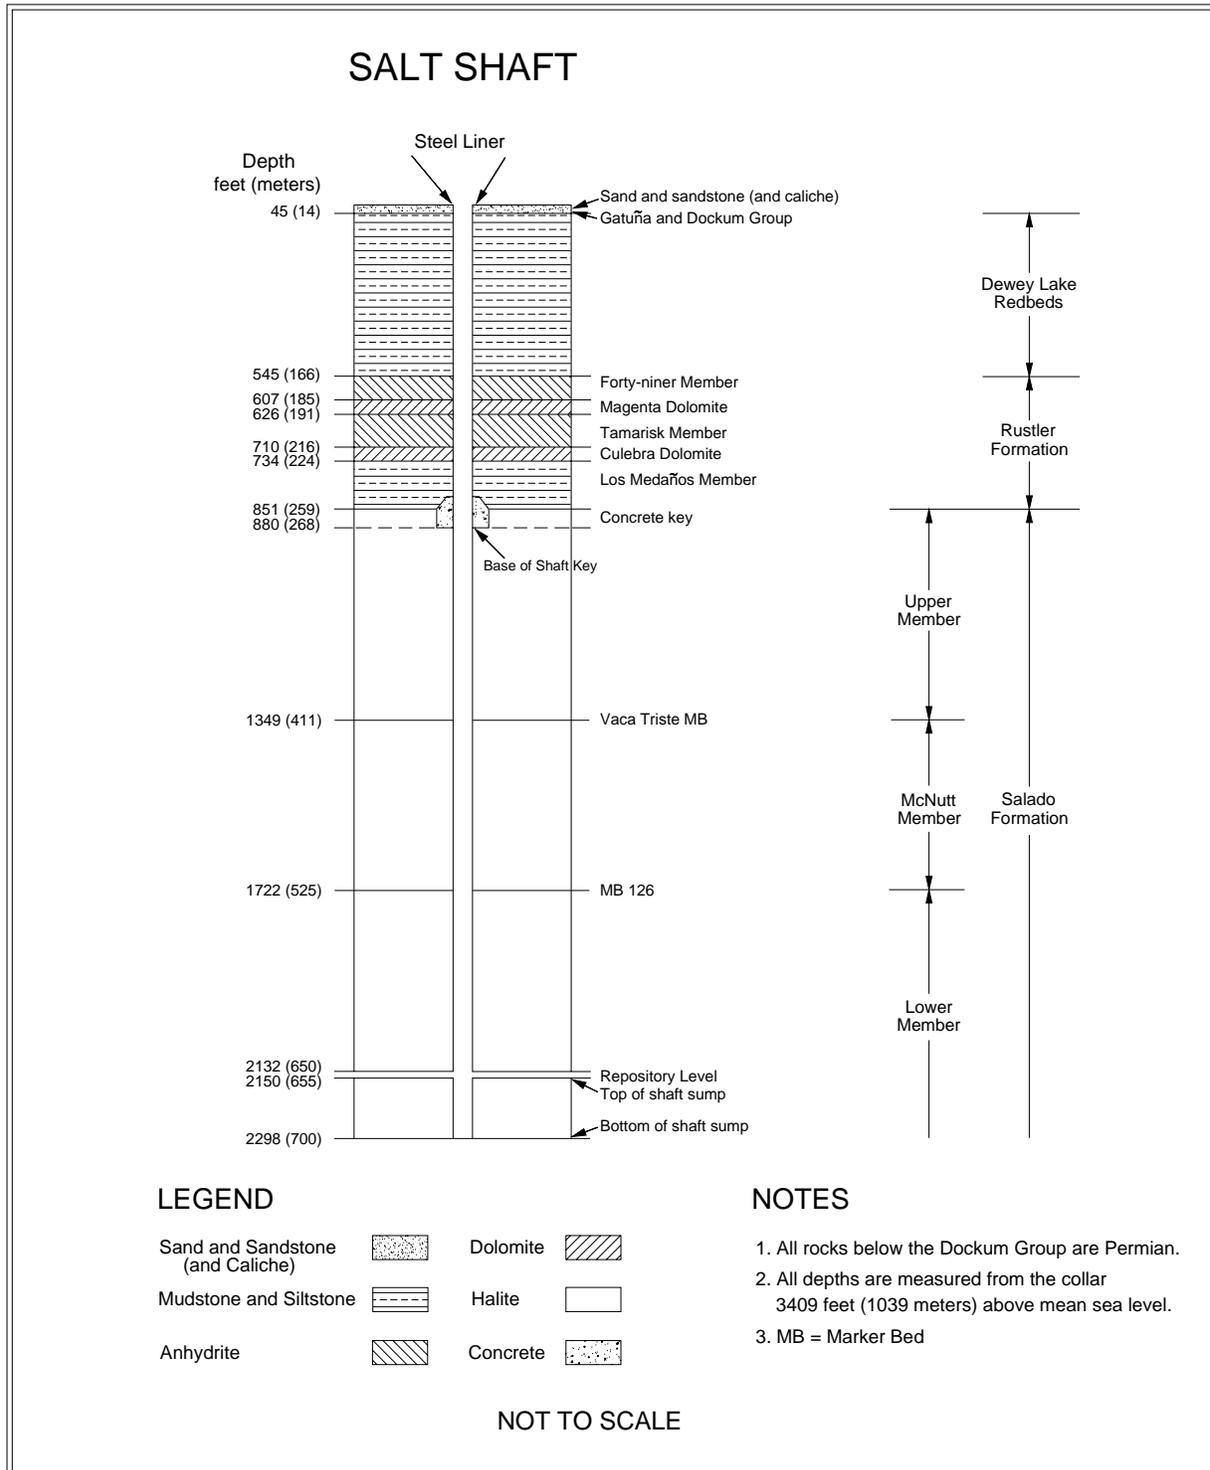
Figure 3-1 – Salt Shaft Stratigraphy

The first construction activity undertaken during the SPDV Program was the excavation of the Exploratory Shaft. This shaft was subsequently referred to as the Construction and Salt Shaft and is currently designated the Salt Shaft (see Figure 1-2). The shaft was drilled from July 4 to October 24, 1981, and geologically mapped in the spring of 1982 (DOE, 1983). Figure 3-1 presents the stratigraphy in the shaft.

The Salt Shaft is lined from the surface to 846 ft (258 m) with steel casing having an inside diameter of 10 ft (3-m). The thickness of the steel liner (including external stiffener rings) increases from 0.62 in (1.6 cm) at the top to 1.5 in (3.8 cm) at the key. Cement grout was placed between the liner and rock face. The 10-ft (3-m) diameter extends through the concrete shaft key to 880 ft (268 m). The shaft key is a 37.5 ft (11.4-m) long, reinforced-concrete structure that begins 3.5 ft (1.07 m) above the bottom of the steel liner. From the key to the bottom at 2,298 ft (700 m), the shaft has a nominal diameter of 12 ft (4 m).

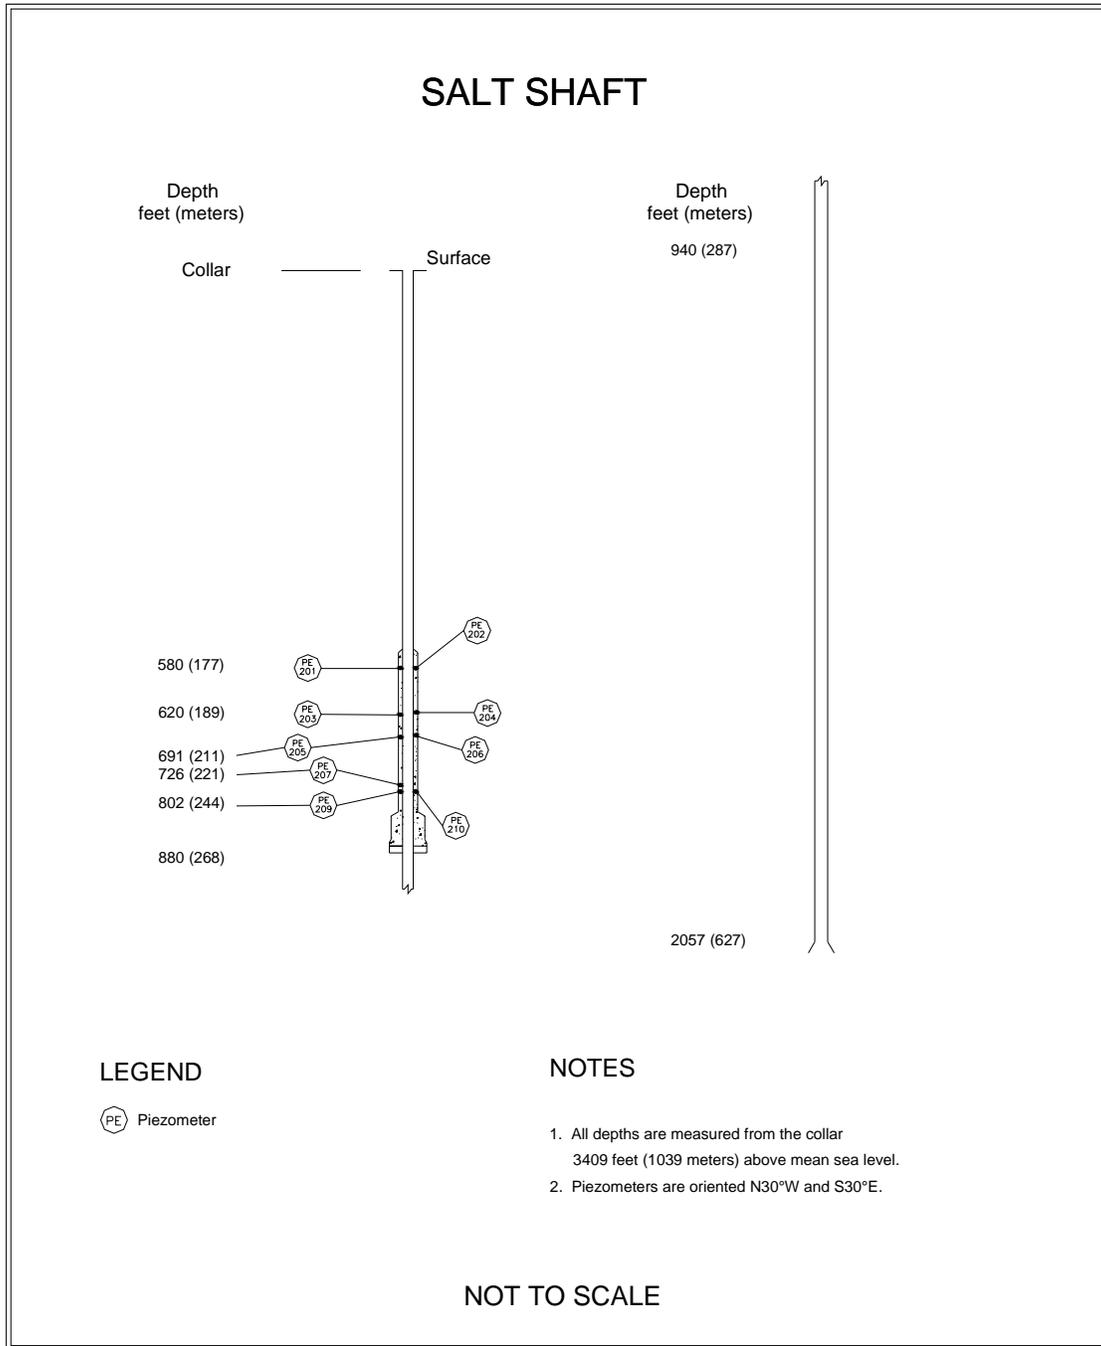
Figure 3-2 – Salt Shaft Instrumentation (Without Shaft Key)

Eleven of the 12 piezometers continue to provide data. The fluid pressures recorded at the end of this reporting period range from approximately 66 pounds per square inch (psi) (455 kilopascals [kPa]) at the 802-ft (244-m) level in the Los Medaños Member to 234 psi (1,613 kPa) at the 620-ft (189-m) level in the Magenta Dolomite Member. The recorded pressures for this reporting period are generally consistent with the readings from the previous reporting period. The fluid pressure on the shaft liner will continue to be monitored on a regular basis.

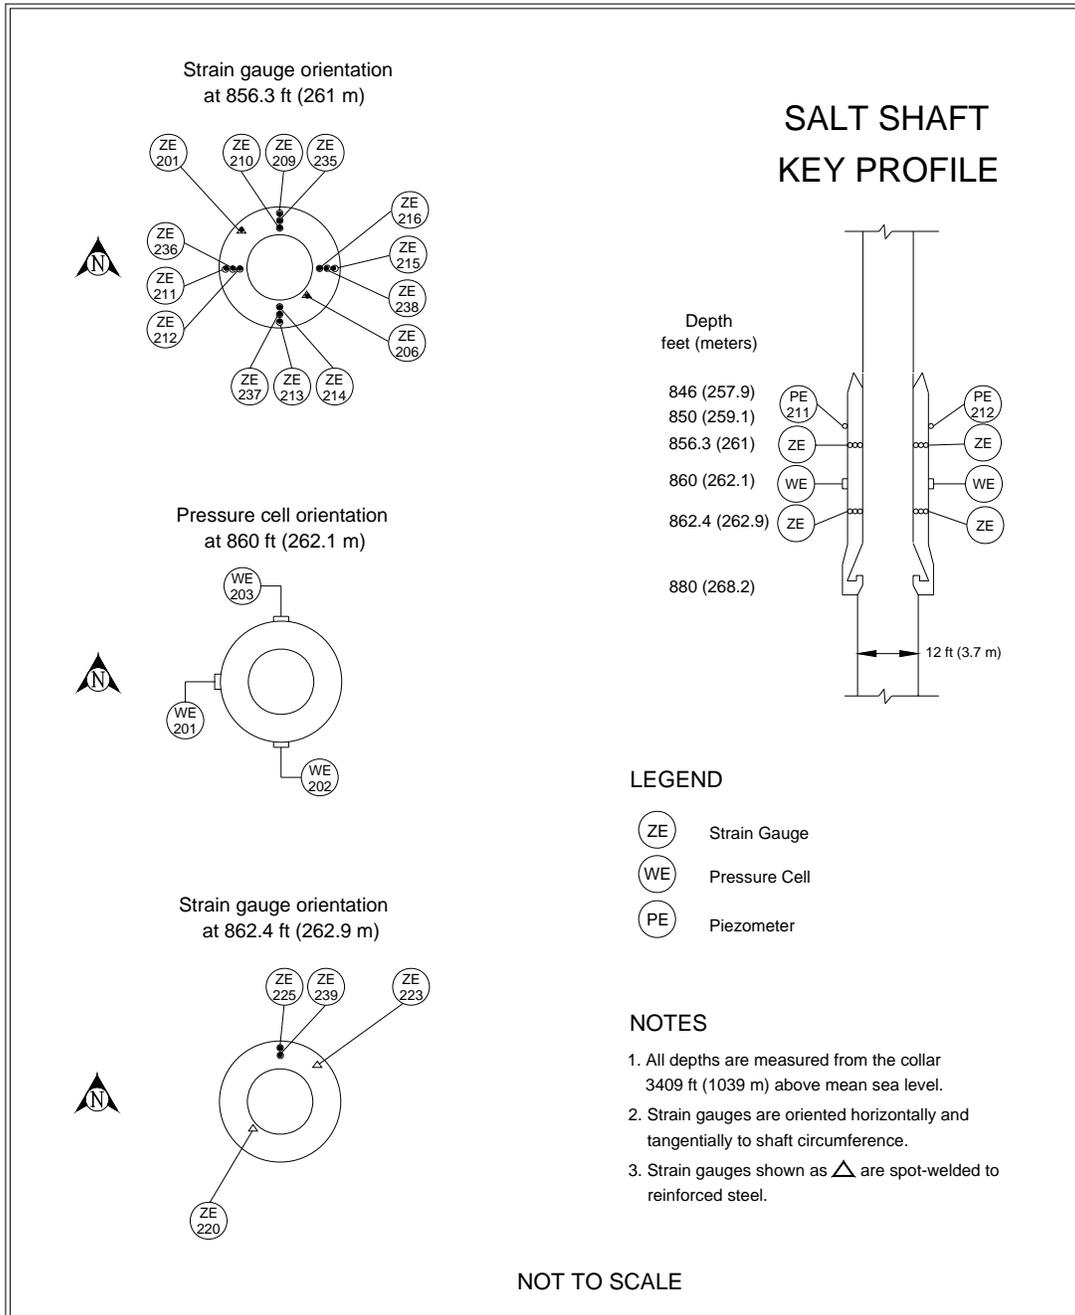
Figure 3-3 – Salt Shaft Key Instrumentation

Four earth pressure cells were installed in the key section during concrete emplacement at the 860-ft (262-m) level. These instruments measure the normal stress between the concrete key and the Salado Formation as salt creep loads up the key structure. Three of the four earth pressure cells continue to provide data. These instruments have indicated essentially no contact pressure since their installation (readings resemble instrument drift at a zero pressure). The contact pressures recorded by the instruments for this reporting period ranged from -22 to 4 psi (-152 to 28 kPa).

Sixteen spot-welded and twenty-four embedment strain gauges were installed on and in the shaft key concrete at both the 856.3-ft (261-m) level and at the 862.4-ft (263-m) level. Four spot-welded strain gauges are still functioning at these levels. Maximum strains at the 856.3-ft (261-m) level were 650 and 722 microstrain. Strains at the 862.4-ft (263-m) level were 627 and 853 microstrain. The strains from the 12 embedment strain gauges at the 856.3-ft (261-m) level ranged from -717 to 987 microstrain. The strains from the two embedment strain gauges at the 862.4-ft (263-m) level were 221 to 357 microstrain. The strains recorded by the spot-welded

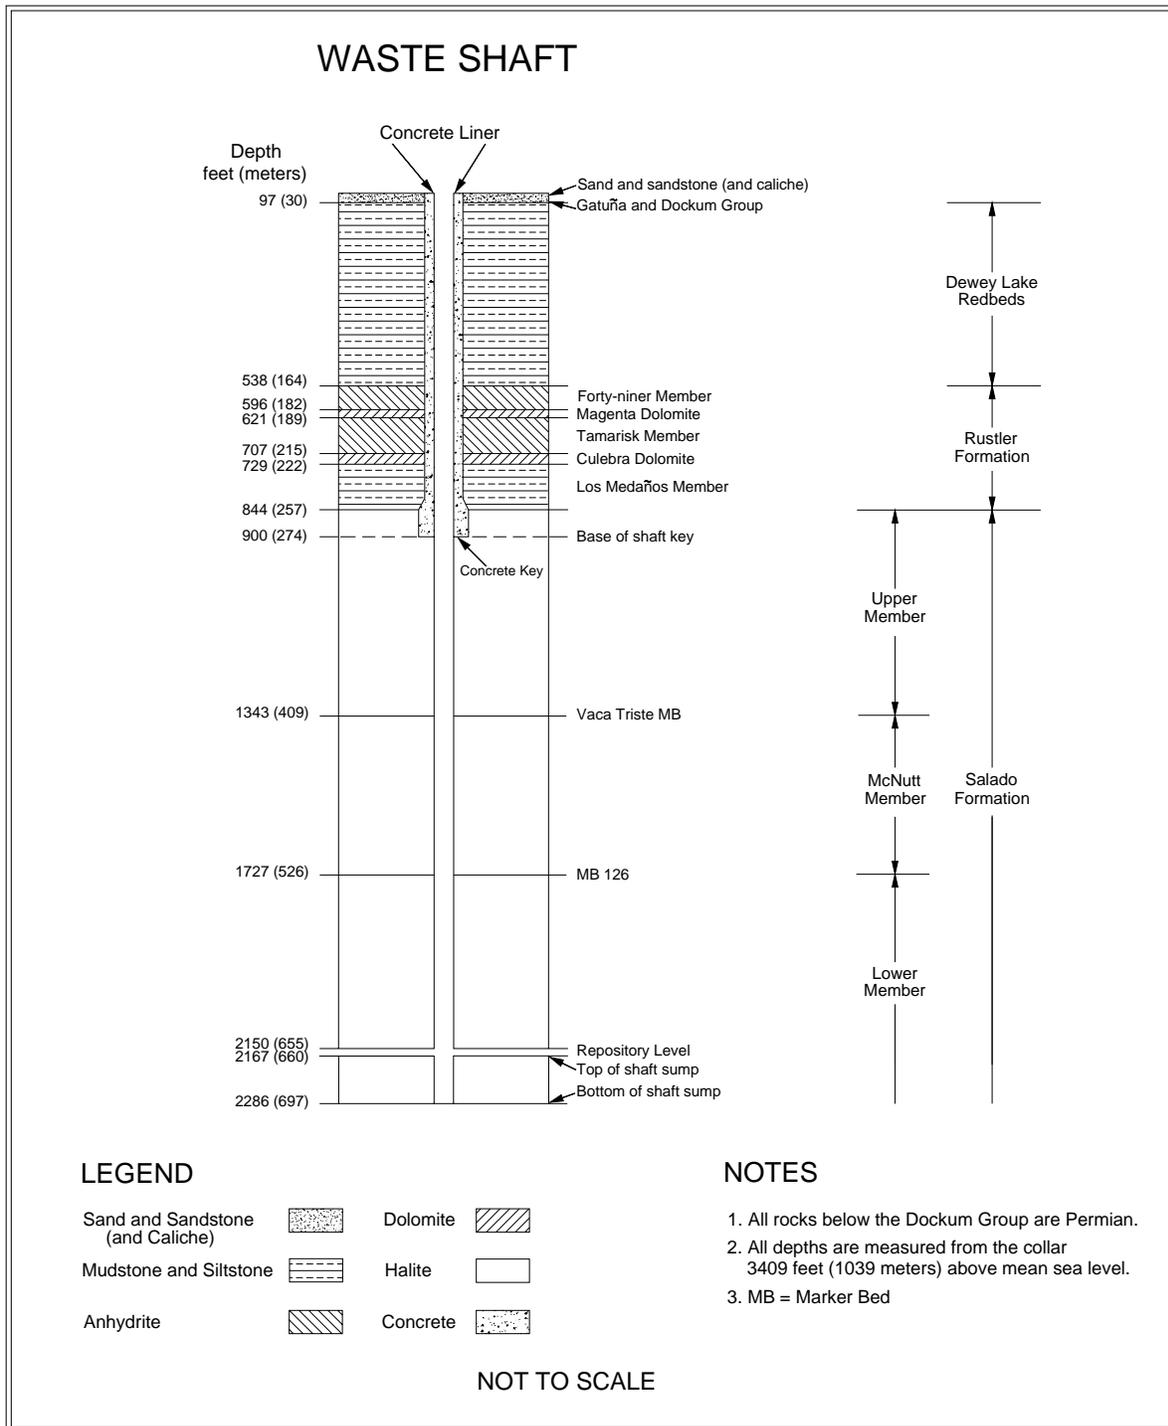
Figure 3-4 – Waste Shaft Stratigraphy

The Waste Shaft is lined with nonreinforced concrete having a 19 ft (6 m) inside diameter from the surface to the top of the key at 837 ft (255 m). Liner thickness increases from 10 in (25 cm) at the surface to 20 in (51 cm) at the key. The key is 63 ft (19 m) long and 4.25 ft (1.3 m) thick and is constructed of reinforced concrete. The bottom of the key is 900 ft (274 m) below the surface. The diameter of the shaft is 20 ft (6 m) at the bottom of the key and increases to 23 ft (7 m) just above the shaft station. The shaft below the key is lined with wire mesh anchored by rock bolts. The diameter of 23 ft (7 m) extends to a depth of approximately 2,286 ft (697 m), with the shaft sump comprising the lower 119 ft (36 m) of that interval.

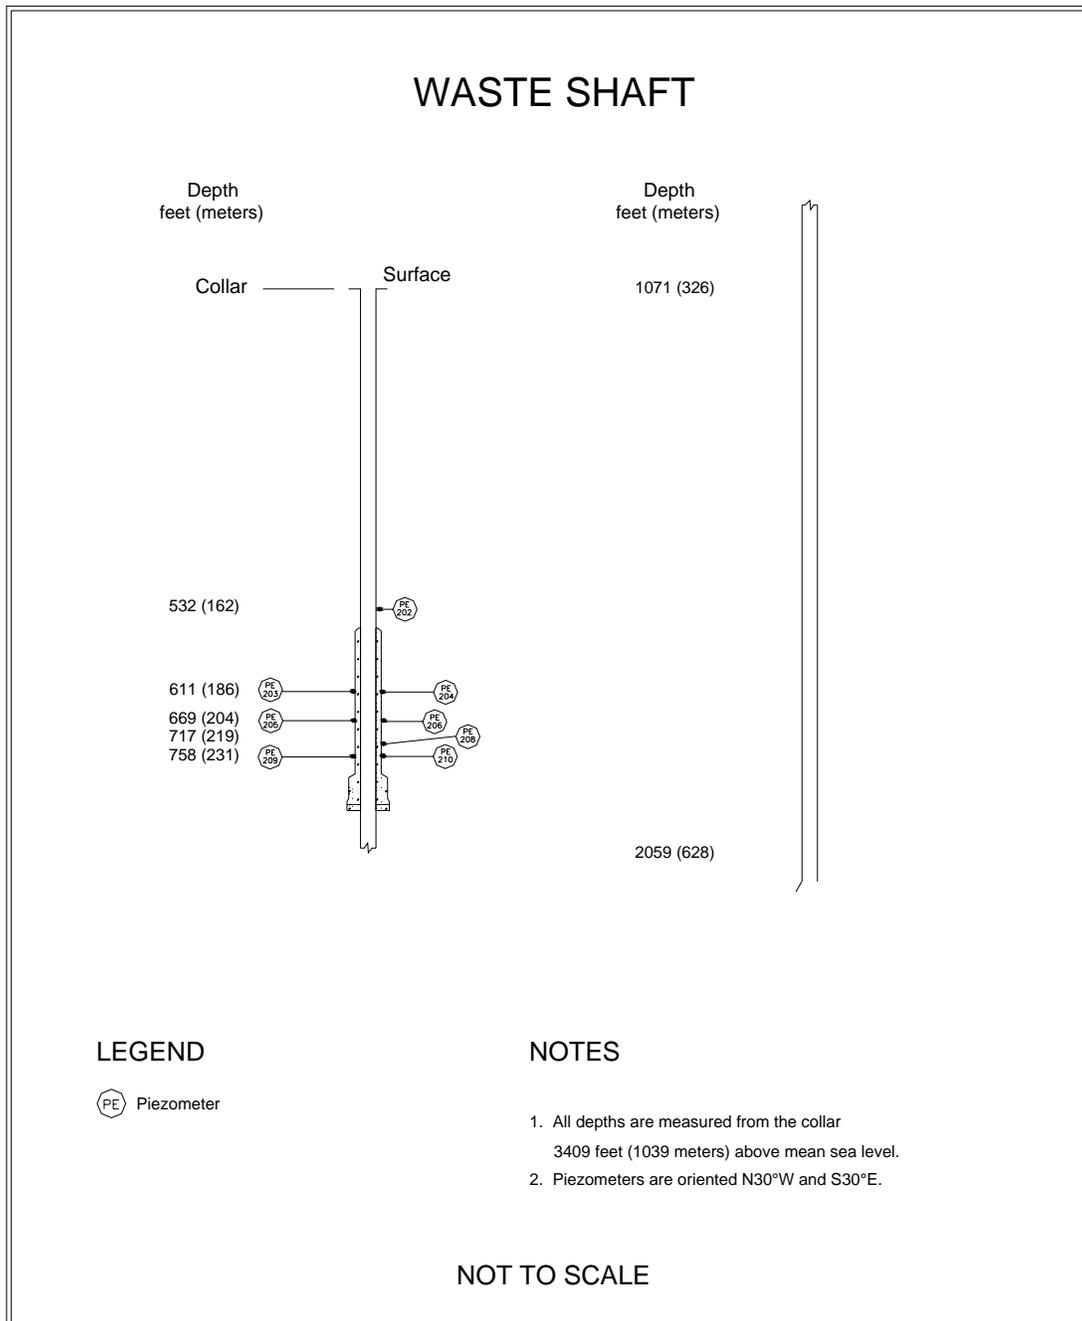
Figure 3-5 – Waste Shaft Instrumentation (Without Shaft Key)

Twelve piezometers were installed in the lined section of the Waste Shaft on September 7 and 8, 1984, to monitor fluid pressure behind the shaft liner and the key section. Data continue to be received from 10 piezometers. The maximum recorded fluid pressure during this reporting period was 143 psi (986 kPa) at the 717-ft (219-m) level. The pressure readings during this reporting period were consistent with the readings from the previous reporting period with a mean change in pressures of less than 2.5 psi (17 kPa).

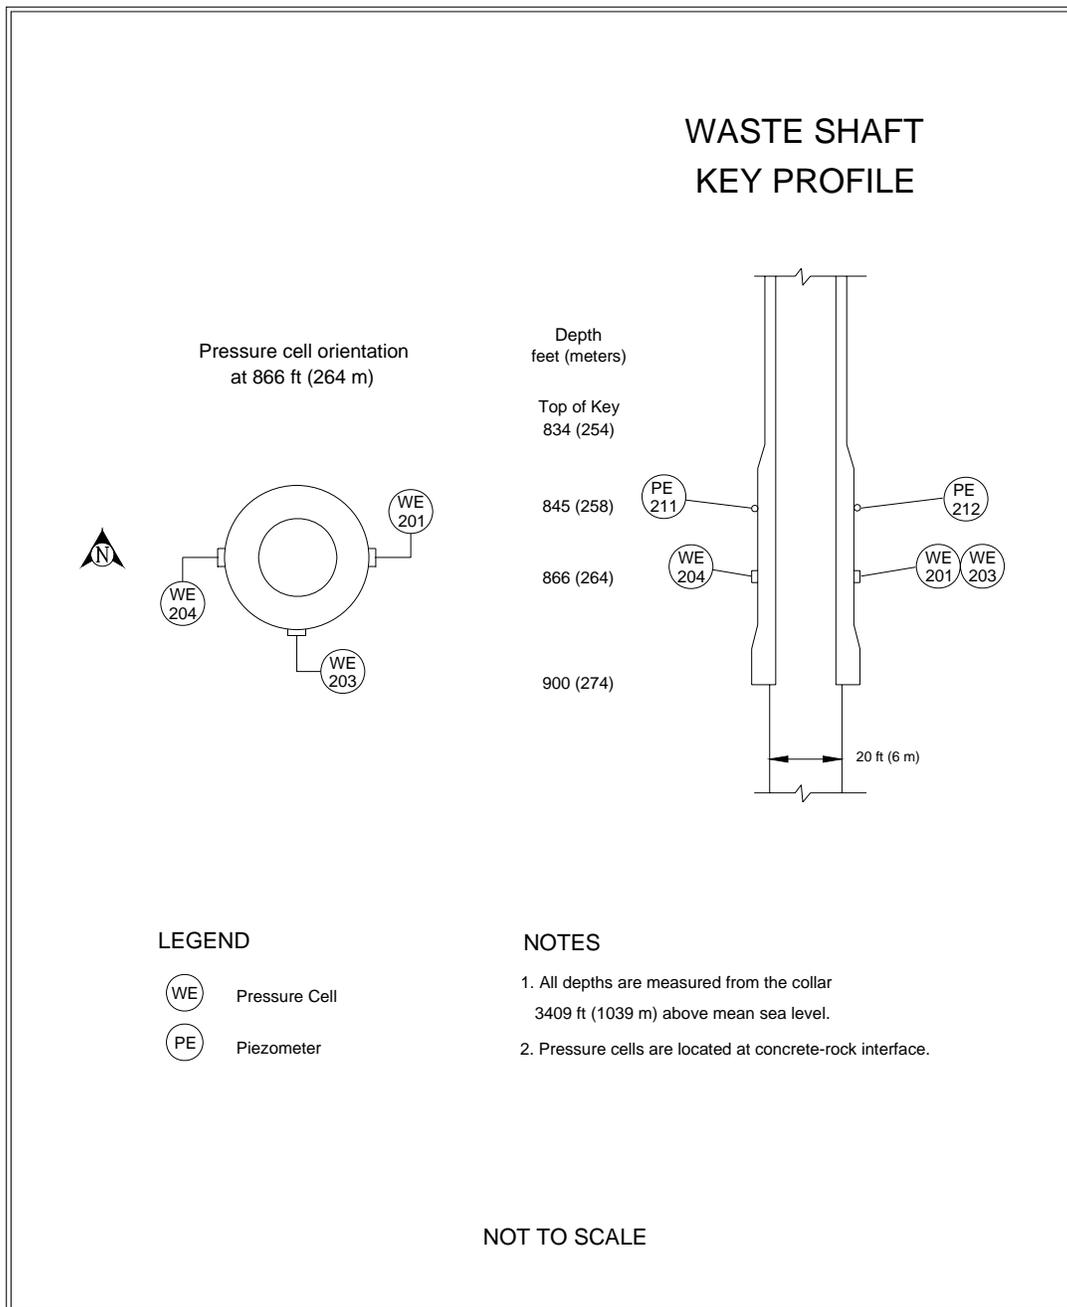
Figure 3-6 – Waste Shaft Key Instrumentation

Four earth pressure cells were installed in the key section of the Waste Shaft during concrete emplacement between March 23 and April 3, 1984. Three are still working. These instruments measure the normal stress between the concrete key and the Salado Formation as salt creep loads the key structure. The contact pressures recorded by the instruments during this reporting period ranged from 81 to 122 psi (558 to 841 kPa).

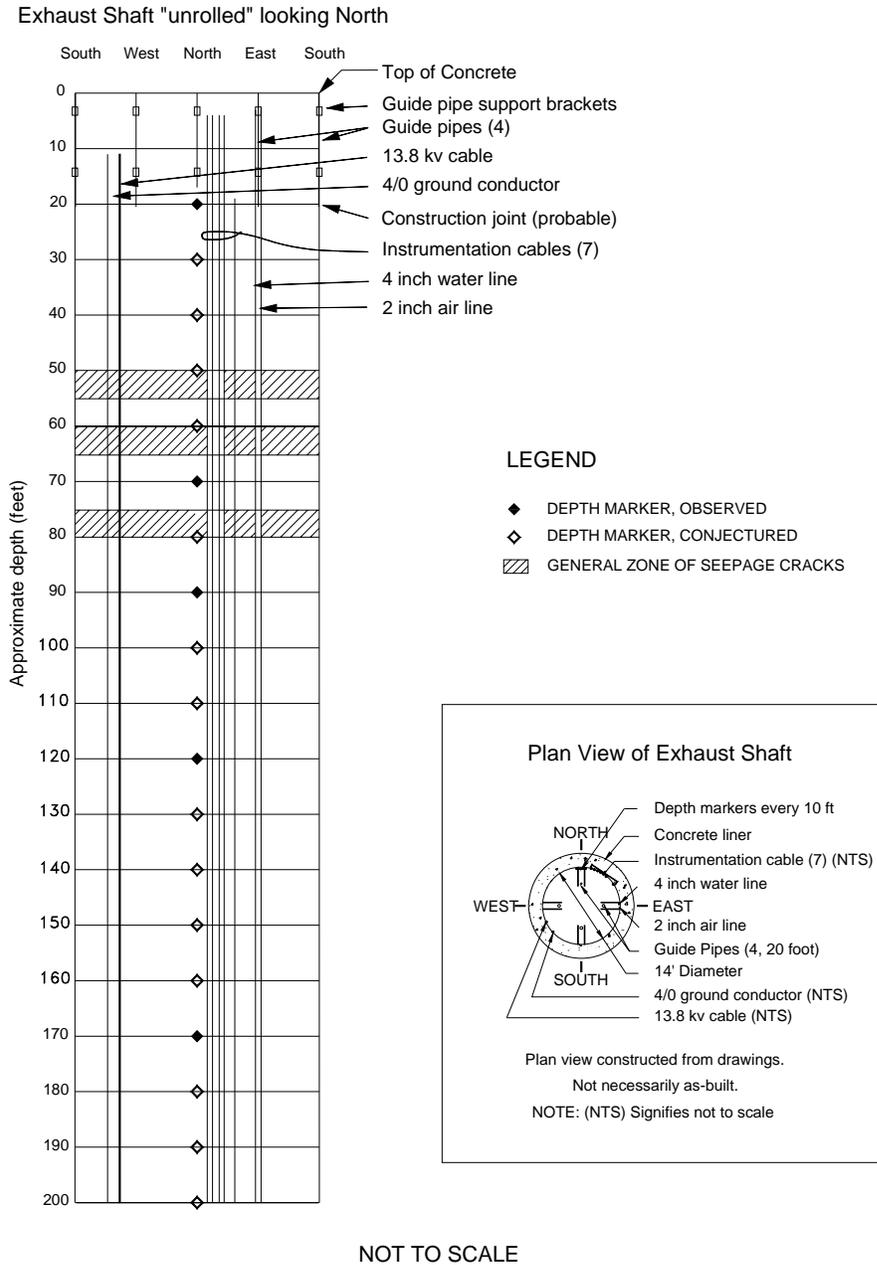
Figure 3-9 – Diagram of Exhaust Shaft Fixtures and Seepage Zones (Upper 200 ft)

The Exhaust Shaft liner is examined for cracks, seepage, and general shaft stability. Currently, there are three principal zones of seepage in the shaft. The first is about 50 to 55 ft below the shaft collar (bsc). The second is about 60 to 65 ft bsc. The third is about 75 to 80 ft bsc, as shown in Figure 3-9. Monitoring of seepage horizons started before 1995. Water entering the shaft through these cracks is believed to originate from a perched aquifer at the base of the Santa Rosa Formation that is being recharged as the result of surface modifications at the site. The fluid level in the Santa Rosa near the shaft is about 43 to 44 ft below the surface. Based on examination of inspection videos, the flow rate into the shaft during this reporting period is estimated at about 1 to 1-1/2 gallons per minute, most of which is carried out of the shaft by the exhaust air. Seepage cracks are confined primarily to the eastern side of the shaft wall.

Though the Magenta and Culebra water rings are encrusted with salt buildup, no water appears to originate from the liner or water rings. Most of the seepage was observed along the east face of the shaft wall near the instrumentation cables and the air lines and waterlines in the upper section of the shaft. Though the presence of water is an inconvenience requiring periodic disposal, at this time it does not appear to have created any hazard or affected the structural integrity of the shaft. However, brine increases the probability of corrosion and deterioration of utility hangers and brackets. There are no visible signs of dissolution of the salt below the key.

When fluid was detected seeping into the shaft, a catch basin was designed and installed at the base of the Exhaust Shaft to intercept water and prevent it from draining into the Waste Shaft Sump. Fluid was removed from the catch basin from March 1996 through October 2005 as needed. The catch basin was damaged in 2004 by fallen debris, either salt or instrumentation cables or both. A new catch basin was fabricated and installed in December 2004. This basin was damaged in August 2005, most likely the result of fallen debris. An interception well system was installed between November 2005 and March 2006 to replace the catch basin. Interception wells were drilled down-gradient in S-400 between E-140 and E-300 (Figure 3-10). The interception well system consists of four 30-ft deep 9-7/8-in diameter holes with a submersible pump and pressure transducer in each. Fluid is pumped from each hole to a series of storage containers in S-550. A data-acquisition system monitors the fluid level in each hole, turning the pump on and off between set limits as needed.

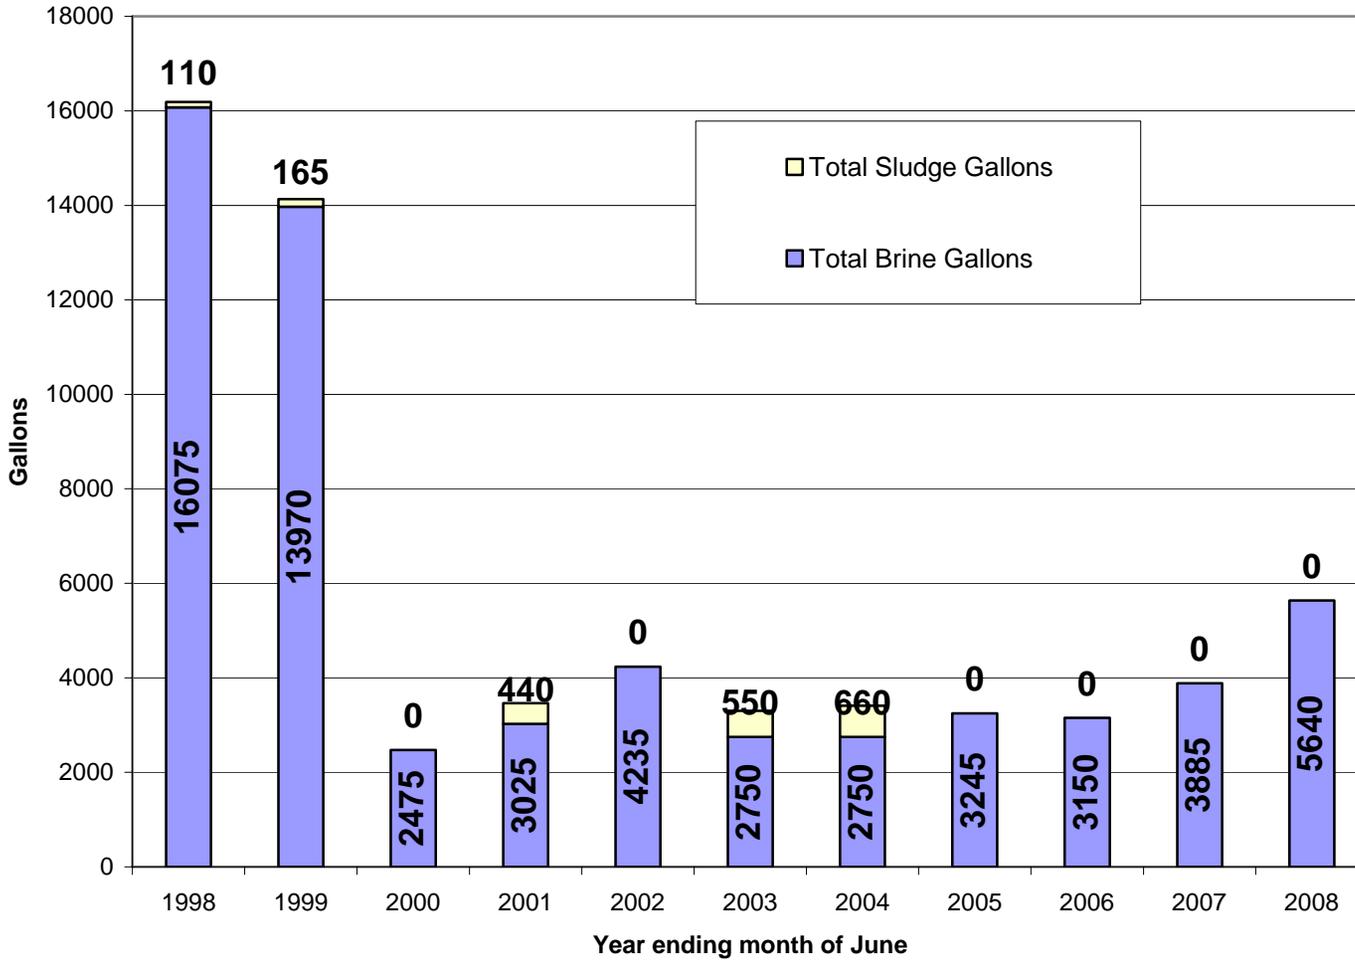
Figure 3-11 - Water Removed from the Exhaust Shaft Catch Basin
and the Interception Well System

Table 3-1 and Figure 3-11 present the volume of fluid removed from the catch basin from July 1997 through June 2006, and by the interception well system from July 2006 through June 2008. The largest reported volumes are typically associated with periods of reduced ventilation and increased humidity. For a discussion of the factors affecting the quantity of fluid produced in the Exhaust Shaft, refer to DOE/WIPP 00-2000, *Brine Generation Study*.

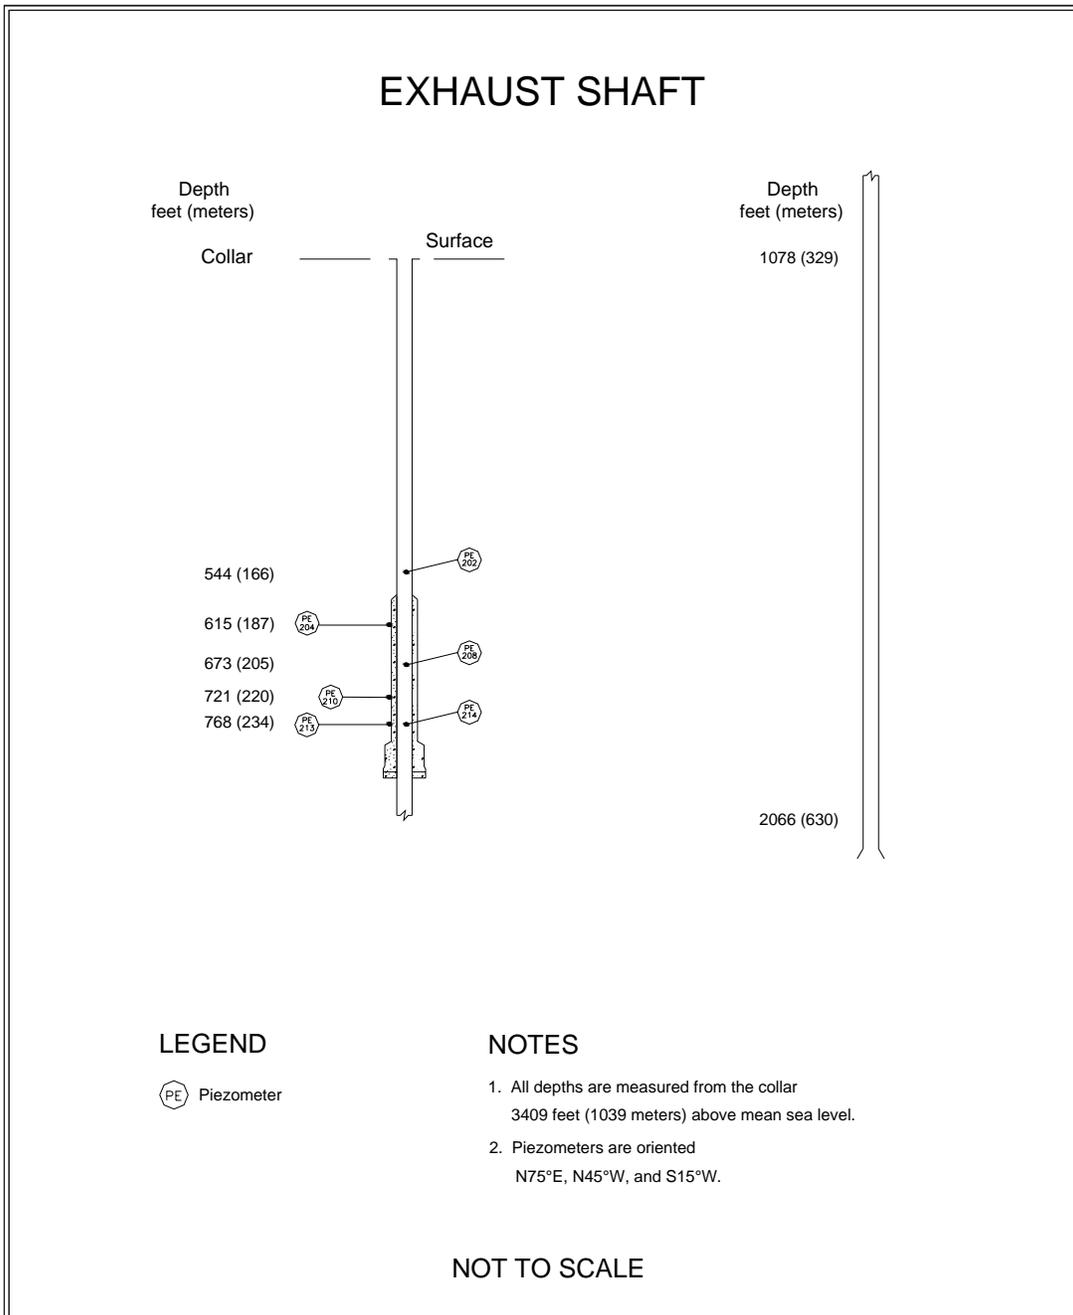
Figure 3-12 – Exhaust Shaft Instrumentation (Without Shaft Key)

The Exhaust Shaft was equipped with geomechanical instrumentation in two stages. Earth pressure cells were installed behind the liner key in November 1984. Piezometers and nine multiposition extensometers were installed during November and December 1985. Figures 3-11 and 3-12 show the instrument locations.

Nine piezometers remain in working condition. The fluid pressure readings from the working piezometers at the end of the reporting period range from -3 psi (-21 kPa) at 544 ft (166 m) to 142 psi (979 kPa) at 721 ft (220 m). Maximum pressure readings from the working piezometers during this reporting period were consistent with maximum readings from the previous reporting period.

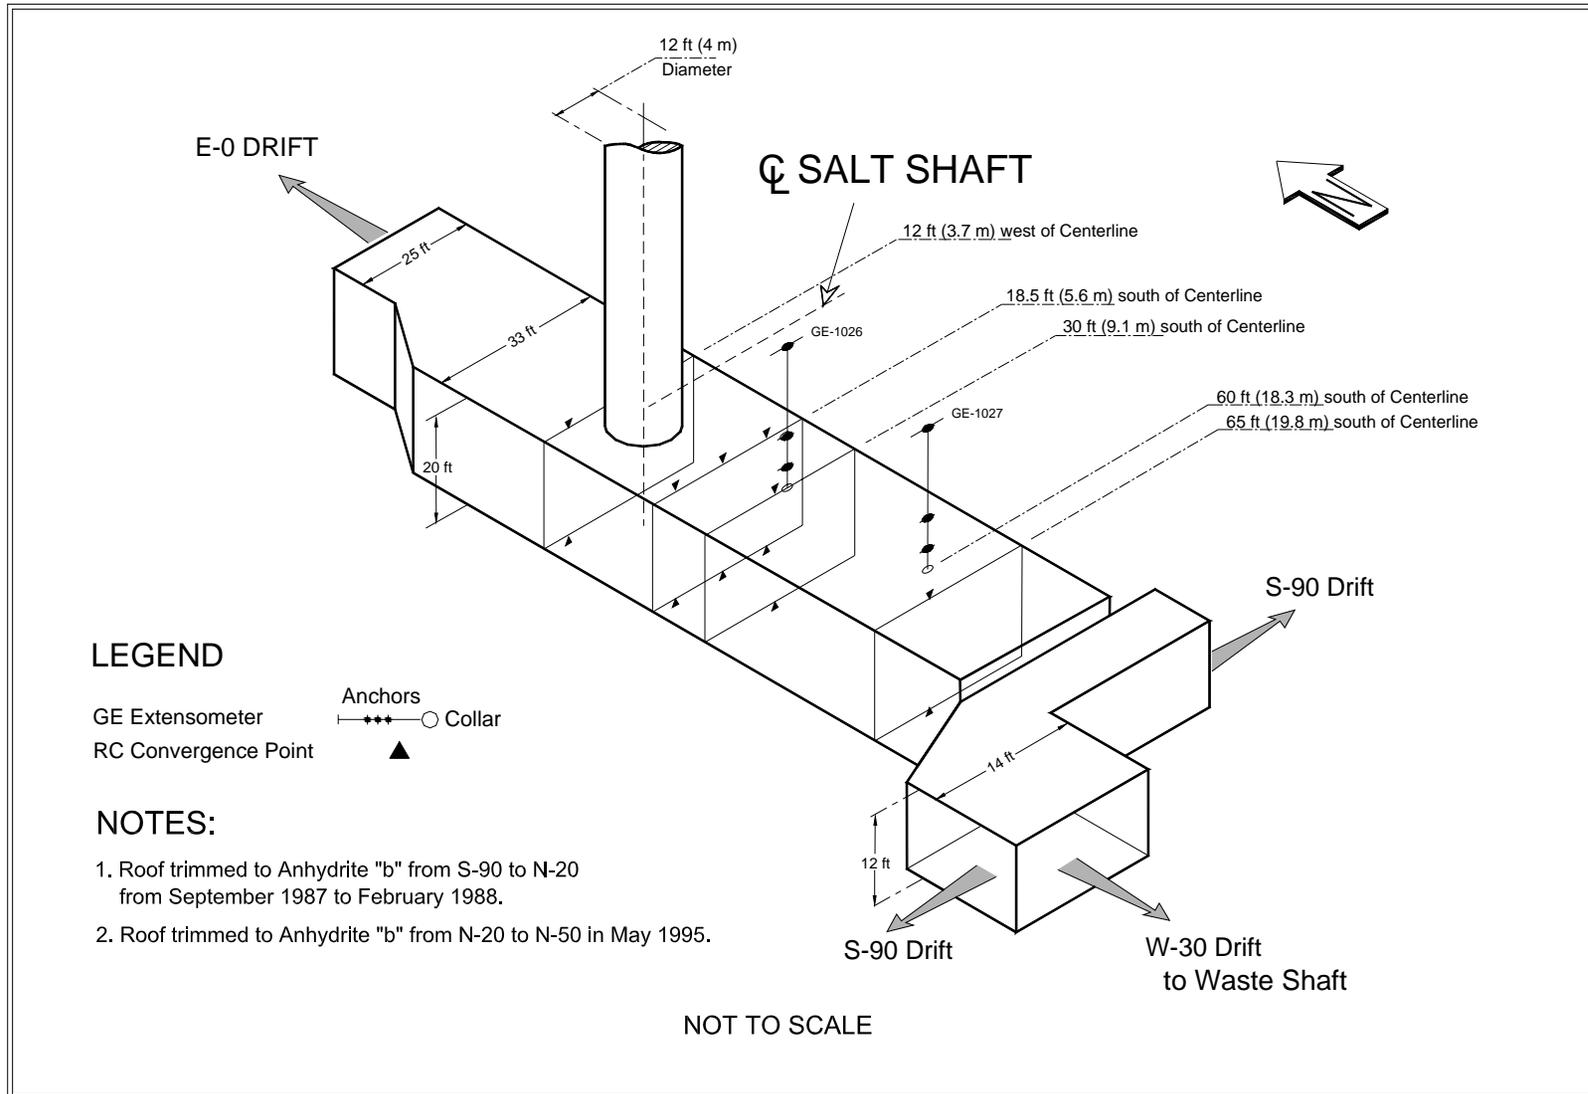
Figure 4-2 – Salt Shaft Station Instrumentation after Roof Beam Excavation

Four vertical convergence point arrays are currently monitored. Table 4-1 summarizes the vertical closure rates in the Salt Shaft Station from July 2007 through June 2008. Salt Shaft Station vertical closure rates indicate that the rates are slightly lower than during the previous reporting period.
