Waste Isolation Pilot Plant
Geotechnical Analysis
Report
For
July 2007 – June 2008

March 2009

Geotechnical Analysis Report for July 2007 – June 2008
DOE/WIPP-09-3177, Vol. 1

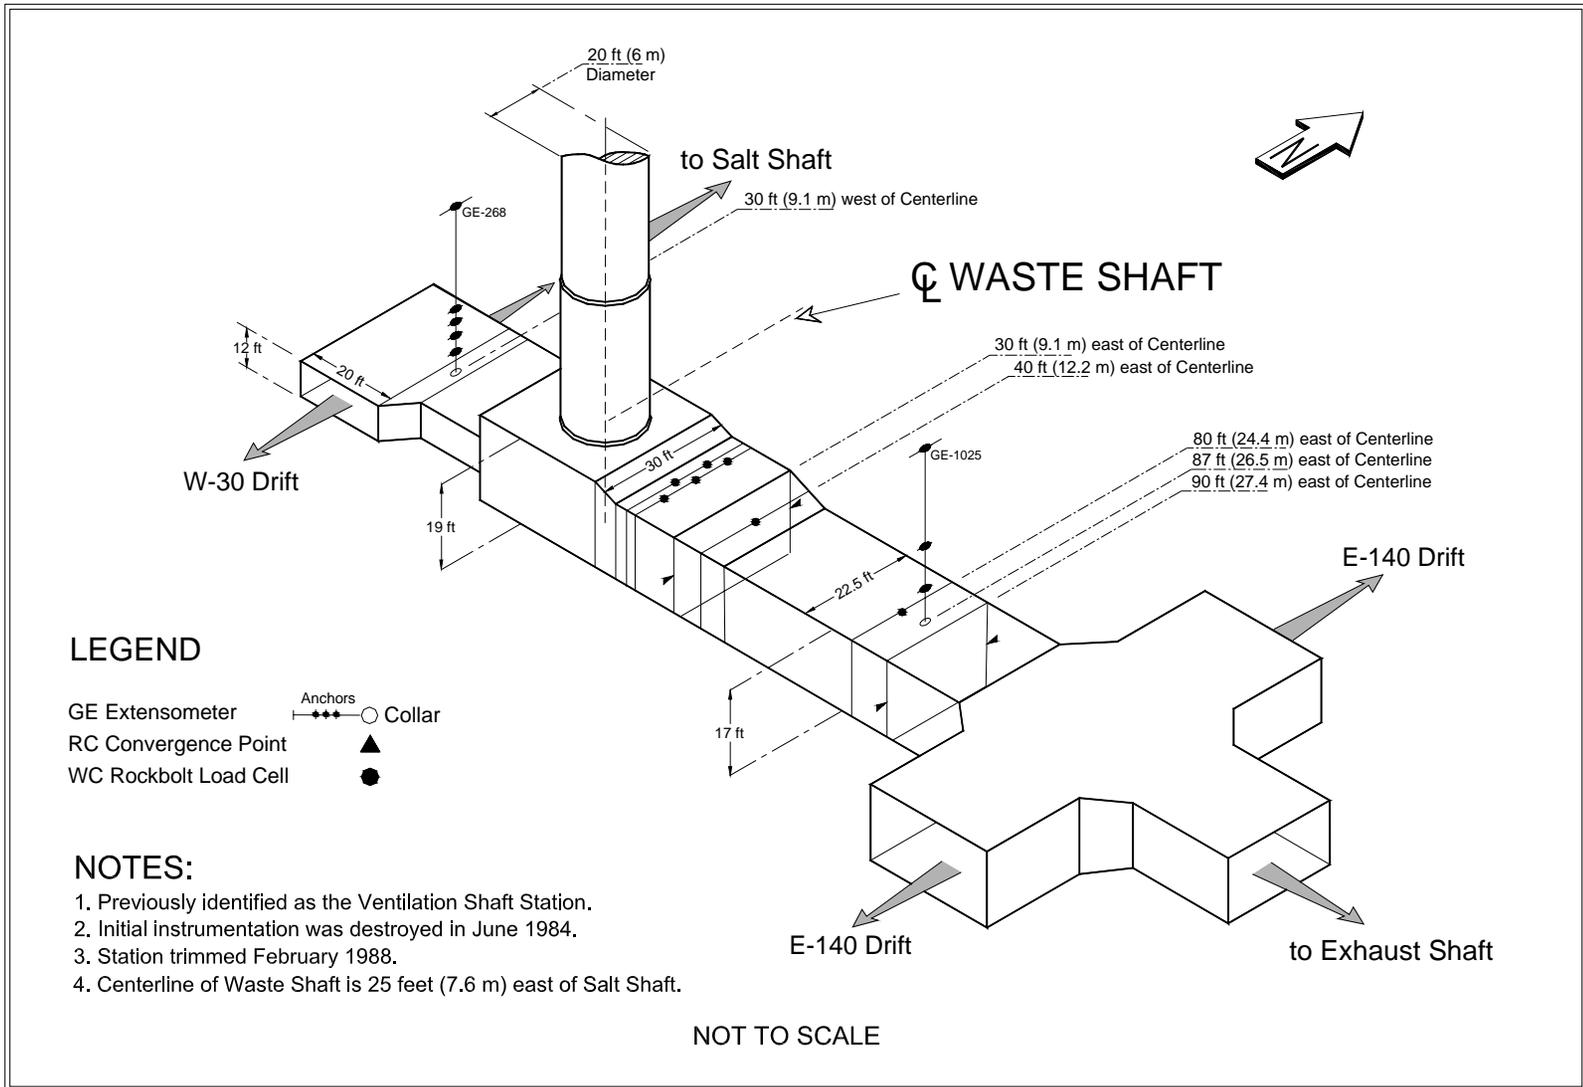
Figure 4-4 – Waste Shaft Station Instrumentation after Wall Trimming

Table 4-2 summarizes the recent history of the roof extensometers in the Waste Shaft Station. Extensometer 51X-GE-00268 (W-30) is installed in a hole drilled into the roof of the station. Extensometers 51X-GE-00356 and 51X-GE-00357 monitor fracture dilation along the shaft wall above the east brow.

Table 4-3 summarizes the annual horizontal closure rates calculated from convergence point data for this reporting period. The data indicate that the horizontal closure rates at both E-30 and E-90 are essentially unchanged from the previous reporting period.

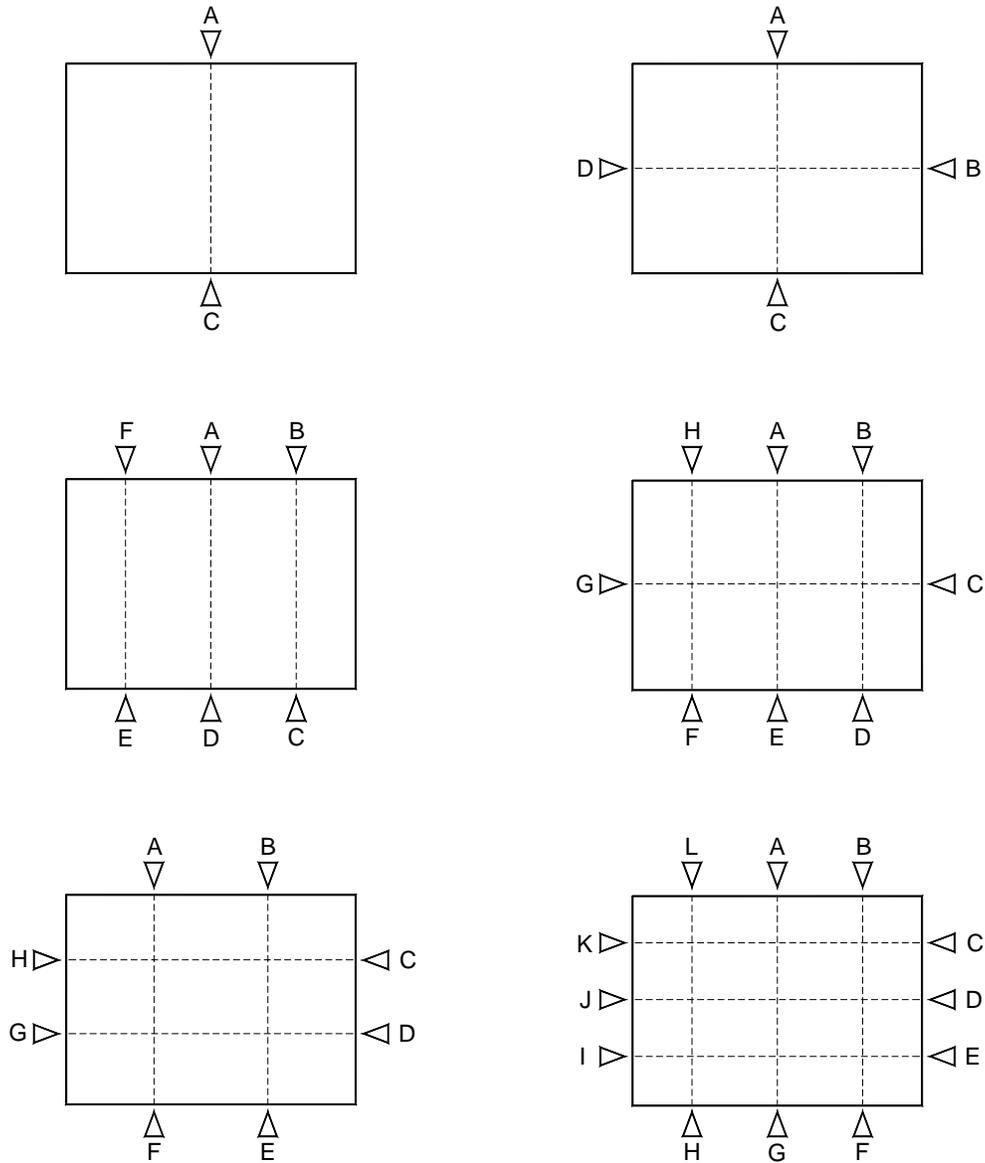
Figure 5-1 – Typical Convergence Point Array Configurations Showing Anchor Designations

Figure 5-1 shows typical convergence point array configurations. Instrumentation installed during this reporting period was limited to the replacement of convergence point arrays in previously mined areas and the installation of new monitoring arrays in the newly mined areas. New and replacement convergence points were installed in 25 locations throughout the WIPP underground access drifts because of mining and trimming activities. Horizontal and vertical convergence point arrays were installed at various locations. Most of these installations were located in the southern access drifts. Convergence points within the access drifts are read manually at least every two months, with more frequent monitoring in some areas. Table 5-2 lists the new and replacement convergence points that were installed during this reporting period.

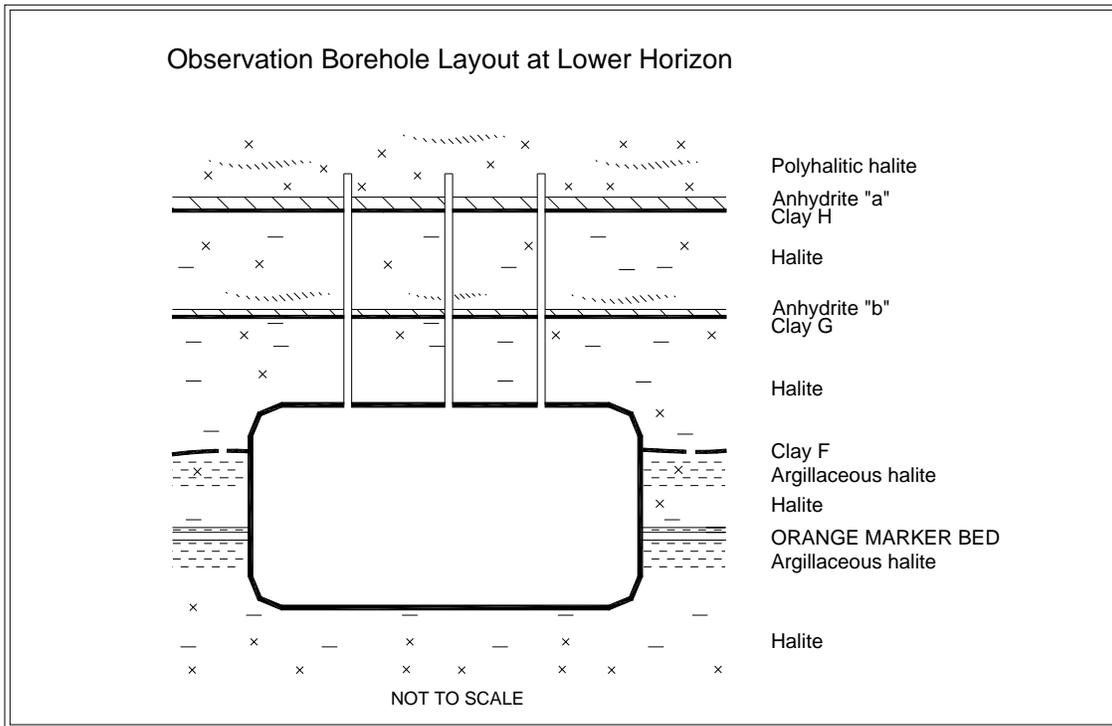
Figure 7-1 – Example of Observation Hole Layout at Lower Horizon

The clay seams nearest the excavation surfaces define the immediate roof beam. The roof beam is bounded by clay G in most of the access drifts and Panels 1 and 2. Some areas, such as the Salt Shaft Station, portions of the E-0 and E-140 drifts, the south mains south of S-2620, and Panels 3, 4, and 5 are excavated to clay G and so have roof beams bounded by clay H.

The offset in a hole is determined by visually estimating the degree of occlusion. The direction of offset along clay seams is observed as the movement of the strata nearer to the observer relative to the strata farther away. Typically, the nearer strata move toward the center of the excavation (Figures 7-3 and 7-4). Based on previous observations in the underground, the magnitude of offset is usually greater in holes located near ribs than in those located along excavation centerlines. Offsetting along the clay layers is observable until the total offset is reached or visibility is obstructed by intervening offsets at other clay seams or fractures. Holes are inspected for fractures, using an aluminum rod with a flattened steel wire probe attached to one end perpendicular to the rod (referred to as a "scratch rod"). Fractures and clay seams are located by moving the probe along the inside of the hole until it is snagged in one of these features. Depth to each feature is recorded, as is the magnitude of separations encountered. A fiber scope camera is occasionally used in addition to the scratch rod to visually document features of interest in a hole.

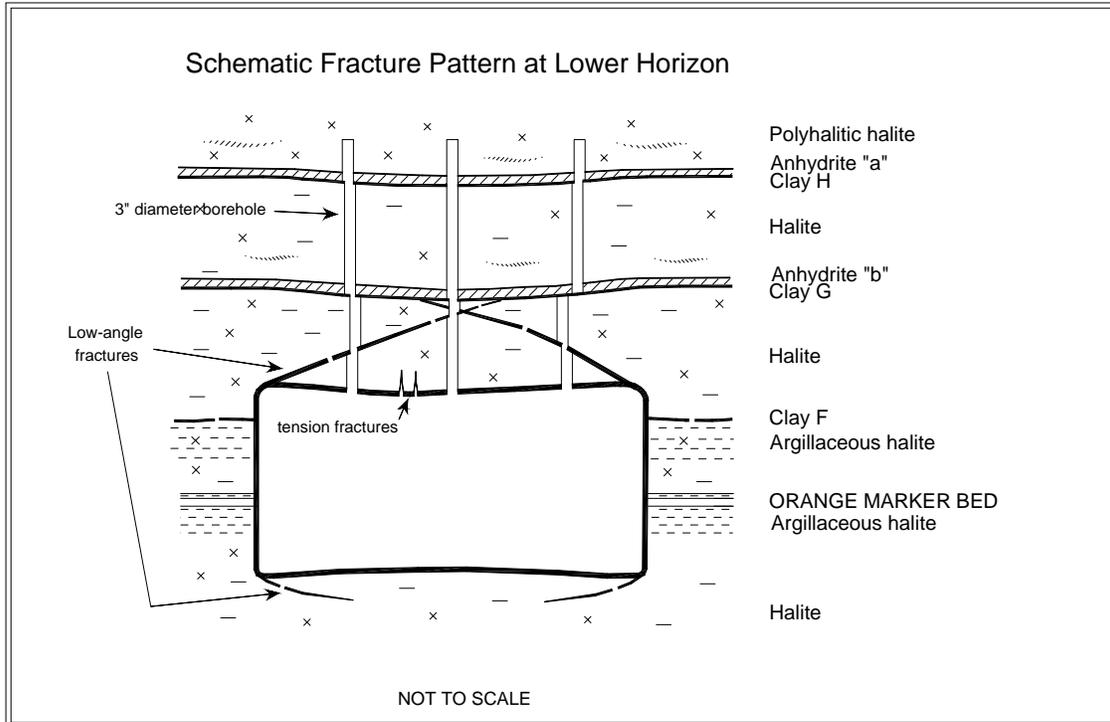
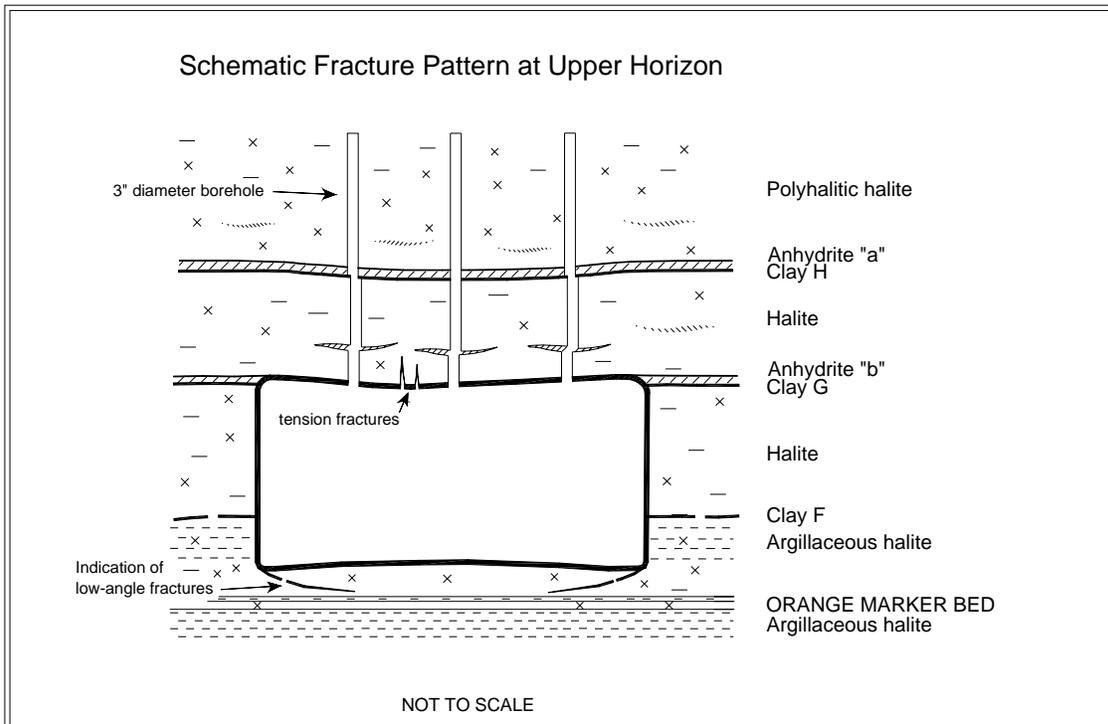
Figure 7-3 – Typical Fracture Patterns at Lower Horizon

Figure 7-4 – Typical Fracture Patterns at Upper Horizon

The separation and offset data observed in accessible holes in the back are presented in the supporting data document for this report. Twenty-two accessible holes were monitored in Panel 4, and 47 in Panel 5. In both Panels 4 and 5, the greatest separations were associated with clay H and anhydrite "a". Seven holes in Panel 4 and seven holes in Panel 5 had fractures associated with anhydrite stringers in the lower portion (first 3 feet) of the roof beam. Twenty-one of the 22 holes in Panel 4 and 37 of the 47 holes in Panel 5 showed some offset.
