**Analysis Report**  
**Task 1B of AP-114**  
**Identify Possible Area of Recharge to the Culebra West and South of WIPP**  
**(AP-114: Analysis Plan for Evaluation and Recalibration of Culebra Transmissivity Fields)**

**Report Date: April 1, 2006**

## **Analysis Report for Task 1B, AP-114**

### **Identify Possible Area of Recharge to the Culebra West and South of WIPP**

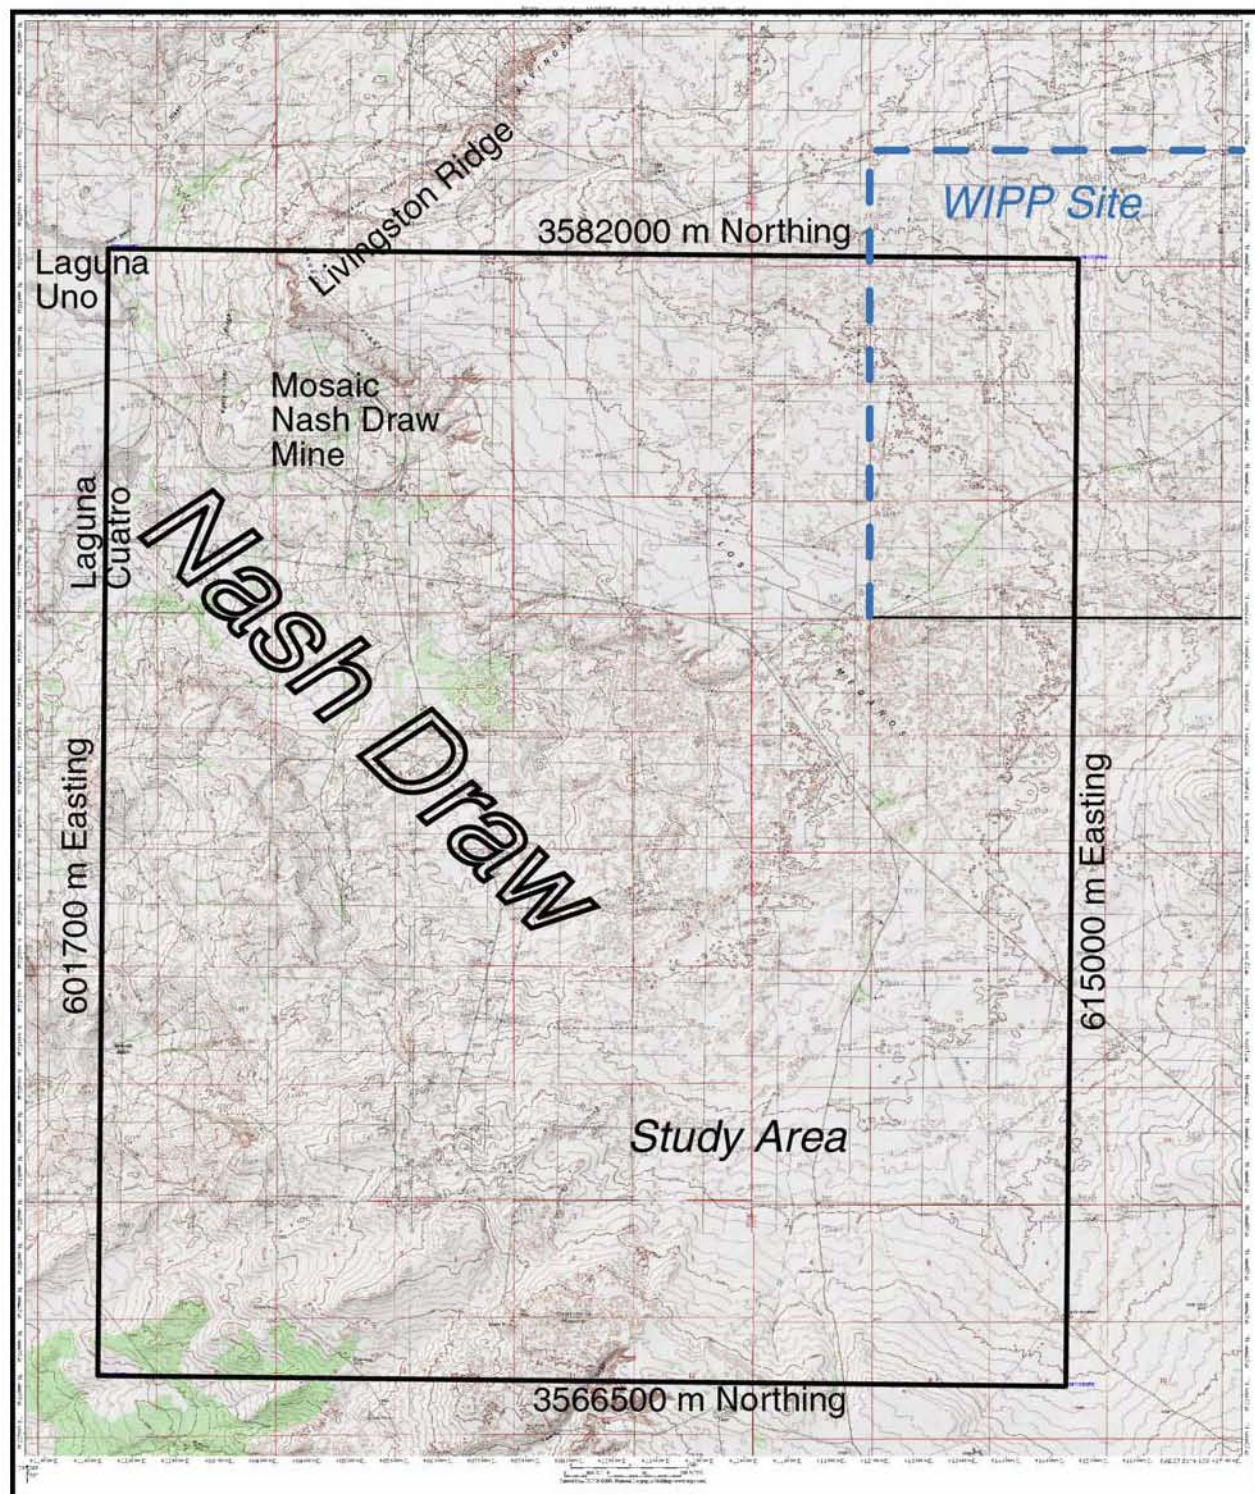
Figure 1 – Study Area. The study area shown in the black rectangle overlaps the southwestern part of the WIPP site (blue dashed outline) and is centered mainly on the southeastern arm of Nash Draw. Boundary limits are UTM (NAD27) coordinates in meters.

The general area for this study south and west of the WIPP site is centered on the southeastern arm of Nash Draw (Figure 1). The boundaries to the west and south correspond to the limits used for earlier modeling (see figure 2, Beauheim, 2004); the northern and eastern boundaries included the southeastern arm of Nash Draw and an area beyond the apparent eastern extent of the draw. The Universal Transverse Mercator (UTM) (North American Datum 1927 - NAD27) western and eastern boundaries are at 601700 m Easting and 615000 m Easting, respectively. The UTM (NAD27) southern and northern boundaries are at 3566500 m Northing and 3582000 m Northing, respectively.

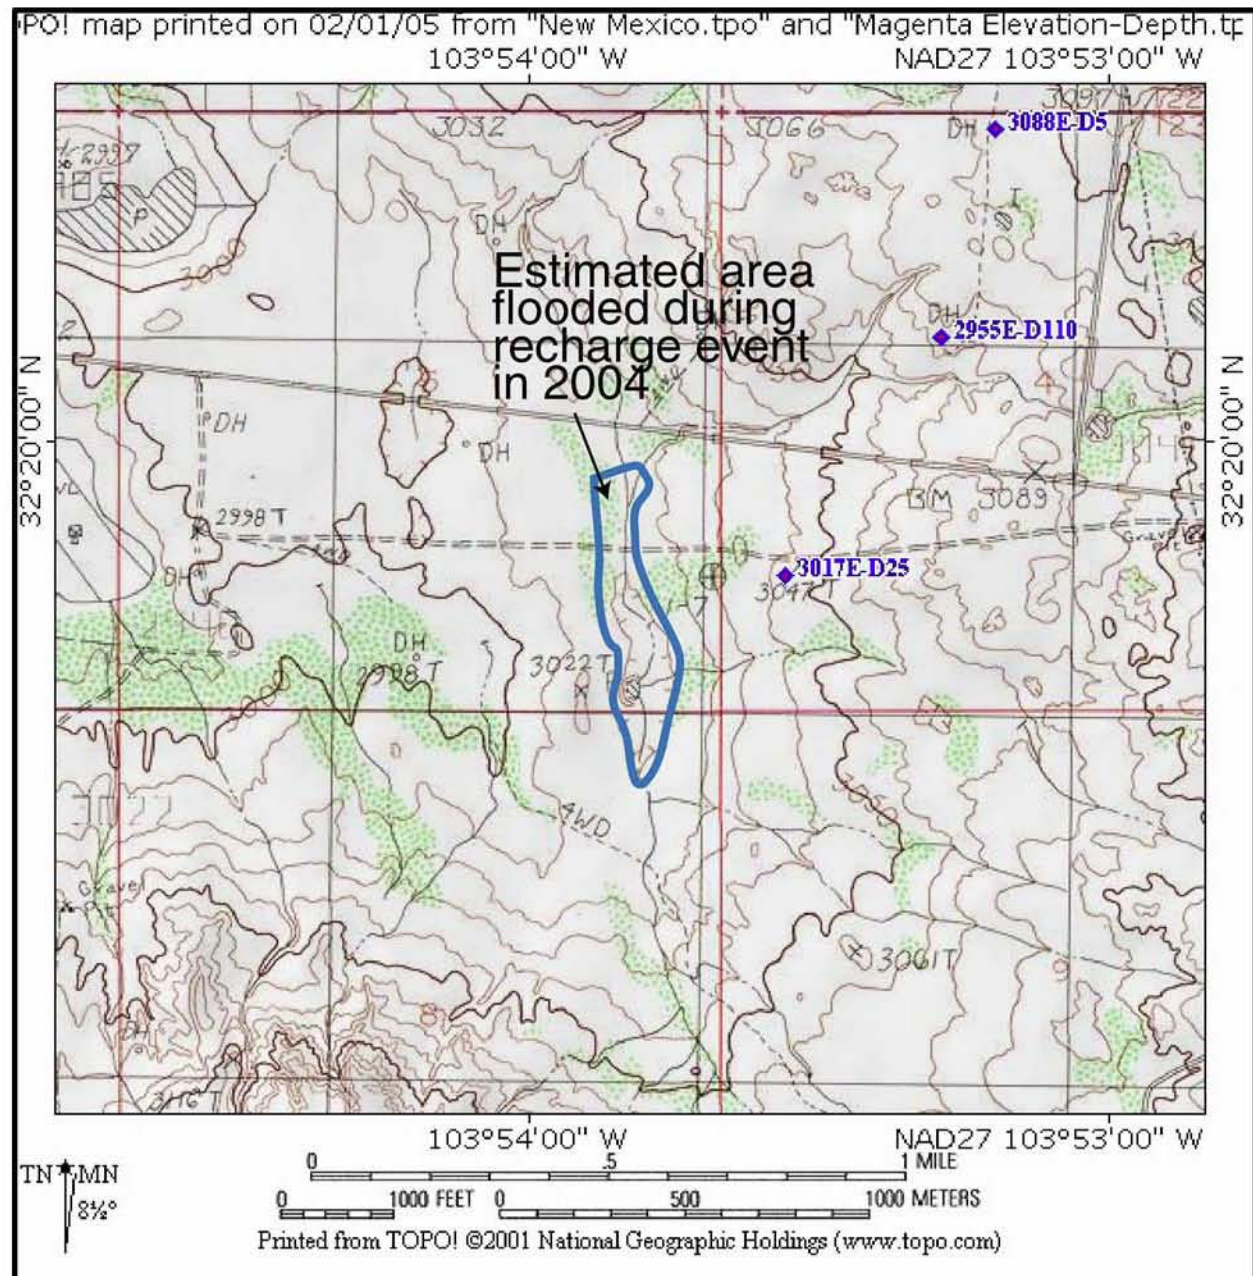
Figure 4 – Topographic map of karst valley in drainage basin #6. The blue outline is approximately the area that appears to have been covered during a flooding event sometime in 2004. The area, estimated from aerial photographs, is about 10,000 square meters at a minimum.

The evidence is relatively straightforward, though circumstantial as to its timing. Some of the drainage channels within drainage basin #6 showed evidence of significant water flow, given the downslope flattening of grasses and debris in brush and trees. As I mapped specific features, such as caves or sinkholes, in the karst valley (Figure 4) that forms the low point in drainage basin #6, I became aware of a debris ring around the edges of the karst valley that indicates a high water mark. Within the valley, mesquite bushes were stained with reddish-brown silt/clay to a fairly uniform level above the valley floor, and floating debris such as dried cow patties were left in mesquite branches at about the same level as the top of the staining (Figure 5).

Area covered is estimated to be approximately  $10^5 \text{ m}^2$ .

The depth is estimated to be approximately 0.5 m, on average.

From this, the volume is estimated to be at least  $5 \times 10^4 \text{ m}^3$  (40.5 Acre-ft or  $13.2 \times 10^6 \text{ gal.}$ ) Because I limited the estimate of the area covered and because the flooding must have occurred over a period of time with significant volume recharging even as the high-water mark was being attained, this volume estimate may be low by factors of 2 or 3 or more.

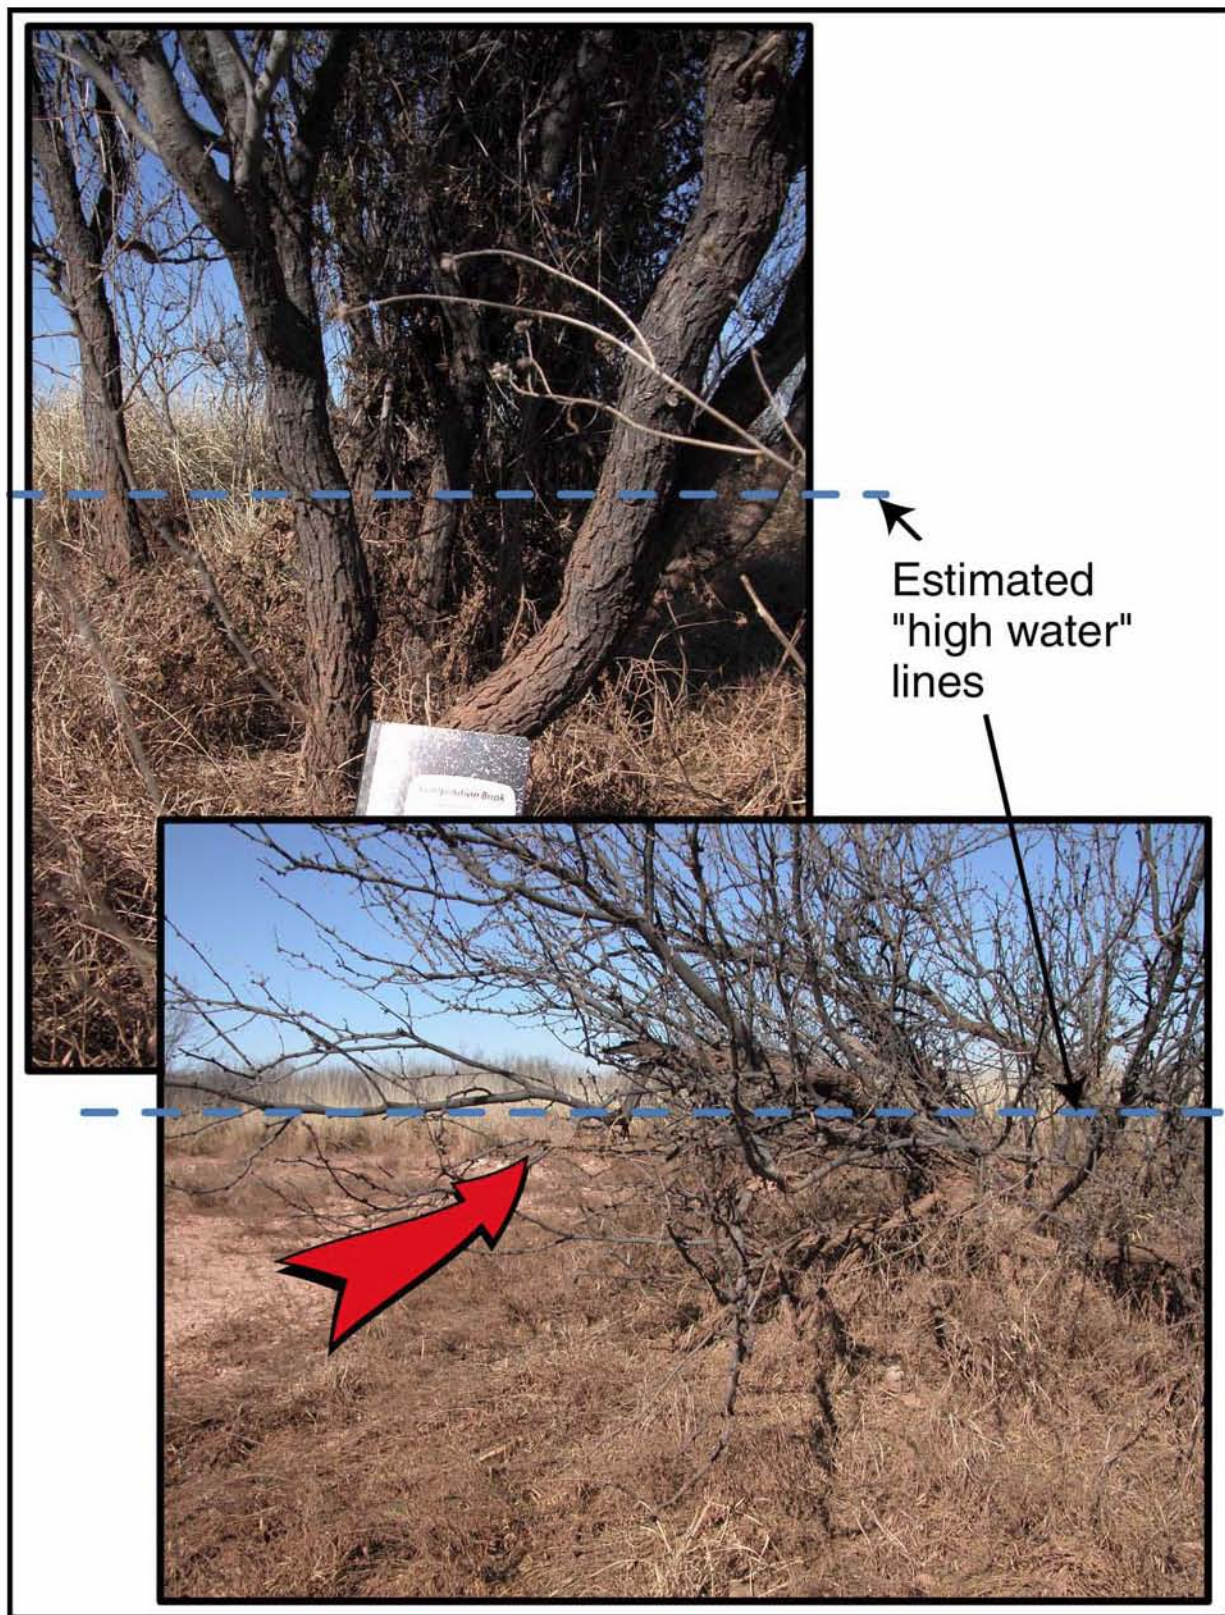
Figure 5 – “High-water” indicators in karst valley in drainage basin #6. Red arrow indicates dried cow patty resting in mesquite branch. Dashed lines show height of staining from flood water.

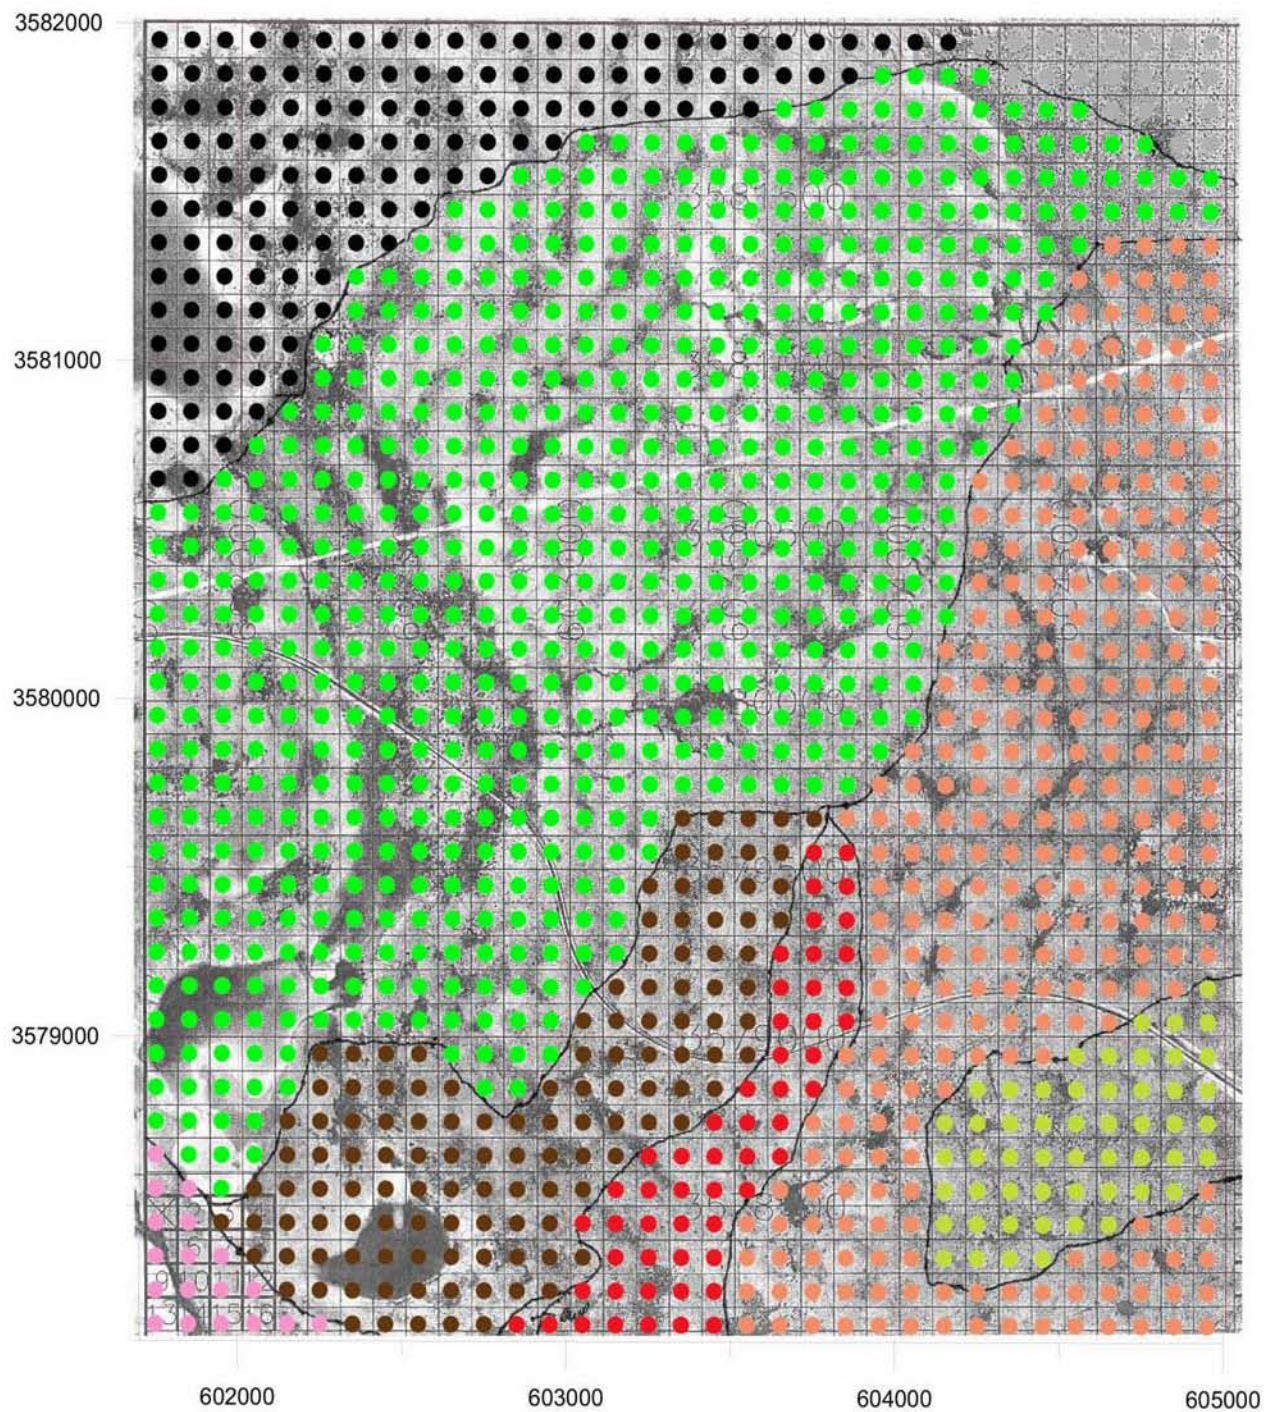
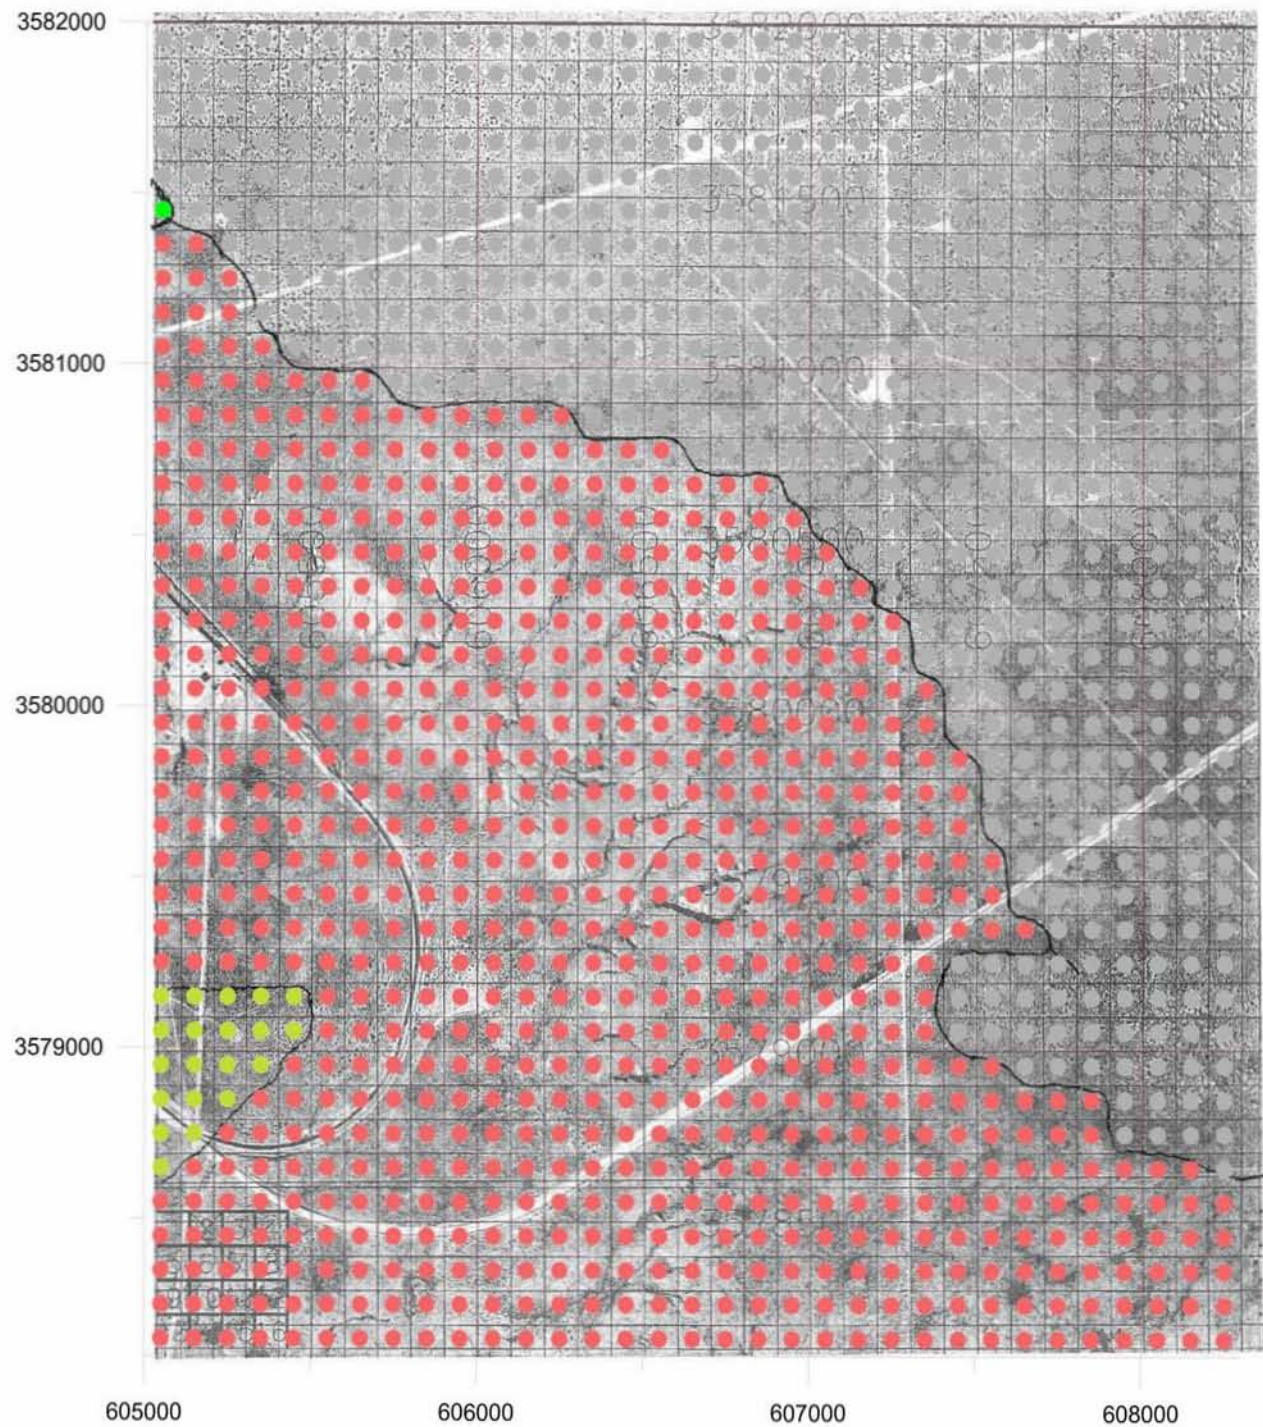
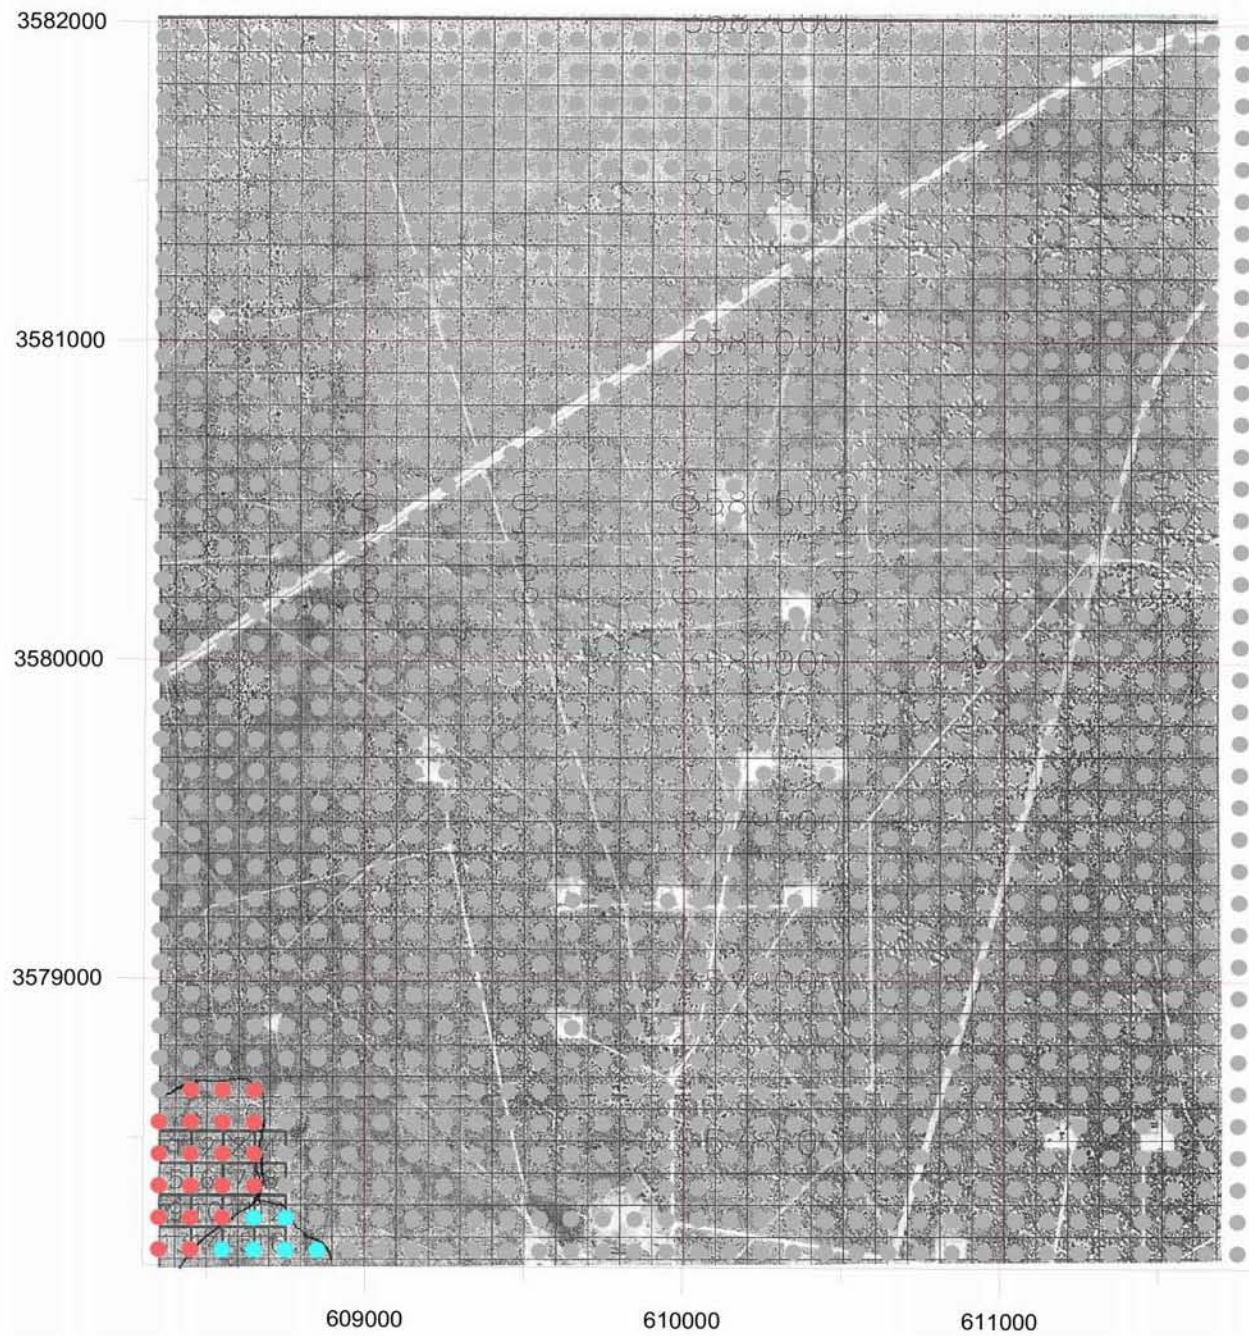
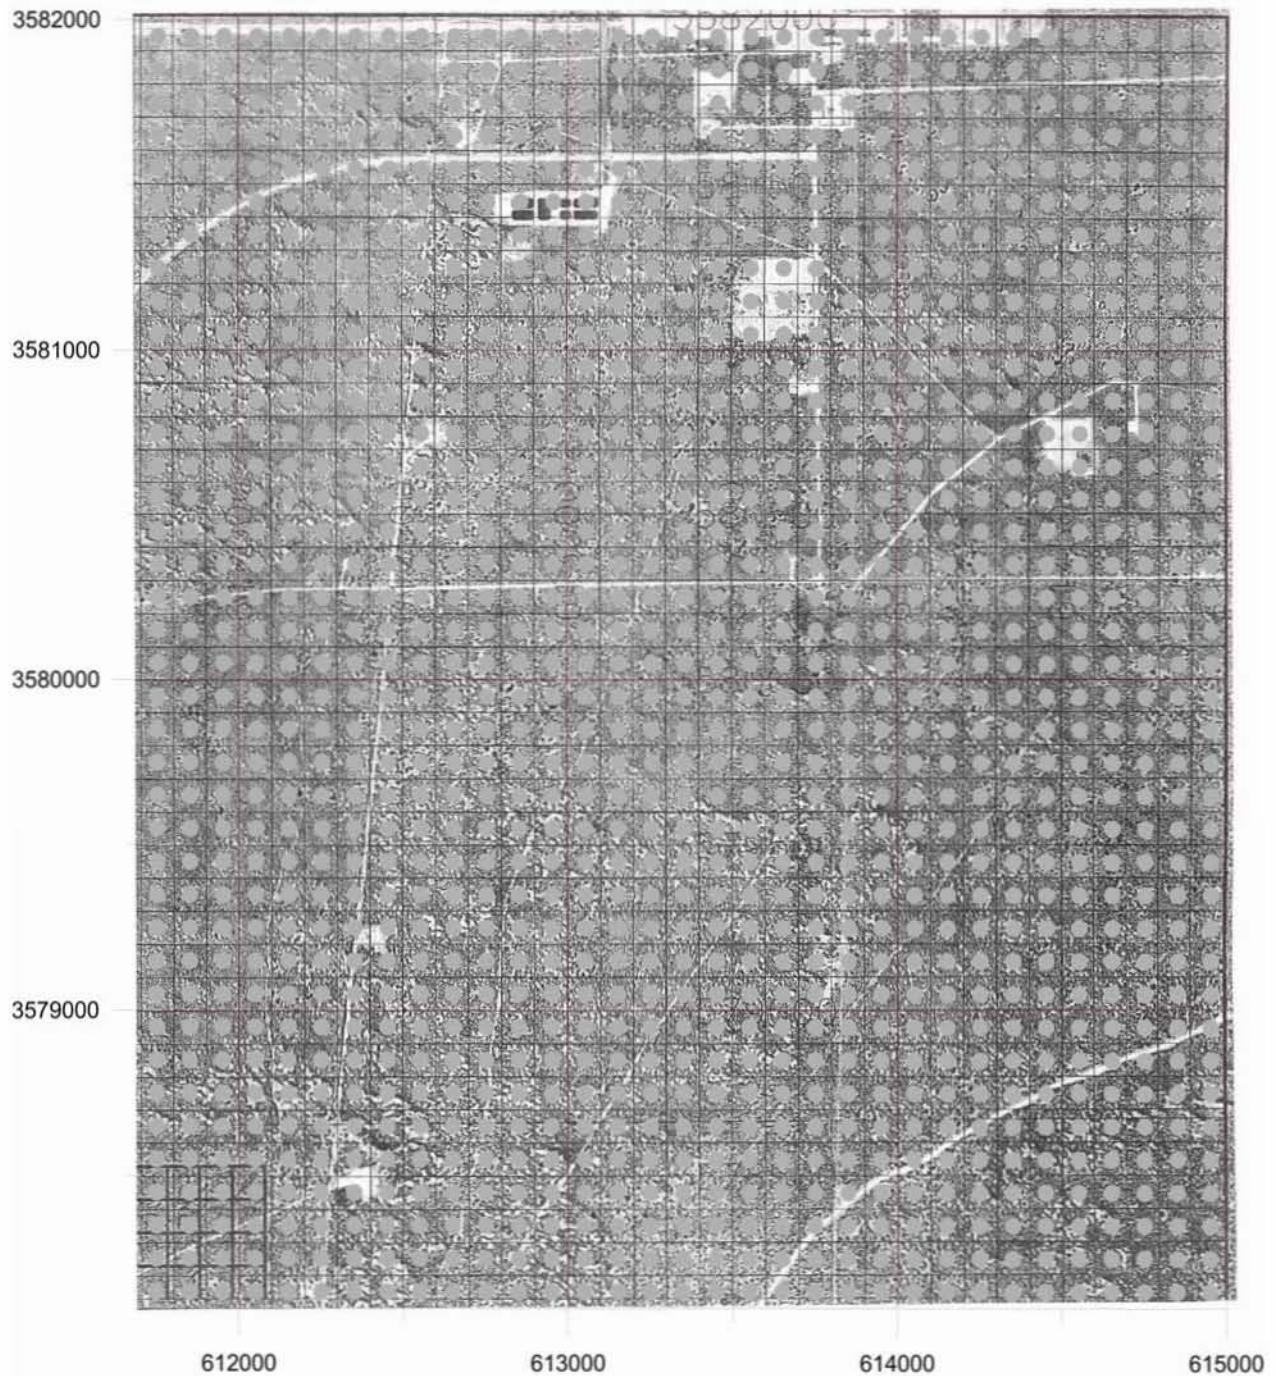
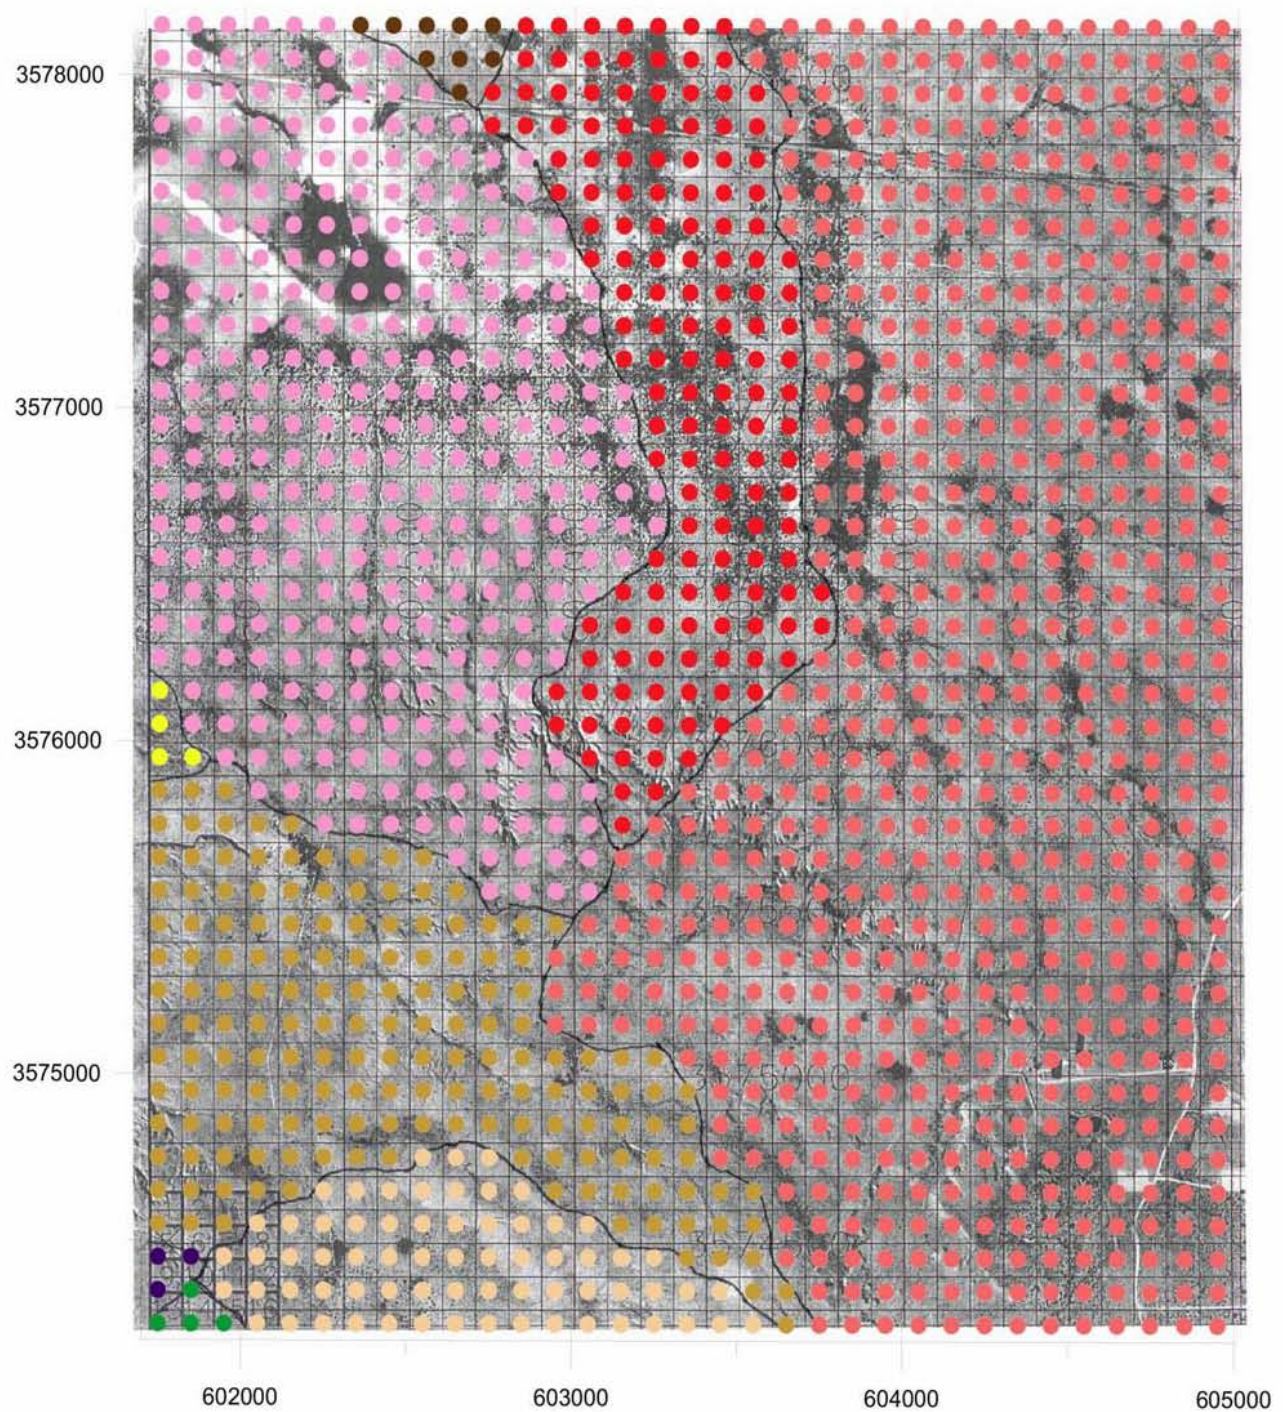
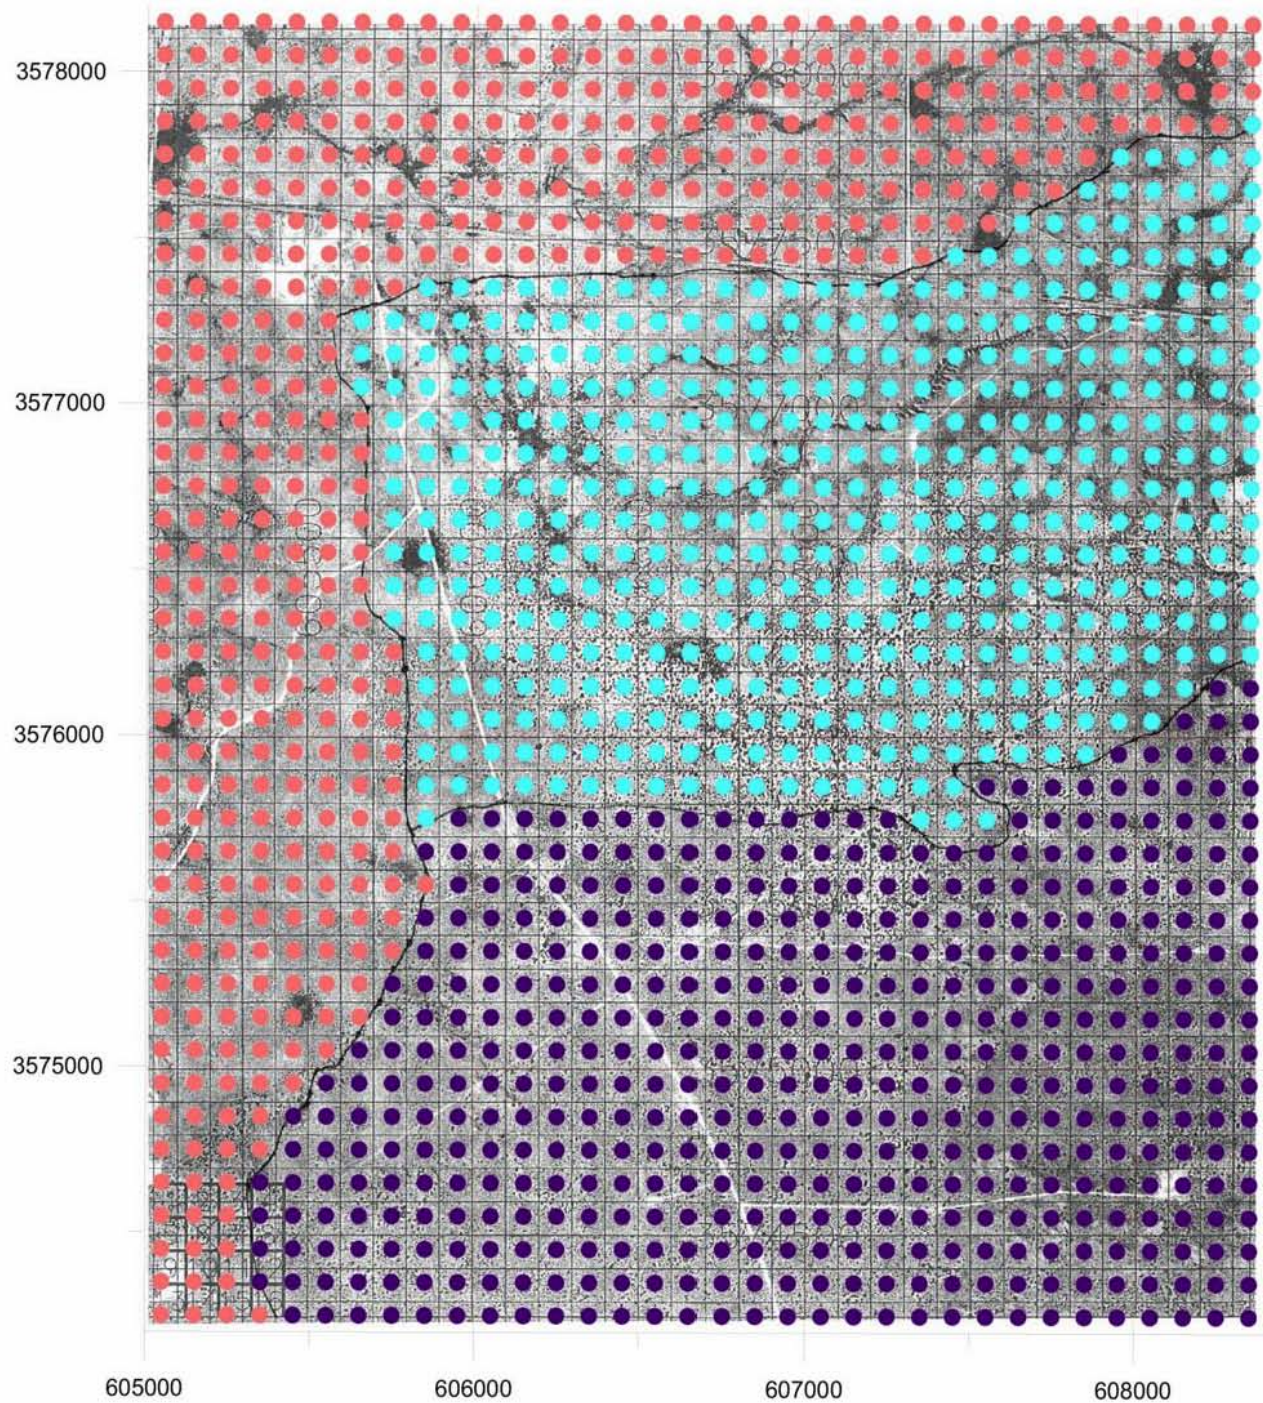
The dot overlays show the correspondence to drainage basins in the following sixteen images where data were plotted independently of the program (VFP) used to transcribe the data. I consider this a suitable verification of data transcription.

An Excel table was exported from the VFP database for plotting drainage basin values separately using Grapher®. The results of plotting the output from VFP and overlaying the plot on aerial photos for a visual check are shown in *Appendix A*. The correspondence between values and underlying drainage basin definition verifies the accuracy of the data transcription.

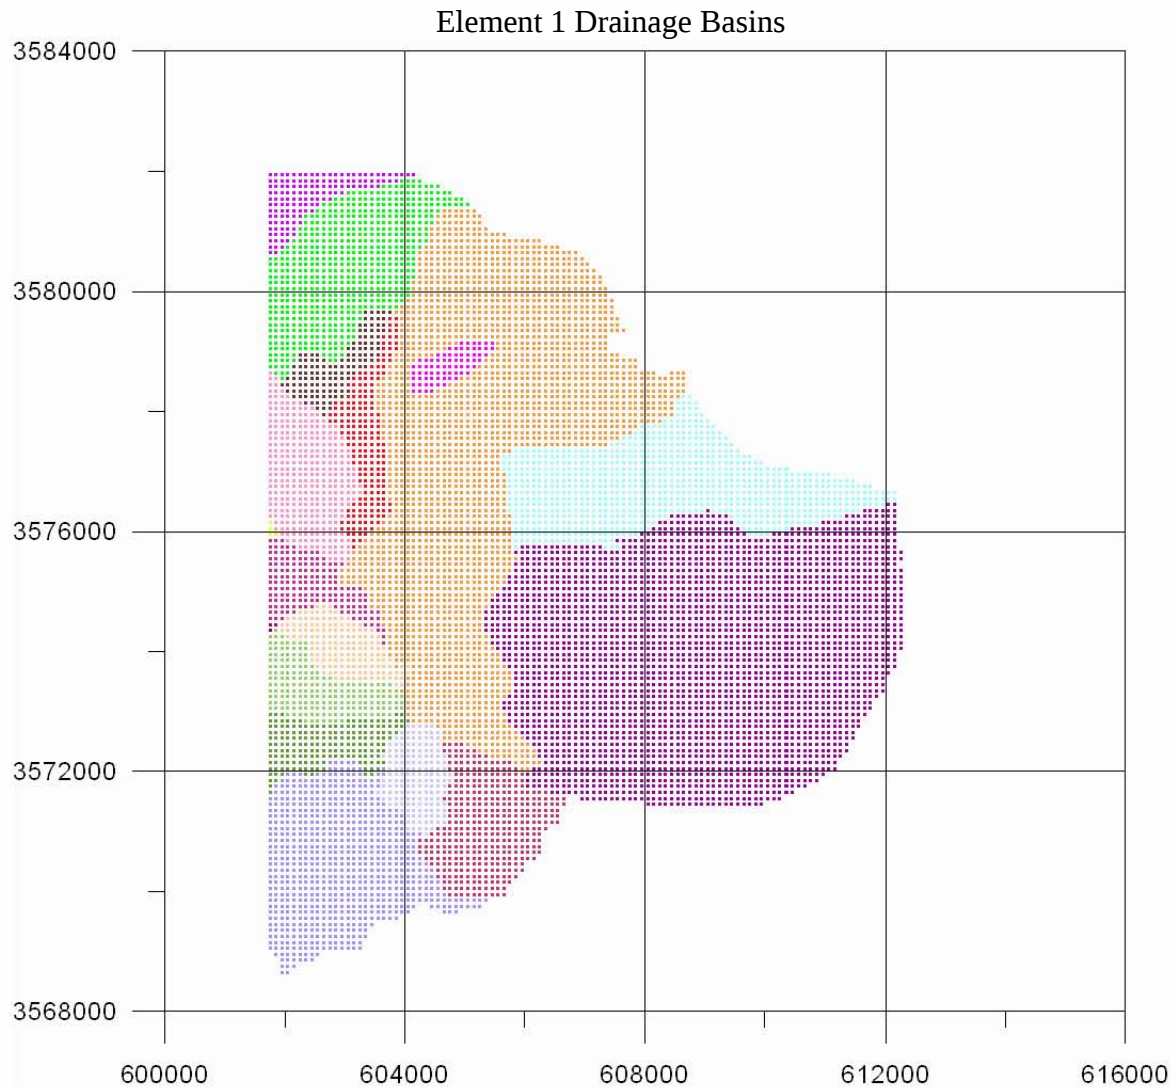
There are seventeen defined drainage basins within the study area (data table values 1 through 17). The “default” value of 0 represents the area (uncolored here) where drainage basins were not defined at this scale because there is very little that can be defined as surface drainage and there is little topographic differentiation. The colors have no significance other than being different for each basin.

The values reported for this field in the electronic file range from 0 to 15. The default value was 0, and this represents areas indicated above that are dominated by sand dune topography, gentle slopes, and no developed surface drainage channels. Number values otherwise reported indicate cell centers belonging to a particular drainage basin (e.g., Figure 3).

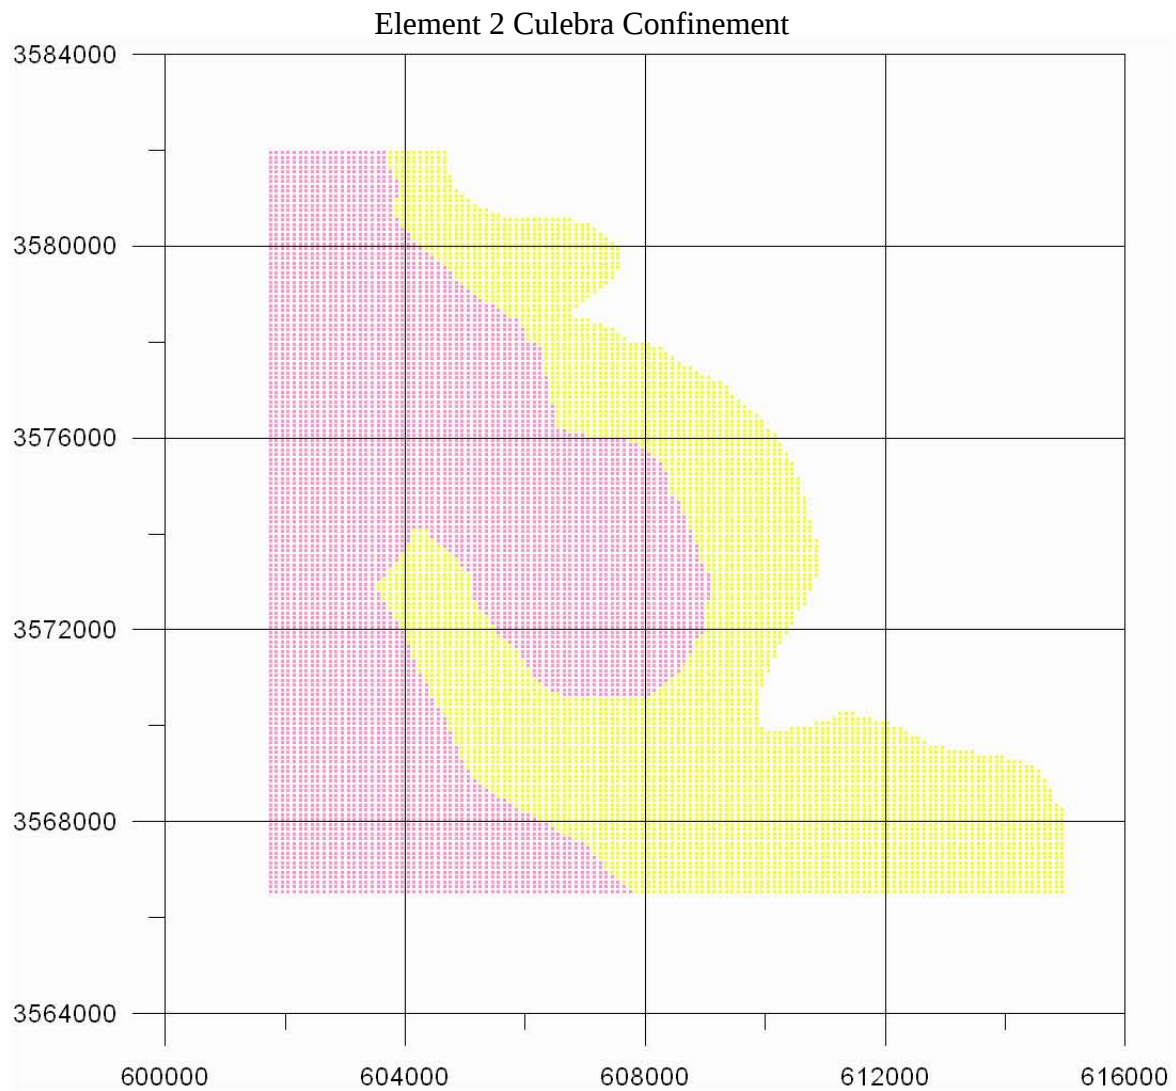
Three zones were differentiated that are generally considered confined, transitional, and unconfined.

The area of the Culebra considered “confined” (default value 0) is defined approximately by the interpreted margin of upper Salado halite dissolution (Powers, 2003; Powers and others, 2003). There is a significant increase in Culebra transmissivity (T) values west and south of this margin, and this change is attributed to changes in fracture aperture associated with strain induced by dissolution. I infer that along this margin and to the west and south, the overlying units are also somewhat strained, changing the vertical hydraulic properties. East of the margin, they are similar to those at the WIPP site proper.

The “transition” zone (value 1) includes areas where there are some data from wells that indicate there is some vertical isolation of the Culebra, but the time constant is not known. Data from monitoring well WIPP-25 indicates that the Magenta and Culebra are not connected vertically on a short time frame. A water well (C-2111) located within the boundaries of the Mosaic Nash Draw property was drilled to a depth near the Culebra. Mini-troll data collected from this well for about 1 year indicate that it does not show pressure (water level) responses matching those in WIPP-26, the nearest monitoring well. It is reasonably isolated hydraulically from the Culebra. In addition, well records from several potash exploration holes (section 33, T23S, R30E) south of the Mosaic Nash Draw property also encountered water at a depth approximately that of the Culebra. In these drillholes, water levels rose well above the horizon where they were first observed indicating some degree of confinement. Alluvium deposited on slopes west of Livingston Ridge also appears to indicate limited vertical infiltration in this zone, and the margin of the alluvium-covered slope was taken as a general indication of the margin between the transition zone and unconfined zone. Surface drainage channels may end or change character at this margin. The transition zone includes areas similar to these in depth, general structure, and slope/drainage configuration.

The “unconfined” zone (value 2) is limited in the study area, as most indications of the Culebra being unconfined are within the more central portions of Nash Draw and out of the study area. The strategy was to select areas where the Culebra is known or believed to be very shallow (~ 30 m or less) and where observed recharge points (caves, sinkholes, alluvial dolines) are believed to access units below the Magenta. Some large caves and sinkholes are developed in the Tamarisk gypsum beds and have a greater likelihood of reaching the Culebra. Many potash exploration holes within Nash Draw encountered lost circulation zones, but the stratigraphic relationships of these zones to Culebra are not well constrained. Thus there is a general sense of factors away from Livingston Ridge and the upper Salado dissolution margin that contribute to greater vertical permeability, but these factors are generally qualitative.

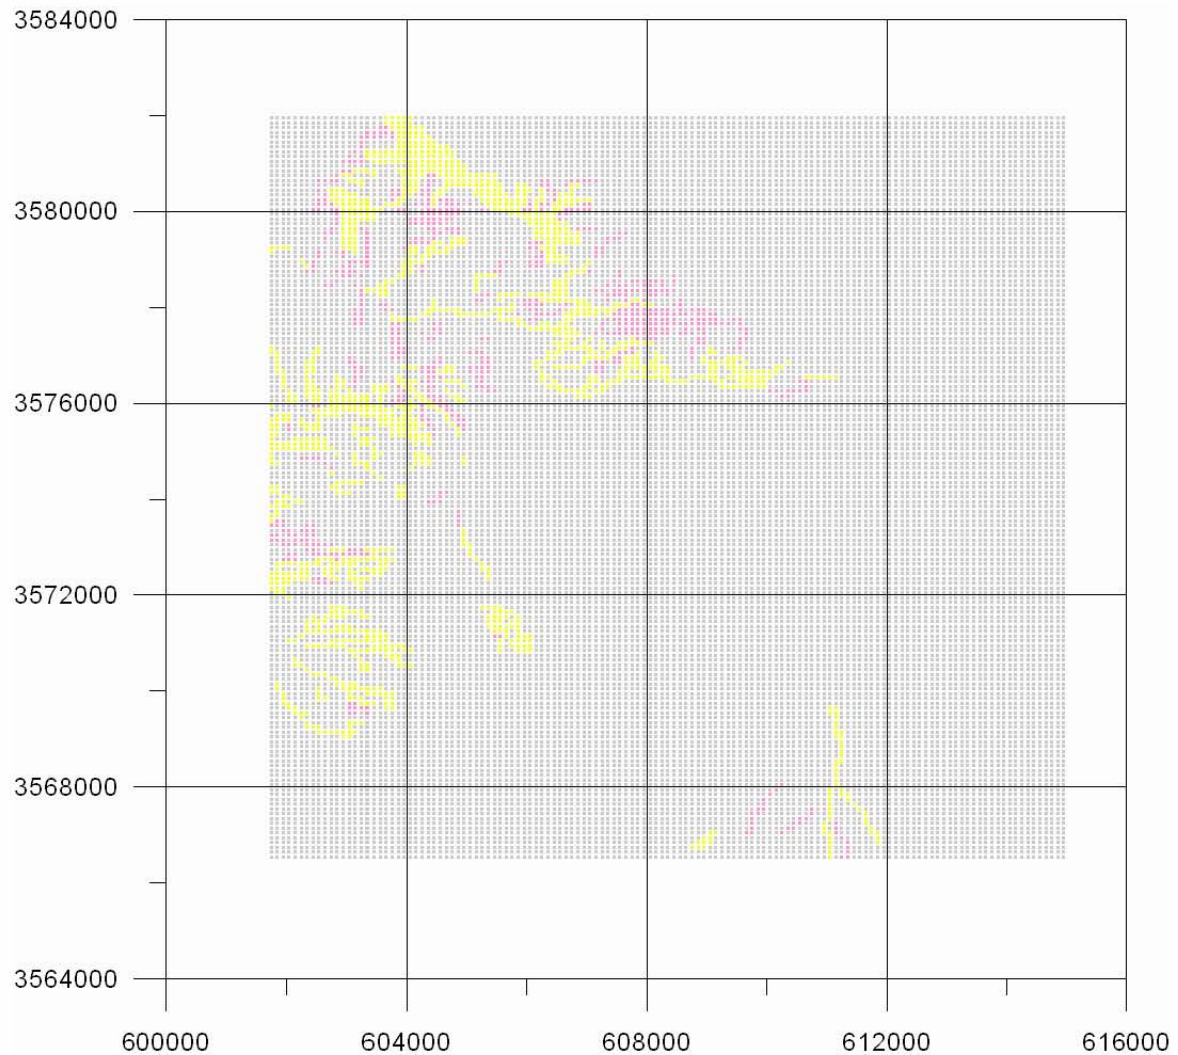
### Element 3 Drainage Channels

Most of the area covered by the study has no significant development of drainage channels. This is represented here with small gray dots.

The areas with developed channels and little vegetation have been coded with the value 1. These are particularly best developed along Livingston Ridge, and there are also some on lesser slopes in areas of minor vegetation.

Areas with channels or arroyos that are heavily vegetated have been coded with the value 2. There are several of these on the gentle slopes on the eastern side of Livingston Ridge. The channels are eroded into or through the Mescalero caliche, are heavily vegetated, and do not have long stretches of open channel. Some of the open channel reaches (coded 1) are intermittently interrupted by vegetated stretches with little indication of a clear channel. These are also coded with the value 2. Some low areas with vegetation do not appear to be integrated into a drainage system and are left unassigned (default value 0).
