**Analysis Report**  
**Task 1B of AP-114**  
**Identify Possible Area of Recharge to the Culebra West and South of WIPP**  
**(AP-114: Analysis Plan for Evaluation and Recalibration of Culebra Transmissivity Fields)**

**Report Date: April 1, 2006**

## **Analysis Report for Task 1B, AP-114**

### **Identify Possible Area of Recharge to the Culebra West and South of WIPP**

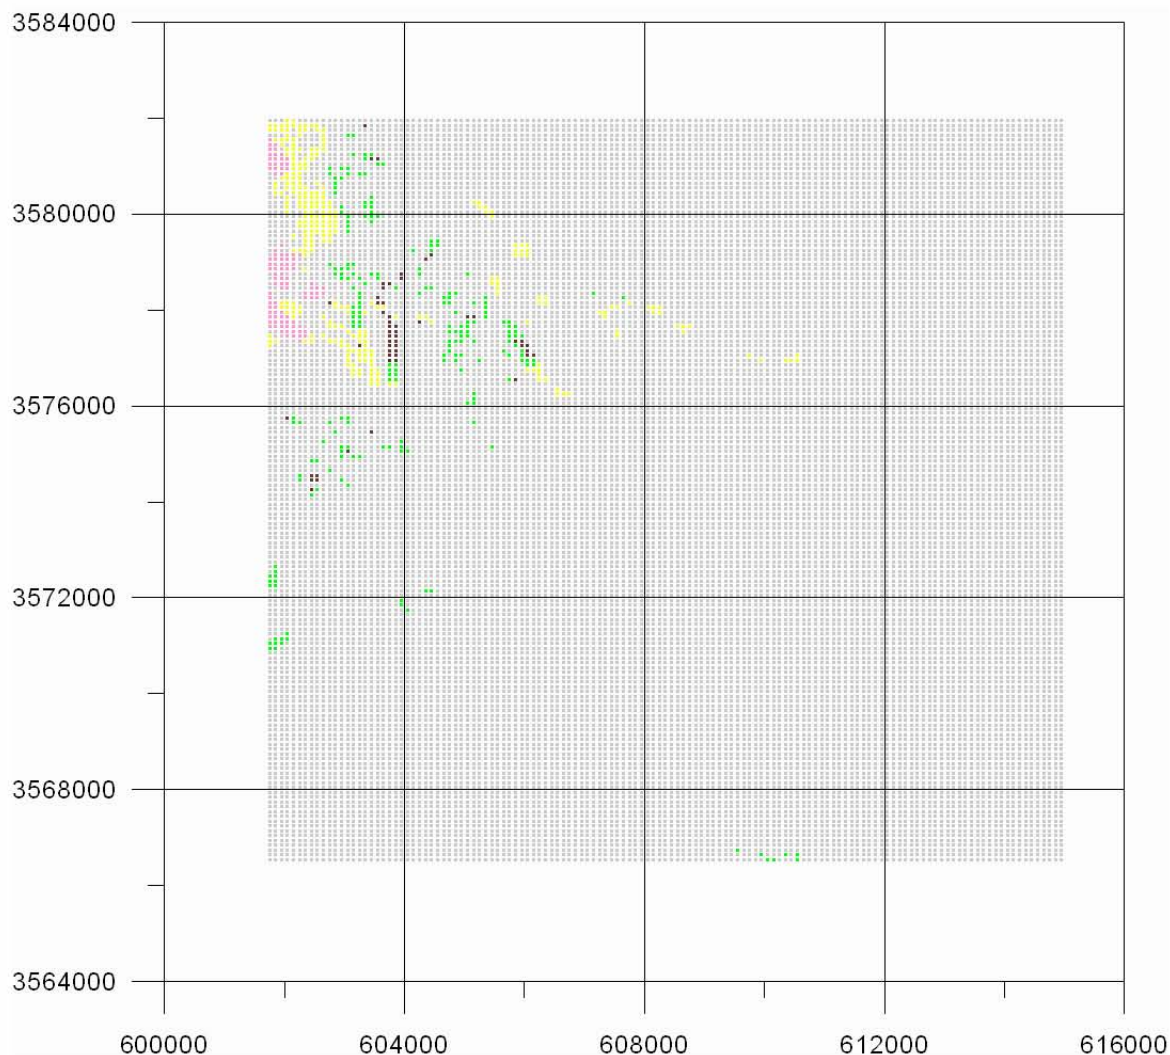
### Element 4 Points and Areas of Potential Recharge

Sand, sand dunes, and Mescalero caliche blanket large areas without visible points or areas that focus recharge. These are coded with small gray dots to contrast with other areas.

There are five values assigned to this element. The default value (0), assigned to the bulk of the study area, indicates that no particular recharge point or area has been defined. It includes most of the area assigned (Element 5 Curve Number) to soil types and vegetation with curve numbers indicating no runoff. One might argue that the small areas between each dune could be recharge points, but they are so numerous and distributed as to be meaningless to try to identify each one.

Vegetated low areas and collection points are potential recharge areas. They have been designated with the value 1 for this element. These areas will correspond closely to some of the curve number assignments based on certain soil associations and vegetative cover. This potential recharge area is mainly assigned here on the basis of topography, and they are mainly at the end of drainages, as would be expected.

Brine lake areas and adjacent marshy areas are assigned value 2 for this element. As previously discussed, it is not clear how much recharge occurs from the lakes. The brine lakes and vegetated low areas are generally the lowest topographic points relative to a drainage basin (Element 1).

Broader karst features such as karst valleys, coalesced areas of alluvial dolines, and alluvial dolines have been assigned a value of 3 for this element. These collection points or areas are generally smaller size than either lakes or vegetated low areas, and they have a more distinctive origin. [The lows for the lakes and vegetated lowlands most likely developed from dissolution subsidence, but sedimentary fill is generally greater and there is less direct association with open karst features such as caves or sinkholes.] There is sedimentary fill and vegetation indicating a level of stability for the surficial sediments in these karst valleys and other features assigned value 3. I hypothesize that they are important to the hydraulic economy of the system here by providing a reservoir for infiltration/recharge for a period after the immediate effects of a storm and runoff.

Specific features that are open conduits (swallowholes, sinkholes, caves) from the surface are mapped and given a value of 4 for this element. They are most common in and around areas assigned a value of 3. These features are expected to provide the most direct and quickest recharge of underlying layers by individual storms and associated runoff. In the study area, these features are developed in the Forty-niner Member, the Magenta Dolomite Member, the Tamarisk Member, and in gypsite deposits of Pleistocene to (?)Holocene age. In no case have I been able to establish that these conduits directly feed the Culebra, but in areas designated “unconfined” in Element 2, it seems much more likely that the Culebra is being recharged more quickly and directly than in other settings in the study area.
