Analysis Report
Task 1B of AP-114
Identify Possible Area of Recharge to the Culebra West and South of WIPP
(AP-114: Analysis Plan for Evaluation and Recalibration of Culebra Transmissivity Fields)

Report Date: April 1, 2006

Analysis Report for Task 1B, AP-114

Identify Possible Area of Recharge to the Culebra West and South of WIPP

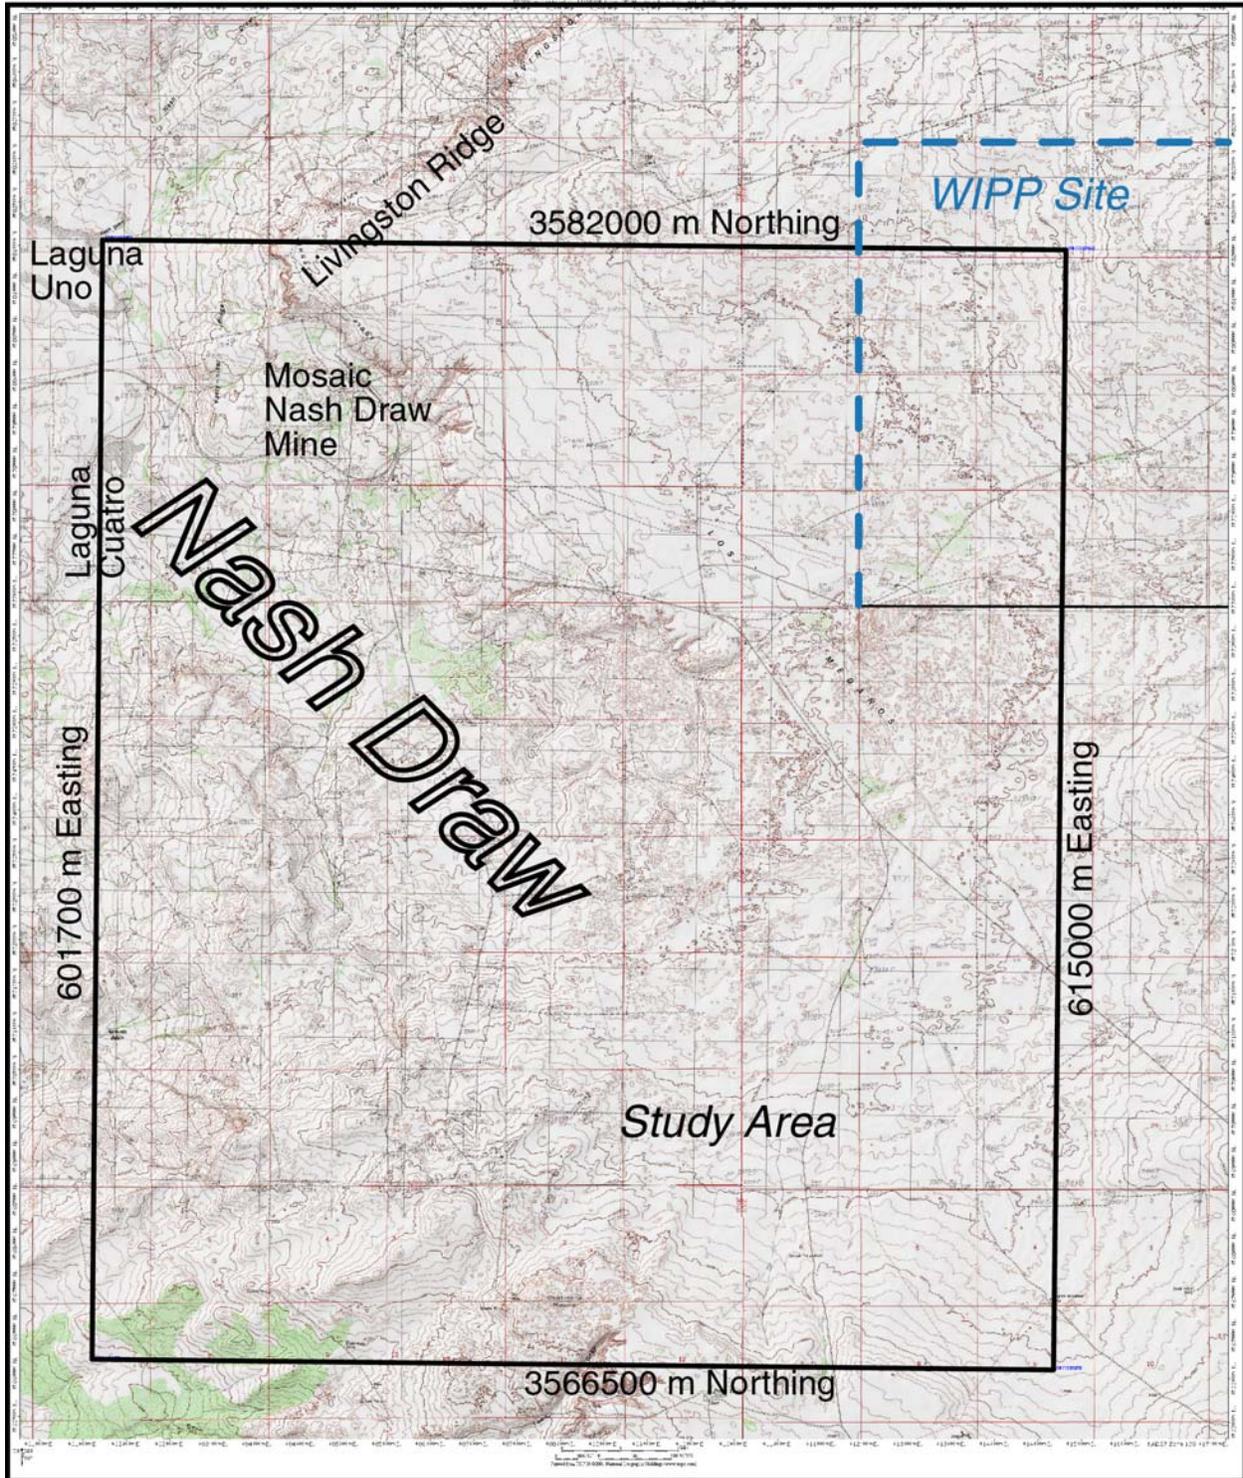
Figure 1 – Study Area. The study area shown in the black rectangle overlaps the southwestern part of the WIPP site (blue dashed outline) and is centered mainly on the southeastern arm of Nash Draw. Boundary limits are UTM (NAD27) coordinates in meters.

The general area for this study south and west of the WIPP site is centered on the southeastern arm of Nash Draw (Figure 1). The boundaries to the west and south correspond to the limits used for earlier modeling (see figure 2, Beauheim, 2004); the northern and eastern boundaries included the southeastern arm of Nash Draw and an area beyond the apparent eastern extent of the draw. The Universal Transverse Mercator (UTM) (North American Datum 1927 - NAD27) western and eastern boundaries are at 601700 m Easting and 615000 m Easting, respectively. The UTM (NAD27) southern and northern boundaries are at 3566500 m Northing and 3582000 m Northing, respectively.

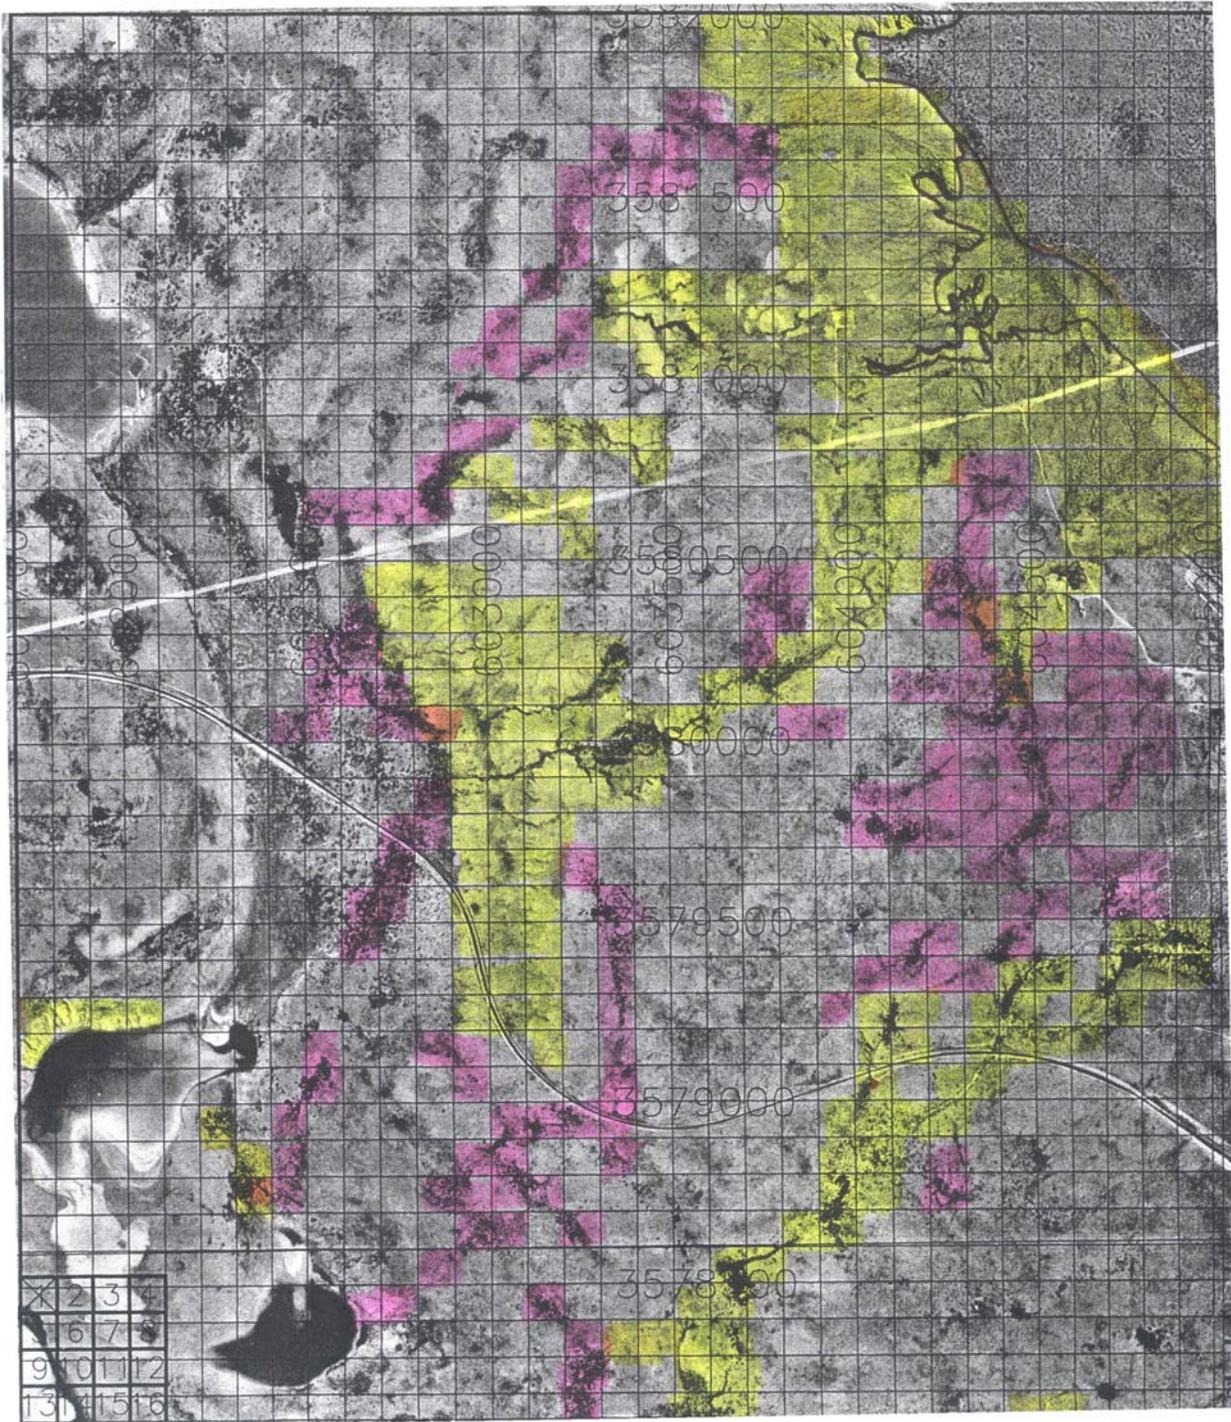
Figure 2 - Example of aerial photography with 100 m gridlines. David Hughes (WRES) provided paper printouts of aerial photography from 1996 with UTM coordinate gridlines at 100 m intervals to assist in defining elements on this grid pattern. Highlight colors on the photograph represent channel types, Element 3, distinguished in this study and were used as a guide in coding the overlay (see *2.0 Methods*).

2.1 Geological and Field Methods. Modeling (Task 3) is expected to apply parameters or factors to grid cells that are 100 m x 100 m in dimensions. To facilitate the transfer of geological data developed during Task 1B, electronic images of aerial photographs of the study area were formatted by David Hughes (WRES – Washington Regulatory and Environmental Services) with grid lines on the 100 m UTM (NAD27) values (Figure 2), and a set was printed for my use. Because of the size of the study area, Hughes divided the aerial photo coverage into 16 images (4 x 4), each with grid lines at 100 m and printed values at 500 m intervals.

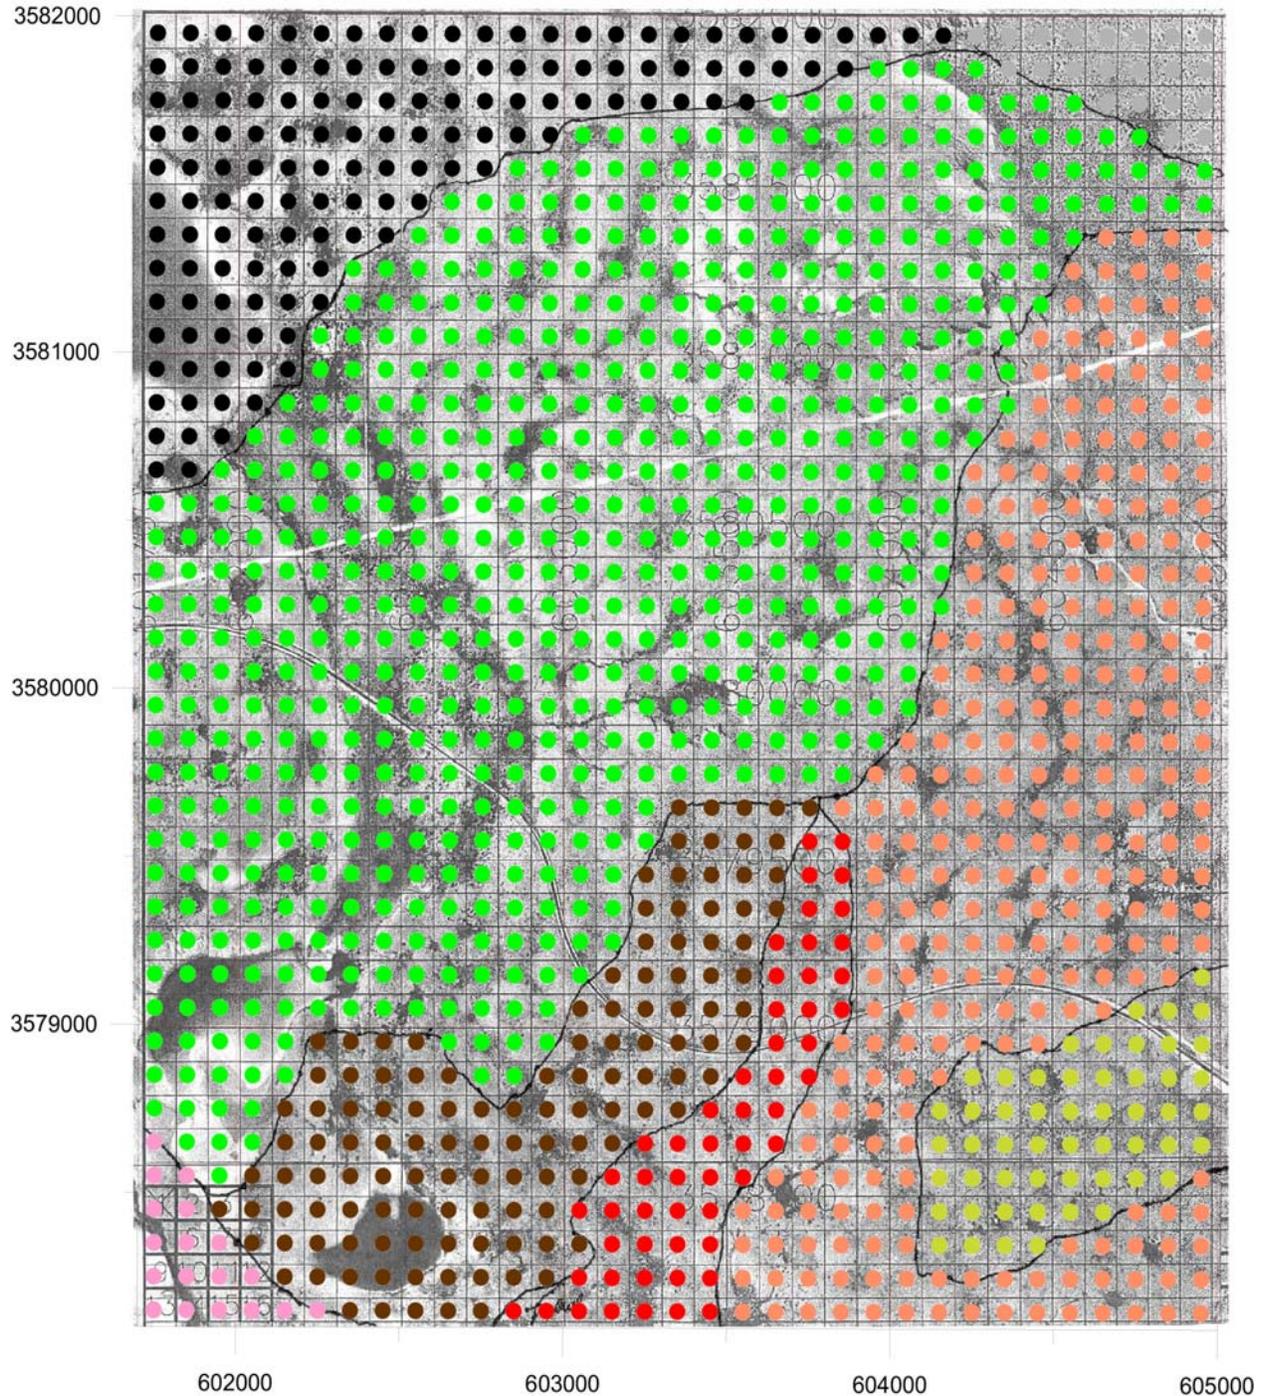
Figure 3 – Example of data values overlain on aerial photograph (same as Figure 2, but reduced in size and with Element 1- drainage basins outlined). The aerial photo underlay and dot overlay appear similar to the screen display after the dots representing grid cell centers have been keyed to the appropriate characteristic for any element (parameter). The visual display permits relatively easy checking of the proper coding, and, in this case, graphing the output data separately and overlaying the graph on the aerial photograph allows further checking that the cell coding is correct. The dots are not perfectly centered on cells due to slight distortions and slant during scanning of the aerial photo.

The principal step is to verify that the macro transcribes a value to the proper location in a database table. The overlay template created for each of the 16 paper copies of portions of aerial photographs was assigned unique UTM X and UTM Y coordinates for each “dot” representing a cell center. Several dots on each template were checked to see that the coordinates were assigned appropriately. To test the transcription, however, the most effective means is to compare output to the source. The simplest source information to use in checking transcription comes from the assignment of drainage basins (Element 1; see Figure 3 and *Task 1B Elements* below).

The values reported for this field in the electronic file range from 0 to 15. The default value was 0, and this represents areas indicated above that are dominated by sand dune topography, gentle slopes, and no developed surface drainage channels. Number values otherwise reported indicate cell centers belonging to a particular drainage basin (e.g., Figure 3).

7.1 Element 1 Surface Drainage Basins. Drainage basin #6 (partially displayed in Figure 3 with orange dots) is unusual among the drainage basins defined because: 1) it has the largest area of any basin with significant developed drainage channels, 2) it encompasses entirely a smaller basin defined by a major sinkhole, 3) it is likely continuous, hydraulically, in the shallow subsurface with at least one other basin of significant size, and 4) it accumulates runoff in a karst valley that is pockmarked with caves and swallowholes. This karst valley shows evidence of a significant runoff event detailed in the previous section. Drainage basin #6 is also surprising because it was not obvious how large it is until considerable work was done on topographic maps, aerial photos, and some field work.

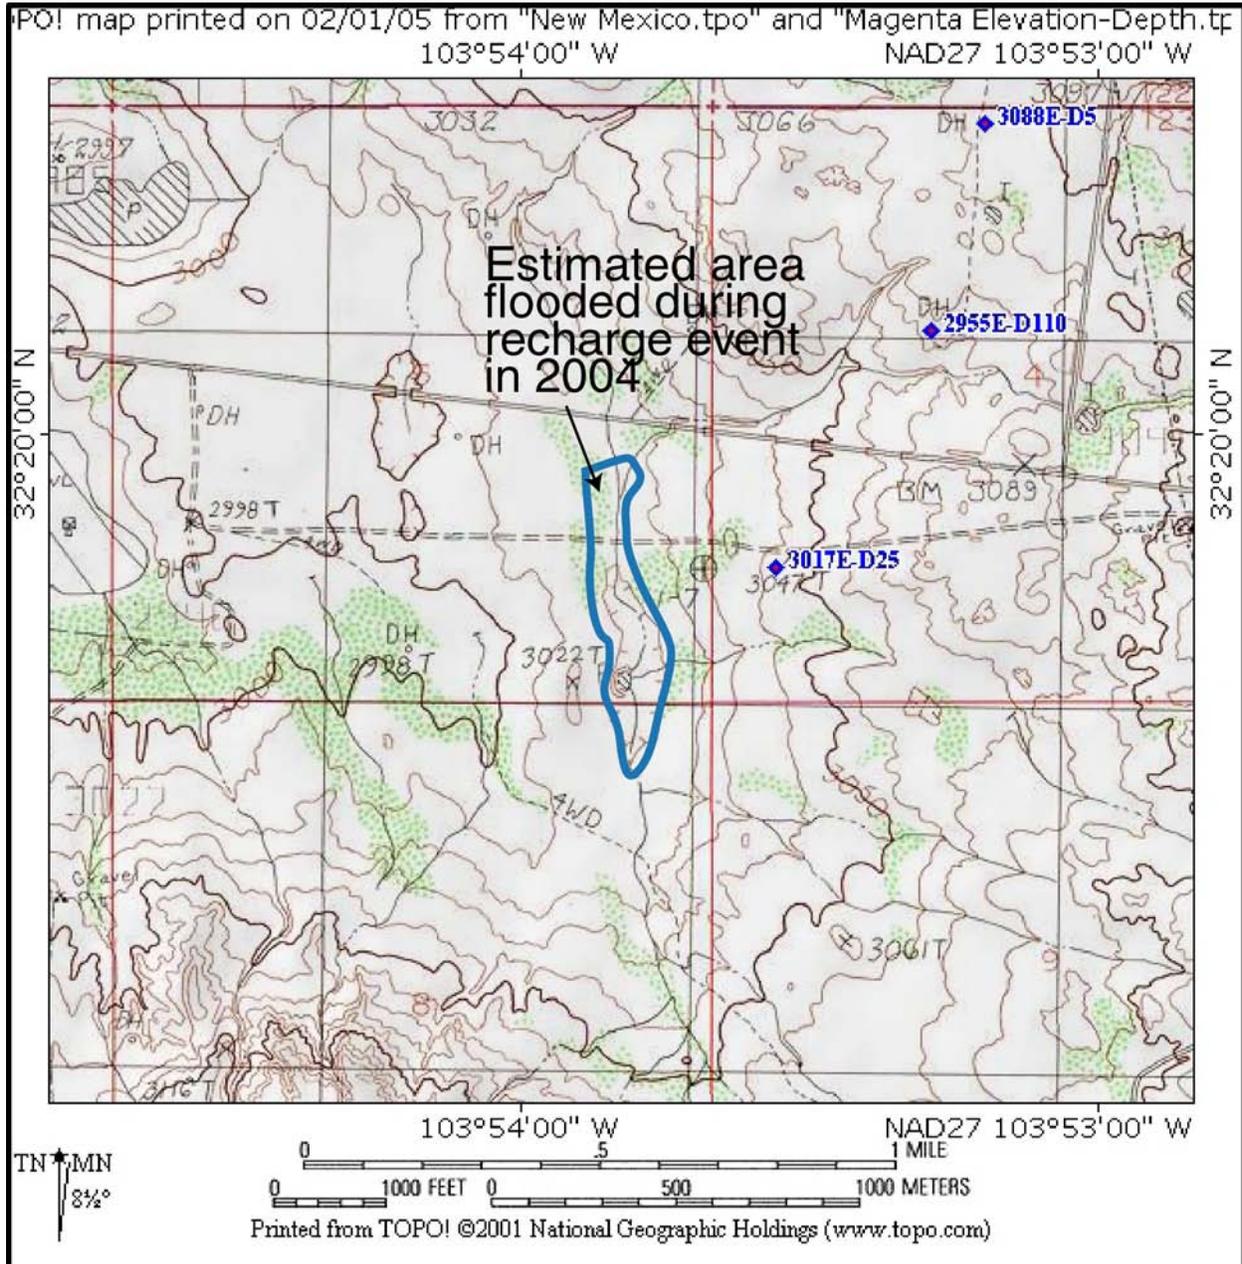
Figure 4 – Topographic map of karst valley in drainage basin #6. The blue outline is approximately the area that appears to have been covered during a flooding event sometime in 2004. The area, estimated from aerial photographs, is about 10,000 square meters at a minimum.

The evidence is relatively straightforward, though circumstantial as to its timing. Some of the drainage channels within drainage basin #6 showed evidence of significant water flow, given the downslope flattening of grasses and debris in brush and trees. As I mapped specific features, such as caves or sinkholes, in the karst valley (Figure 4) that forms the low point in drainage basin #6, I became aware of a debris ring around the edges of the karst valley that indicates a high water mark. Within the valley, mesquite bushes were stained with reddish-brown silt/clay to a fairly uniform level above the valley floor, and floating debris such as dried cow patties were left in mesquite branches at about the same level as the top of the staining (Figure 5).

Area covered is estimated to be approximately 10^5 m^2 .

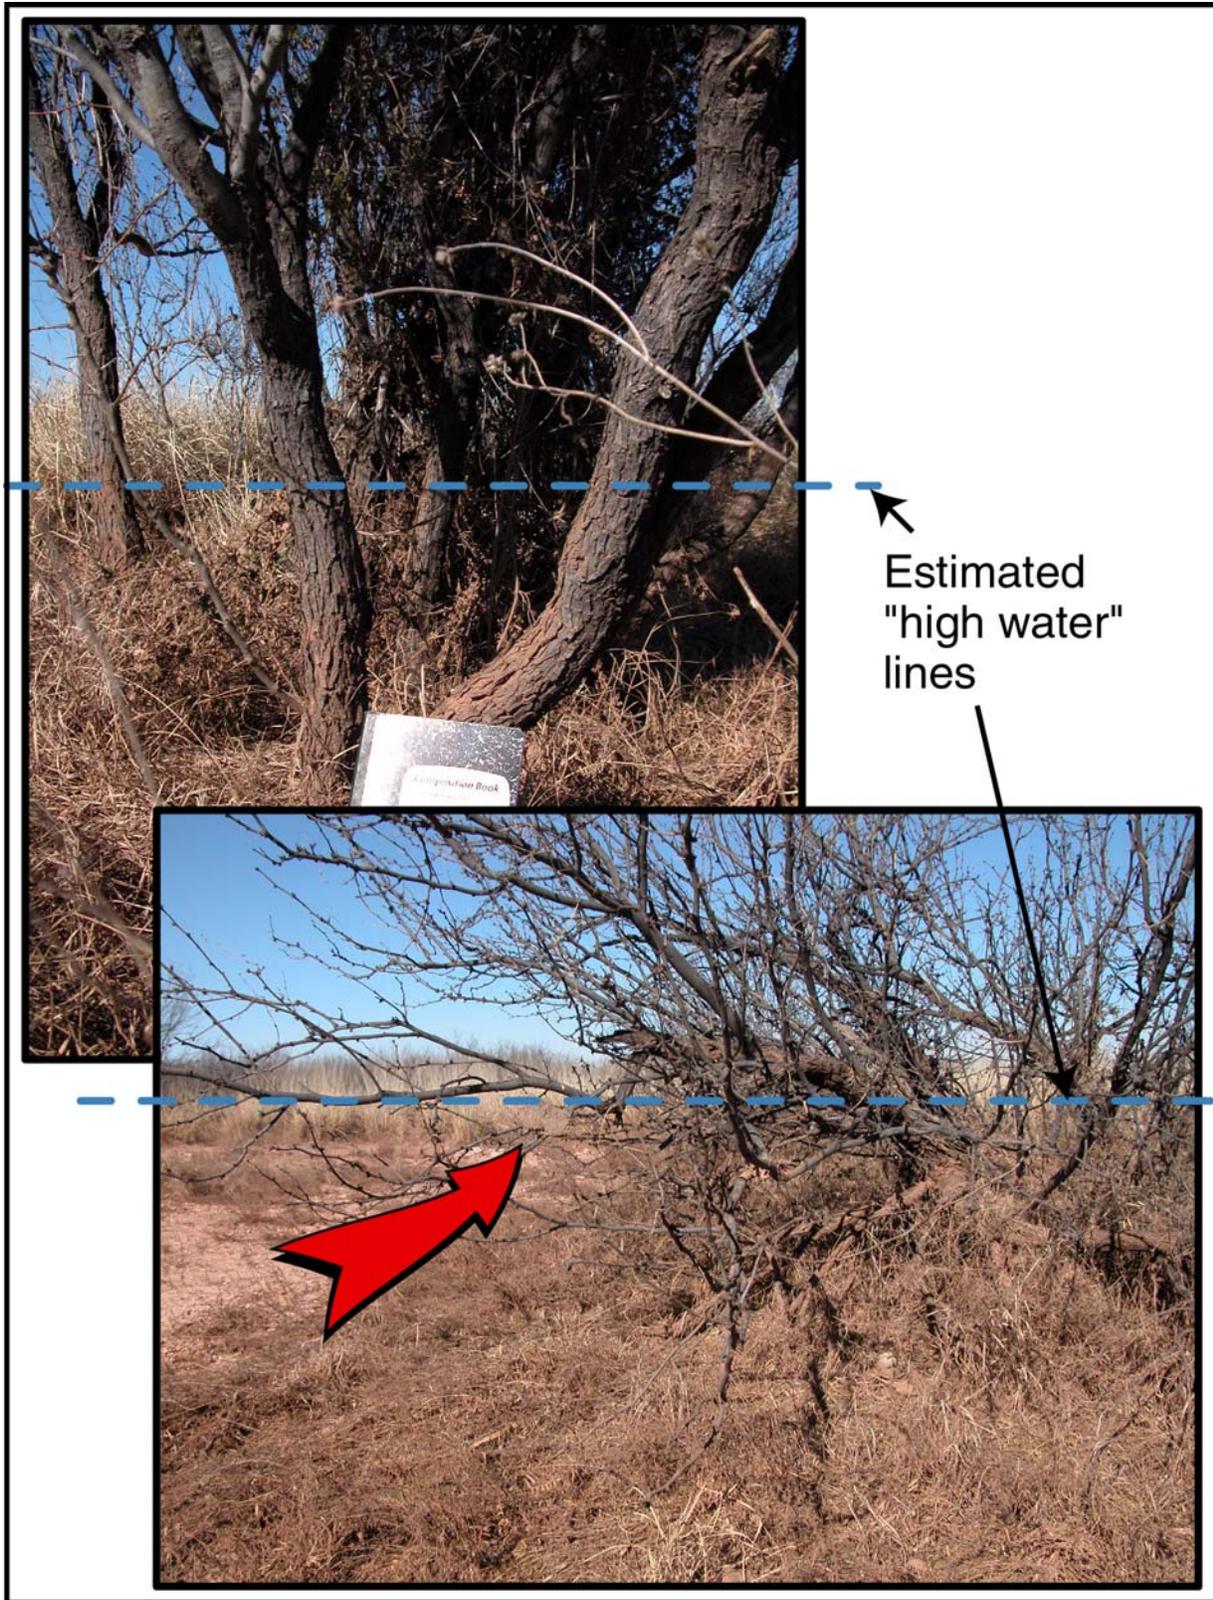
Figure 5 – “High-water” indicators in karst valley in drainage basin #6. Red arrow indicates dried cow patty resting in mesquite branch. Dashed lines show height of staining from flood water.

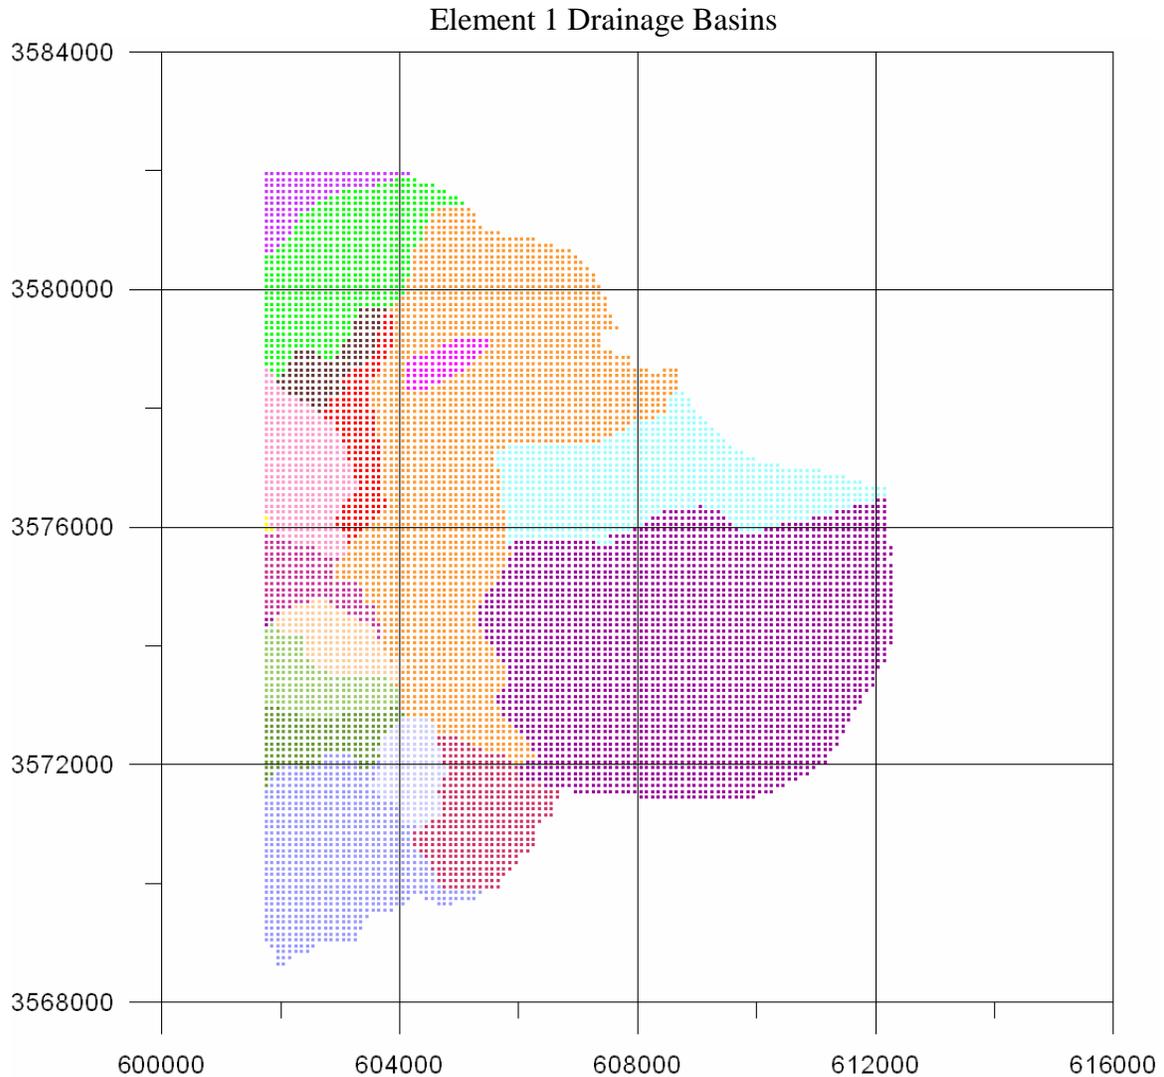
There are seventeen defined drainage basins within the study area (data table values 1 through 17). The “default” value of 0 represents the area (uncolored here) where drainage basins were not defined at this scale because there is very little that can be defined as surface drainage and there is little topographic differentiation. The colors have no significance other than being different for each basin.

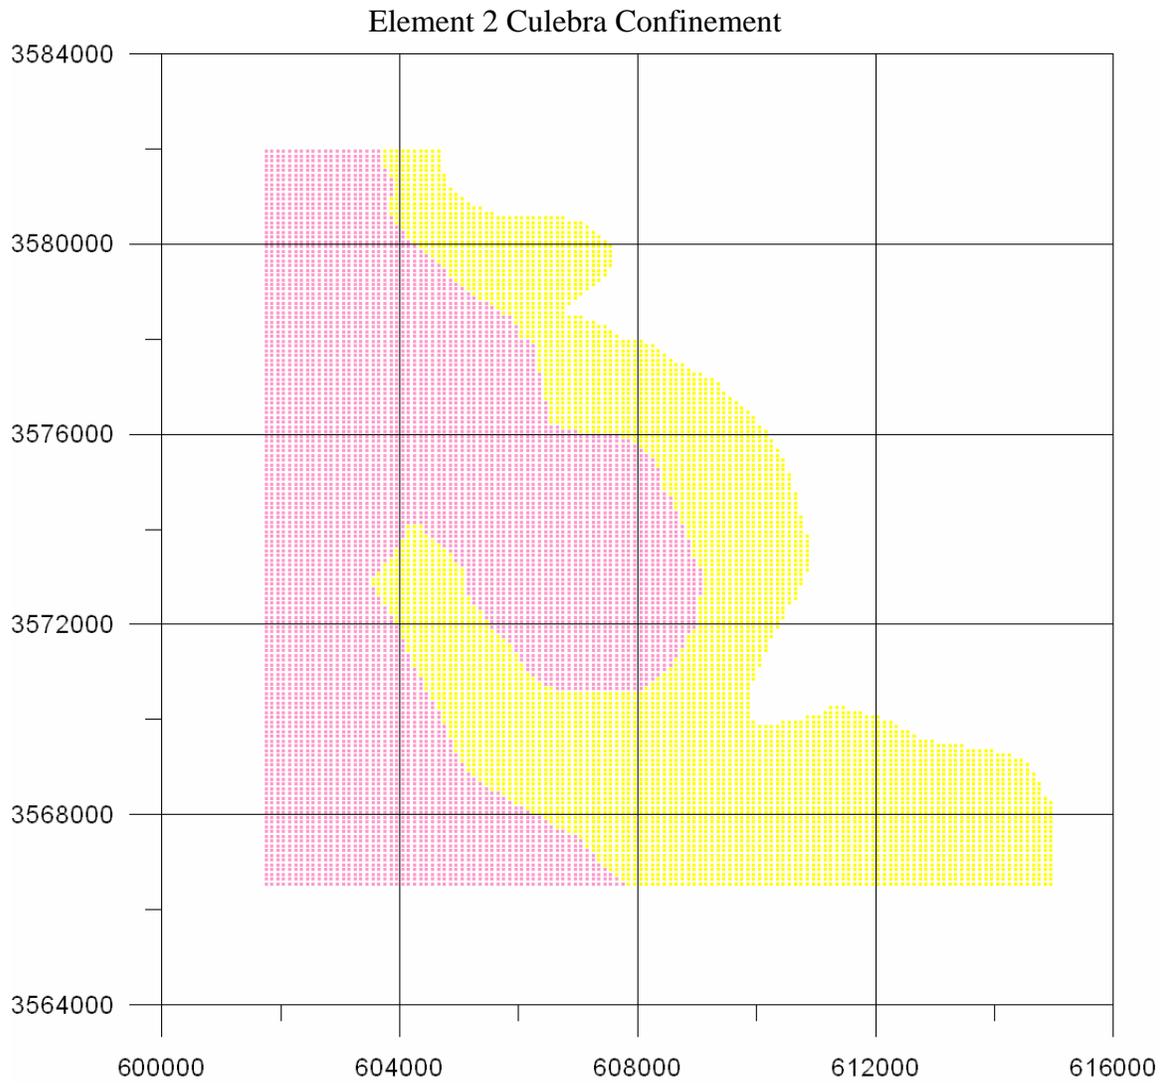
Three zones were differentiated that are generally considered confined, transitional, and unconfined.

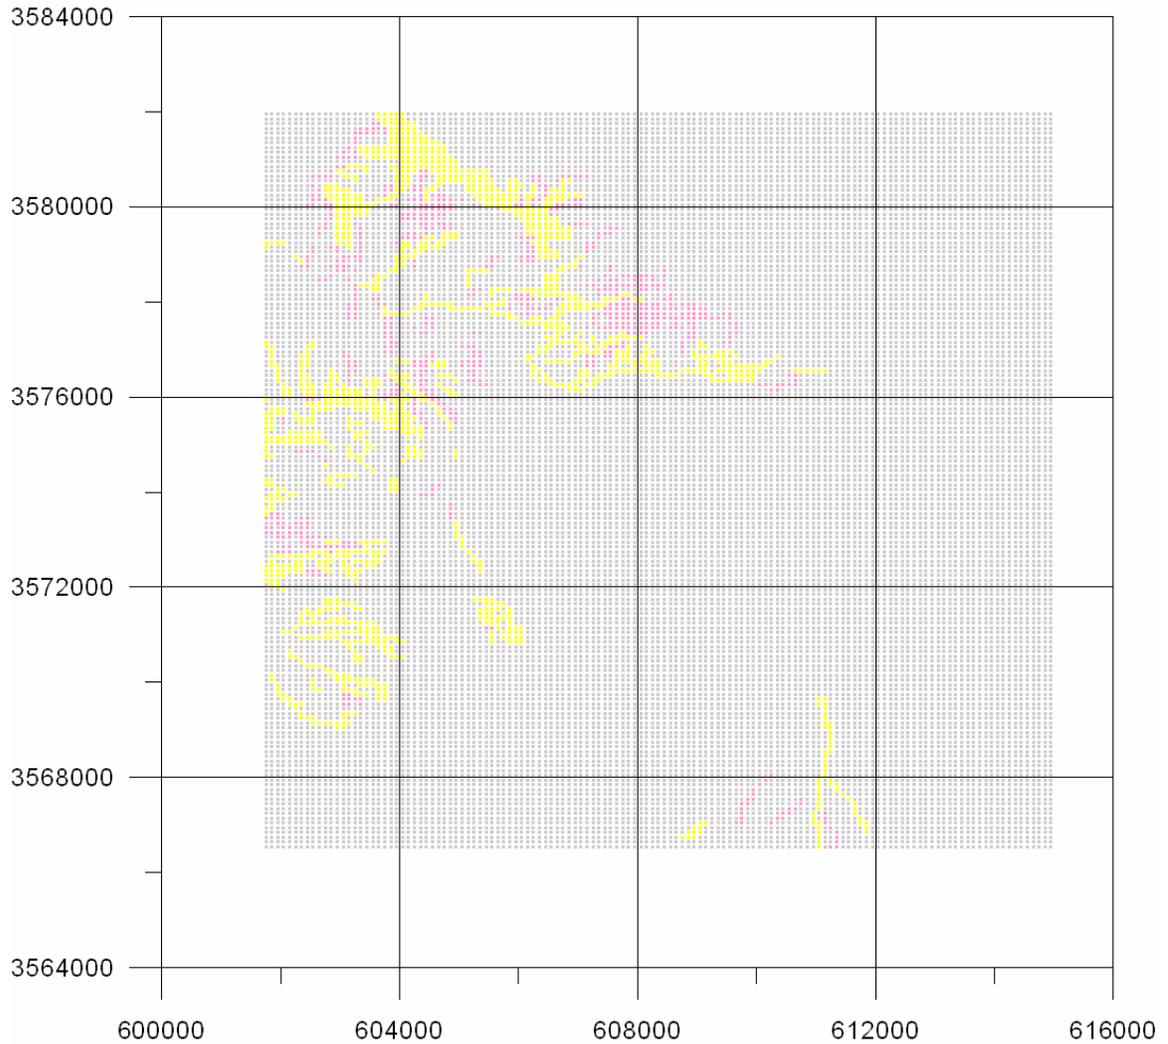
Element 3 Drainage Channels

Most of the area covered by the study has no significant development of drainage channels. This is represented here with small gray dots.

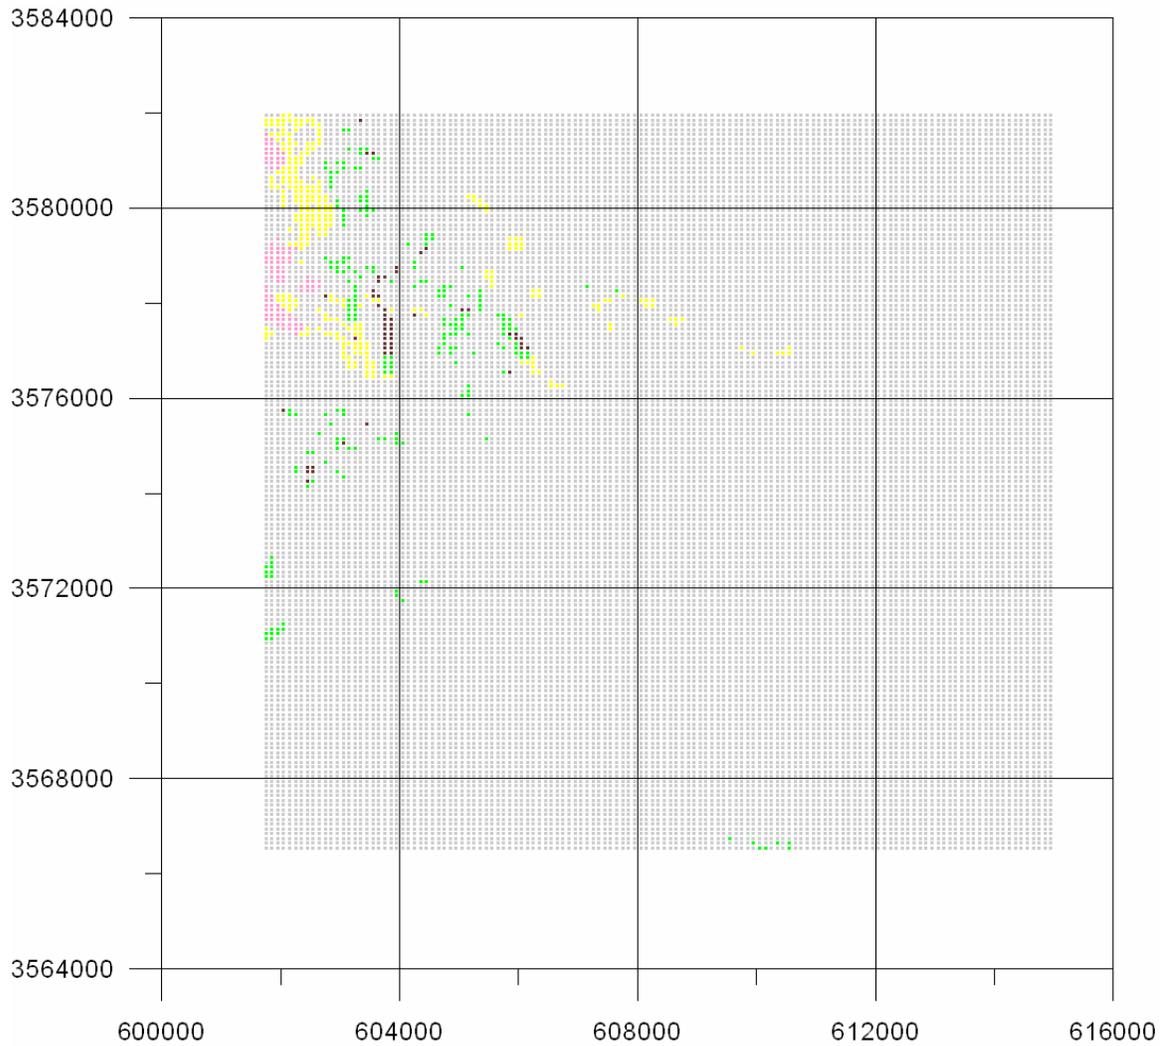
Element 4 Points and Areas of Potential Recharge

Sand, sand dunes, and Mescalero caliche blanket large areas without visible points or areas that focus recharge. These are coded with small gray dots to contrast with other areas.
