DOE/WIPP 04-3177  
Volume 1

**Geotechnical Analysis  
Report  
for  
July 2002 – June 2003**

March 2004

Waste Isolation Pilot Plant

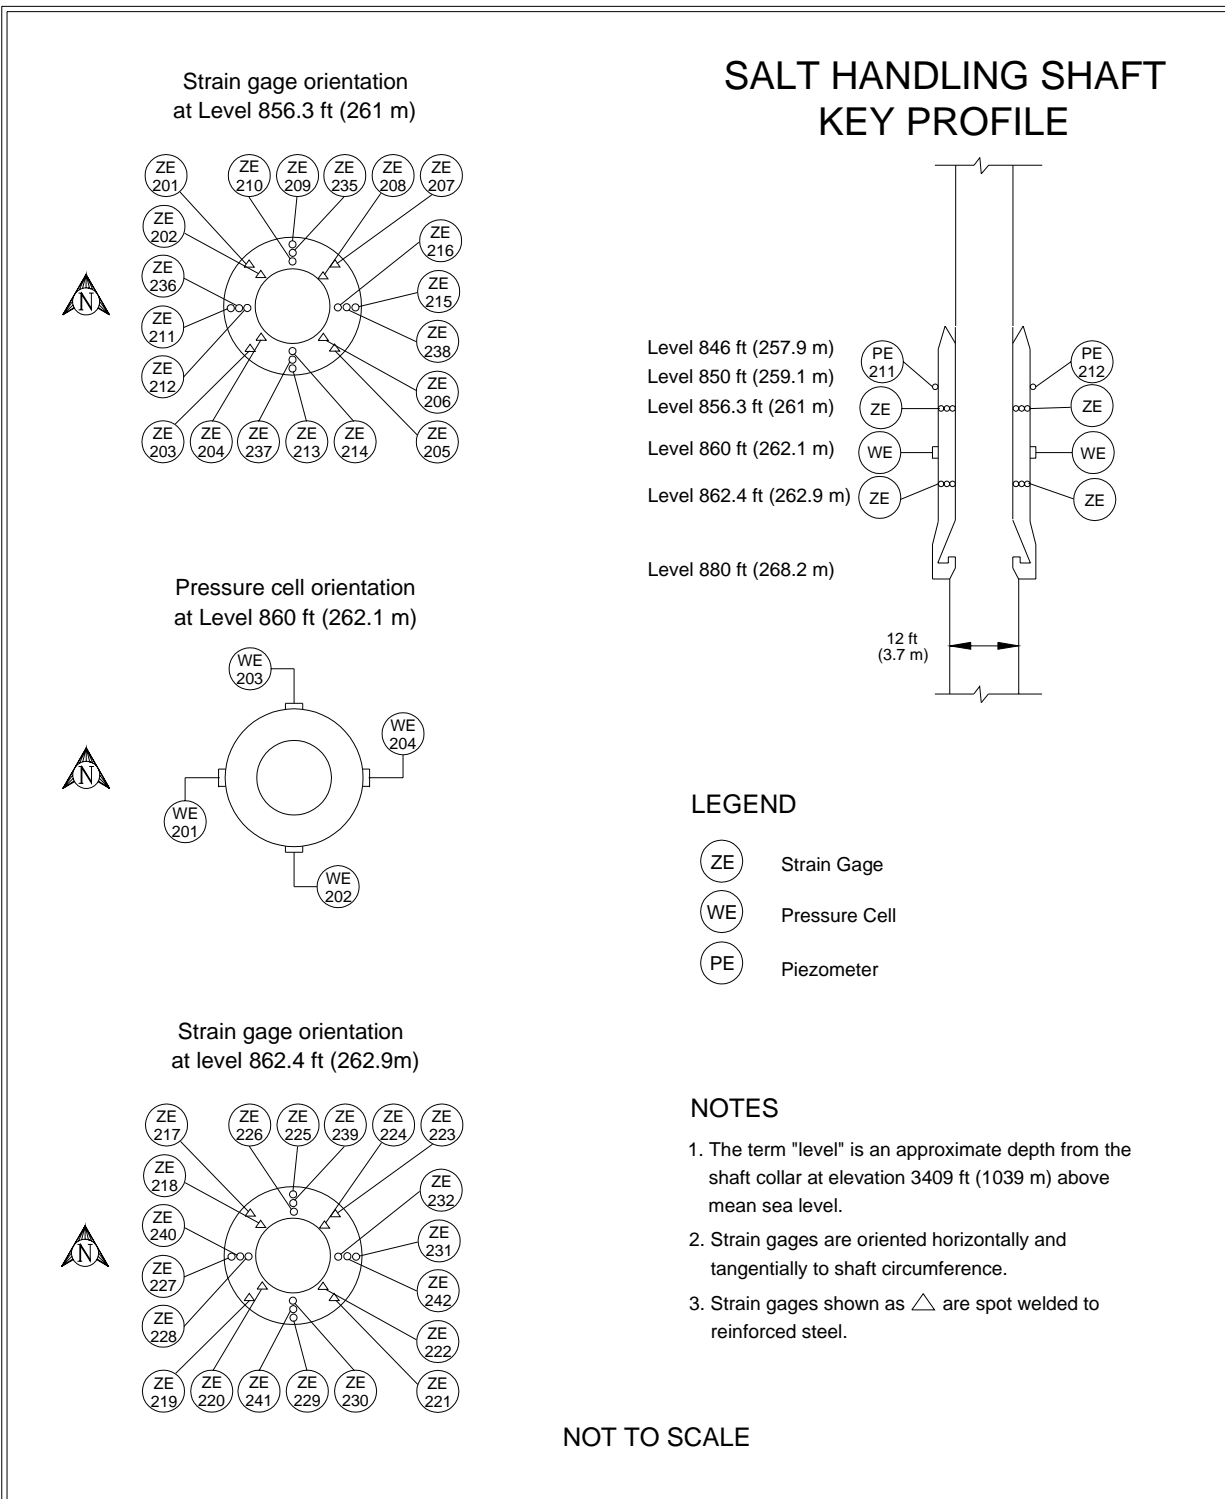
**Figure 3-3**  
**Salt Handling Shaft Key Instrumentation**

The contact pressures recorded by the instruments for this reporting period ranged from -21.1 to 0.6 psi (-145 to 4 kPa). Sixteen spot-welded and 24 embedment strain gages were installed on and in the shaft key concrete at both the 856.3-ft (261-m) level and at the 862.4-ft (262.9-m) level. There are four functioning spot-welded strain gages located at these levels. The reported strains at the 856.3-ft (261-m) level were 652 and 748 microstrain. The reported strains at the 862.4-ft (262.9-m) level were 507 and 784 microstrain. The strains reported for this reporting period from the 12 embedment strain gages located at the 856.3-ft (261-m) level range from -676 microstrain to 977 microstrain. The strains reported for this reporting period from the two embedment strain gages located at the 862.4-ft (262.9-m) level were 161 microstrain to 297 microstrain. The strains recorded from the spot-welded strain gages and the embedment strain gages are very similar to the recorded strains from these instruments at the end of the previous reporting period.

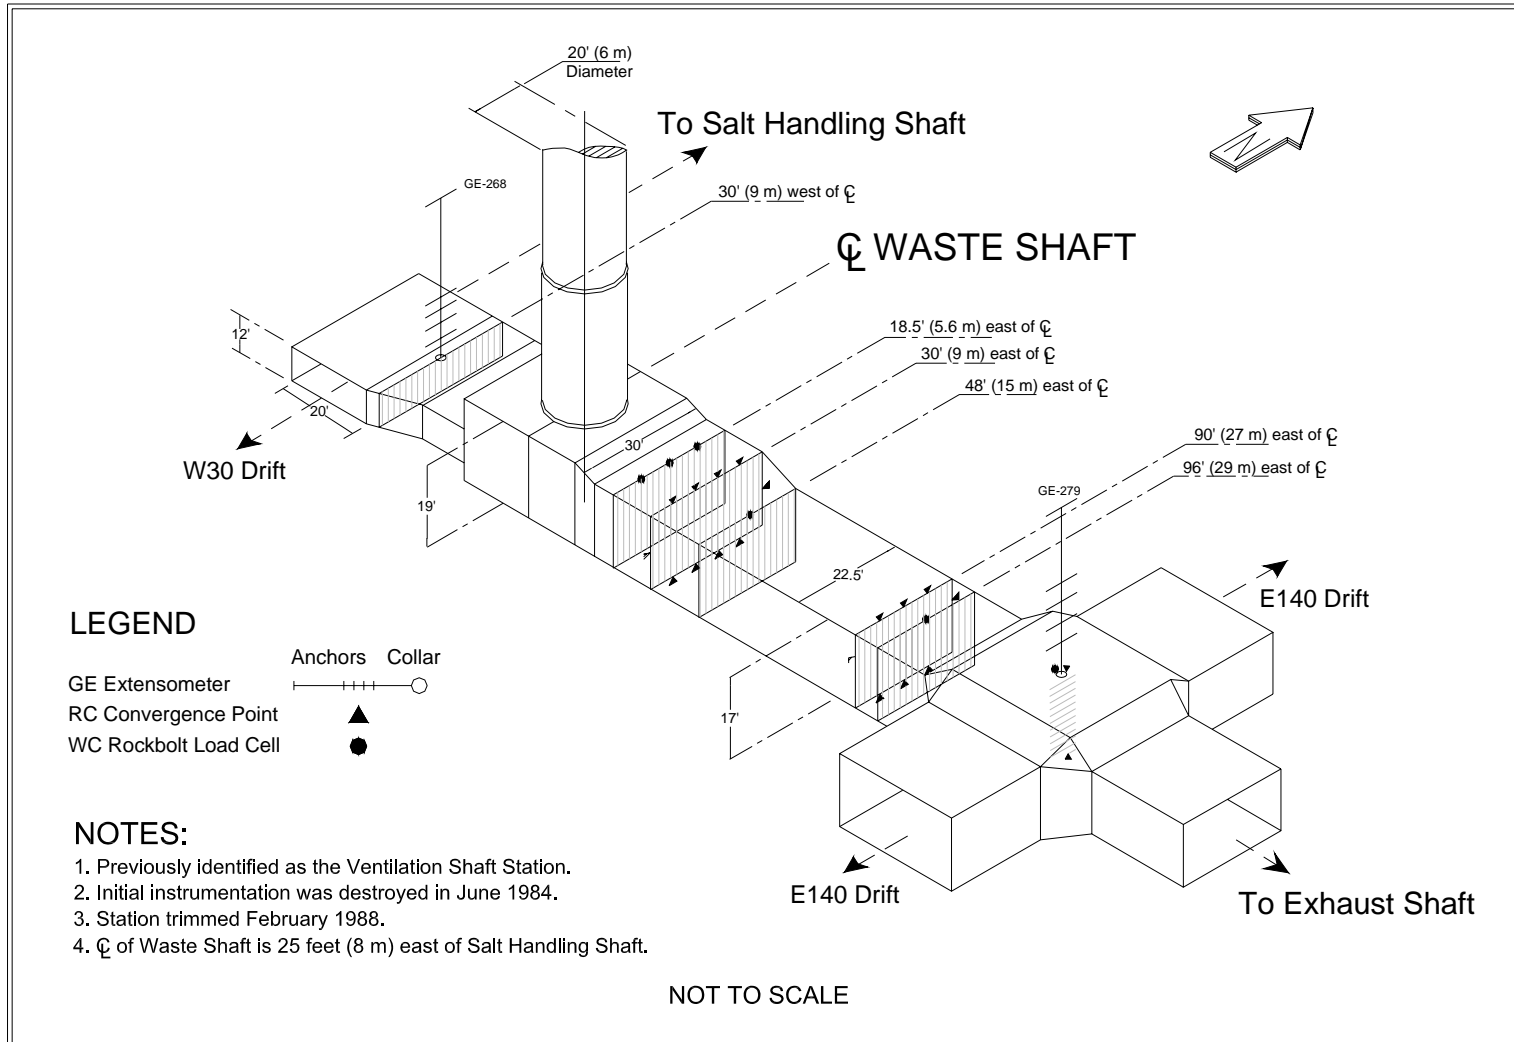
**Figure 4-4  
Waste Shaft Station Instrumentation After Wall Trimming**

Ground control activities performed in the Waste Shaft Station during this reporting period consisted of routine rib maintenance and the routine replacement of failed rock bolts.
