Waste Isolation Pilot Plant

Geotechnical Analysis Report For July 2010 – June 2011

U.S. Department of Energy

MAY 2012

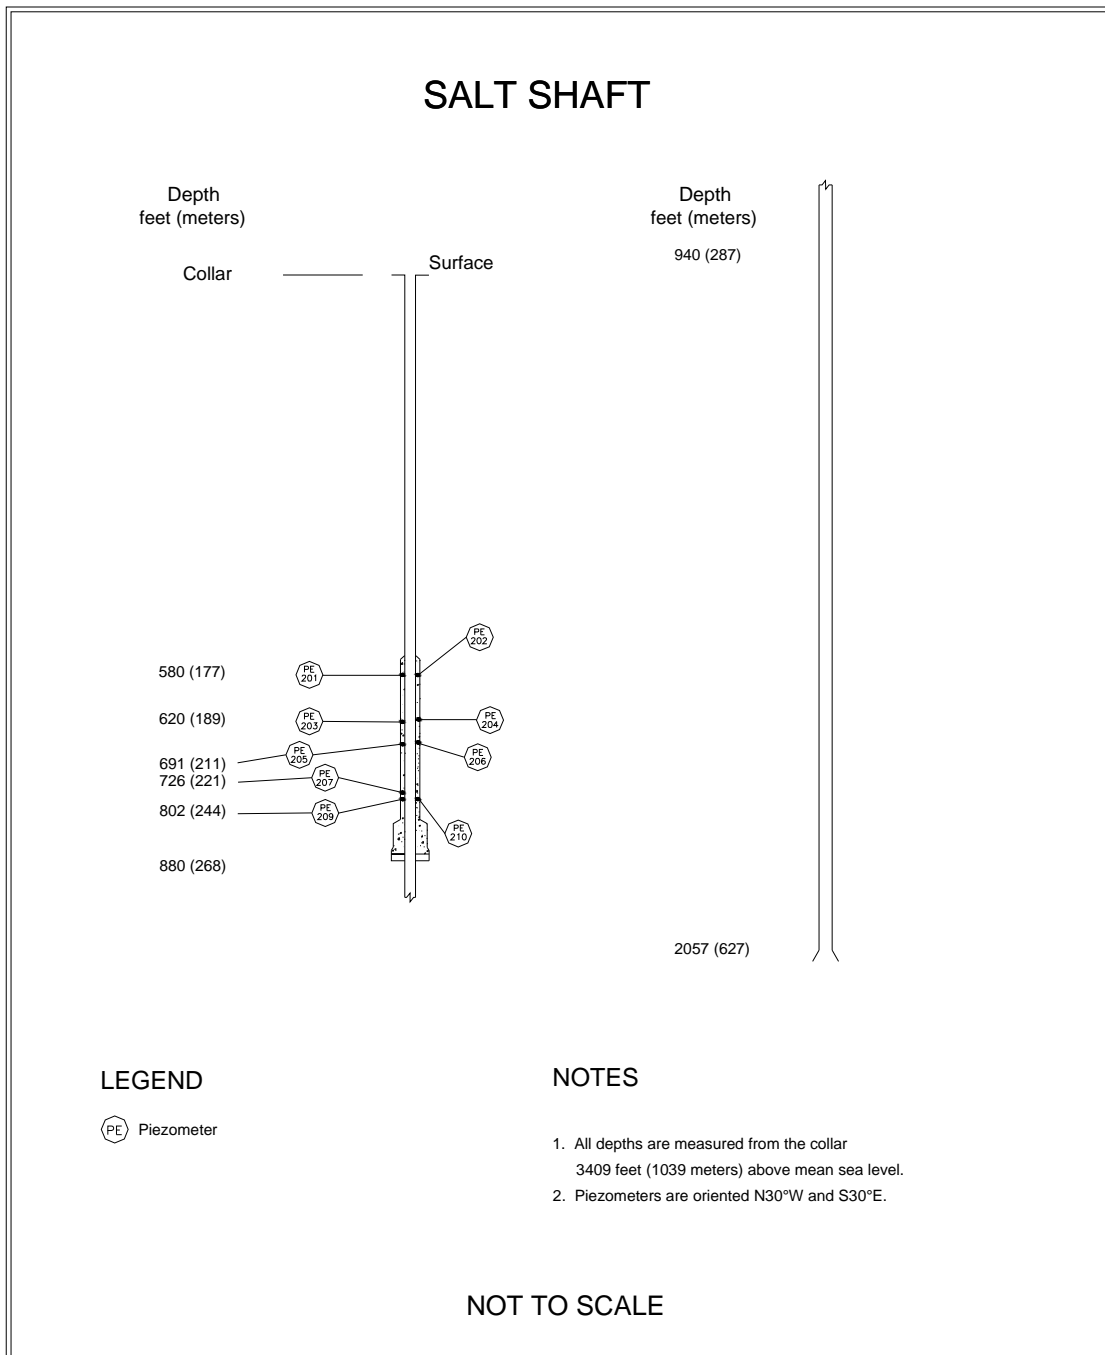
Figure 3-2 – Salt Shaft Instrumentation (Without Shaft Key)

Ten of the 12 piezometers continue to provide data. The fluid pressures recorded at the end of this reporting period range from approximately 60 pounds per square inch (psi) (414 kilopascals [kPa]) at the 802-ft (244-m) level in the Los Medaños Member to 188 psi (1,296 kPa) at the 691-ft (211-m) level in the Magenta Dolomite Member. The recorded pressures for this reporting period are generally consistent with the readings from the previous reporting period. The fluid pressure on the shaft liner will continue to be monitored on a regular basis.
