WIPP Underground Fire Accident Investigation Summary February 5, 2014

Ted Wyka
Chairman, Accident Investigation Board
March 2014

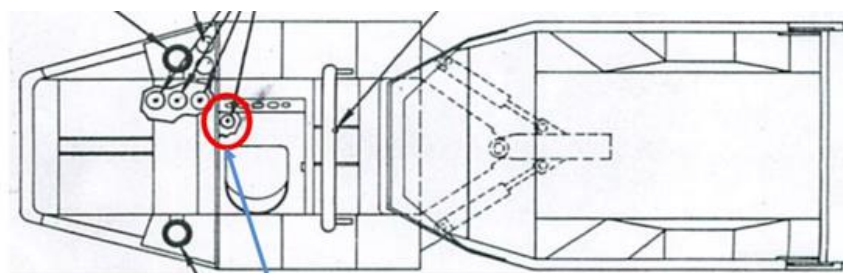
(a) Plan View

- The Board has been unable to perform detailed physical forensics on the vehicle underground due to the February 14th radiological event.
- The Board reviewed photographs taken with forensic experts including a New Mexico Fire Investigator from the State Fire Investigation Bureau and the Eddy County New Mexico Fire Marshall.
