Accident Investigation Report

Underground Salt Haul Truck Fire at the Waste Isolation Pilot Plant February 5, 2014

March 2014

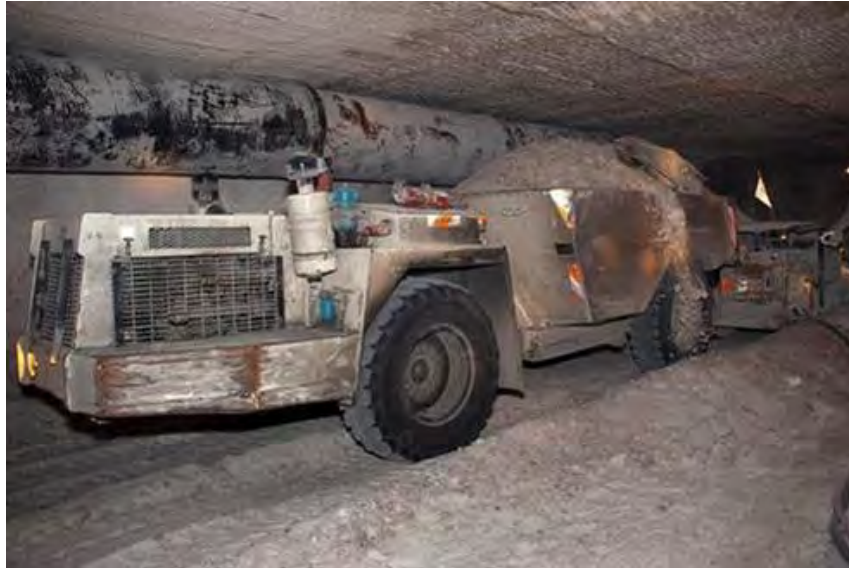
Figure 4: EIMCO 985T 15 Haul Truck (74-U-006A)

EIMCO Model 985T-15 haul truck 74-U-006B was purchased in May 1985 and has been used continuously over the past 29 years to transport mined salt to the salt hoist for removal from the underground. A second Model 985-15 salt haul truck 74-U-006A is also in operation in the mine. Figure 4 is a photograph of a Model 985 haul truck (74-U-006A)

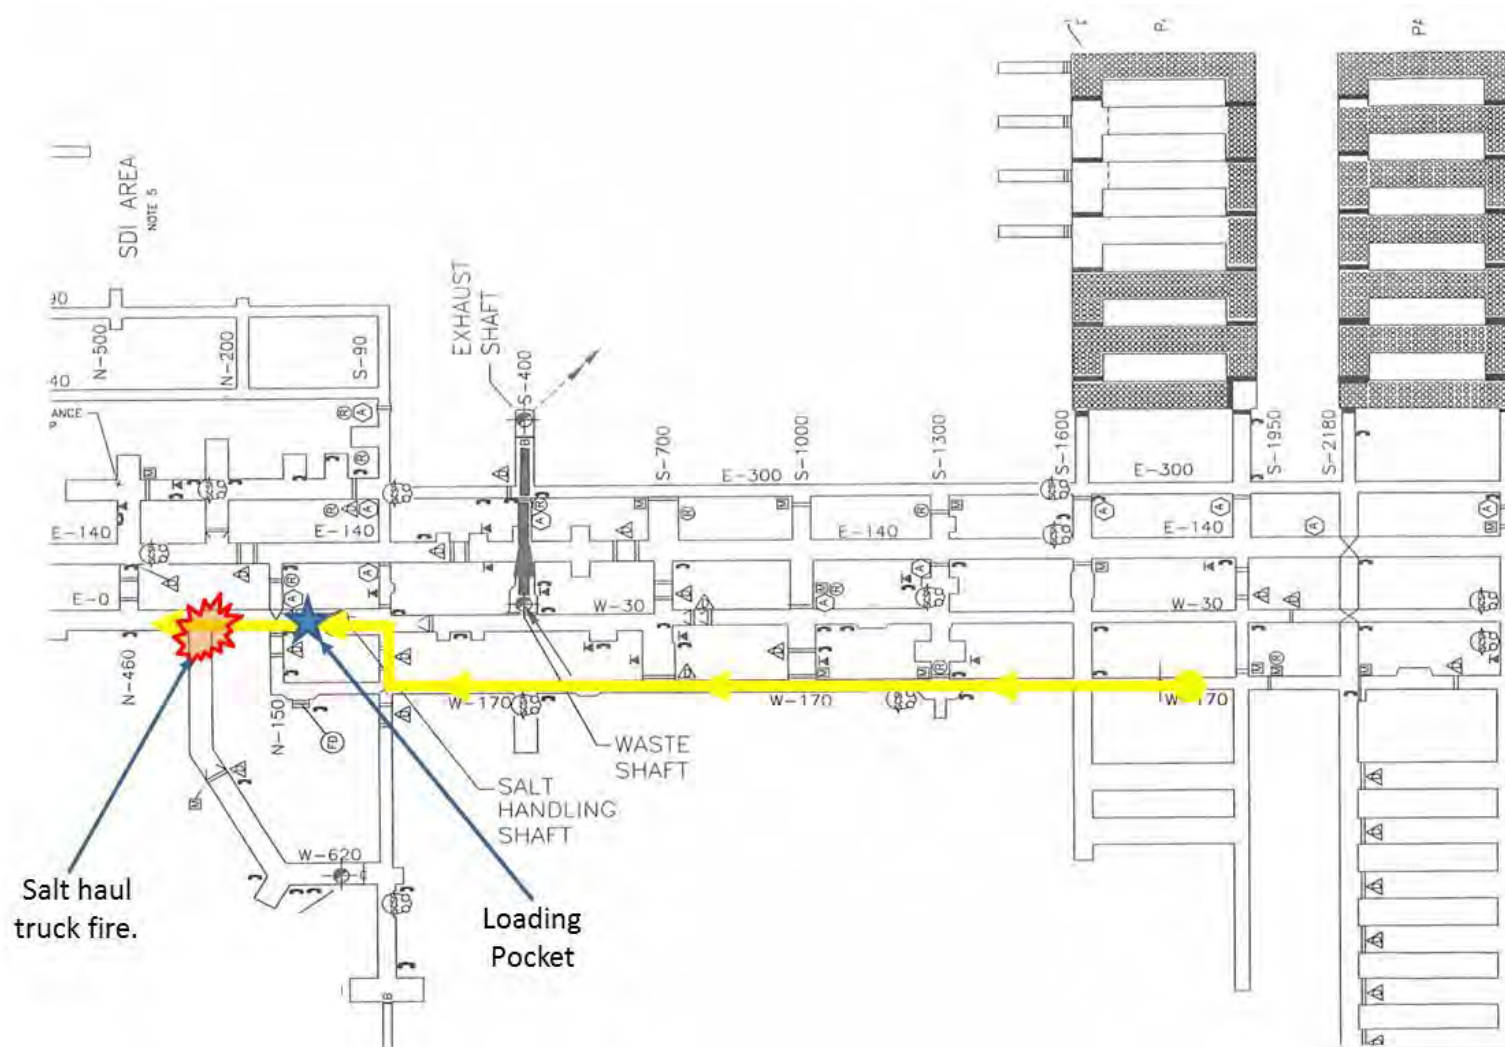
Figure 8: Route of Haul Truck from Panel 8 to Accident Scene

An Operator picked up a load of salt using haul truck 74-U-006B at Panel 8 at approximately 1045 and headed north on W-170 toward the loading pocket (Figure 7) to dump the load. Figure 8 shows the Operator's route from Panel 8 to the scene of the fire. He turned right on S-90, left on E-0, dropped half of his load at the loading pocket, continued north in E-0, and passed N-150 to drop the rest of his load. The Operator pulled into N-300, backed up into E-0, and unloaded the rest of the truck. As the Operator lowered the bed, he looked back to see if it was clear of muck. It was at this point that he noticed an orange glow and then flames between the engine and the dump sections of the truck.

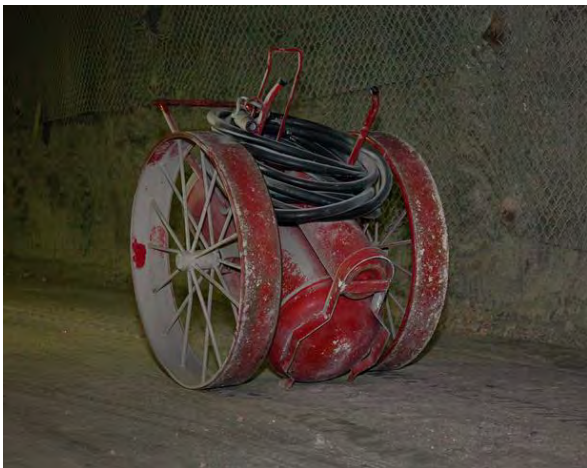
Figure 11: 300-Pound Extinguisher in the Underground

The two U/G Services workers attempted to push a 300-pound wheeled fire extinguisher (see Figure 11) to the airlock at E-0/N-150. When the workers opened the airlock, their ITX (carbon monoxide) monitor alarmed and the smoke worsened. The Operator's supervisor (after notifying his room closure crew and the Mine Manager of the fire)

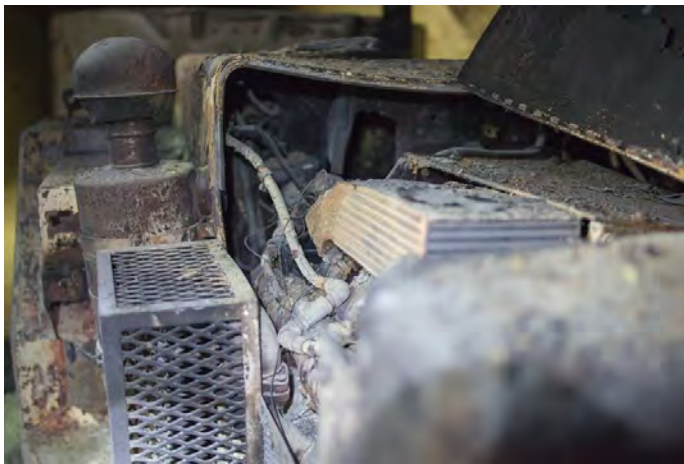
**Figure 19: Engine Cooling Coils**

The Board observed accumulated grime in the engine compartment of other salt haul vehicles that would have been sufficient to create a sustained fire that would result in additional fluid leaks. The normal hauler ventilation flow pulls air through the front grill and directs it across the cooling coils above the engine block (see Figure 19). This flow exits at the back of the engine compartment and would push the fire towards the transmission (see Figure 18, illustration (c)). In the actual fire, this condition occurred within about 5 to 10 minutes of initial ignition (assumed start time is

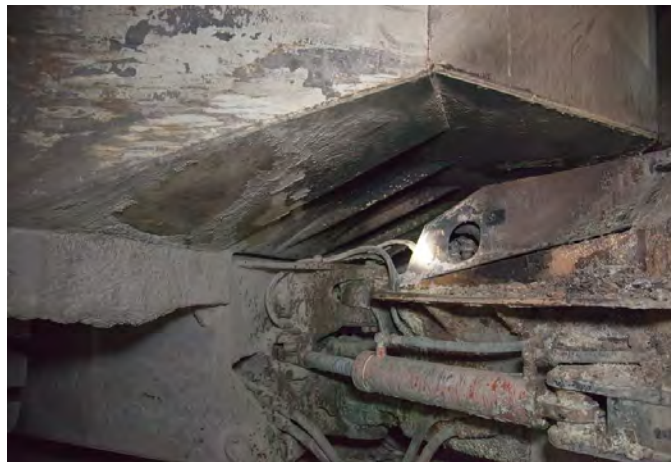
**Figure 20: Transmission Fluid Stick Access**

1043) and was recognized by the truck Operator at 1048. The Operator shut down the engine, exited the hauler on the left side, and moved to the right side. The Operator then discharged his hand-held fire extinguisher through the transmission access hole, which is forward of the pivot pin (see Figure 20) and under the haul truck. Because the fire was enclosed, using a handheld fire extinguisher was ineffective. The delay between initial ignition and activation of the engine compartment fire suppression system resulted in development of multiple leaks.
