SUBJECT:

Field Investigation at the U.S. Department of Energy's Waste Isolation Pilot Plant (WIPP), ID No. 29-01857, Carlsbad, New Mexico (RCD Control Number 17AA01)

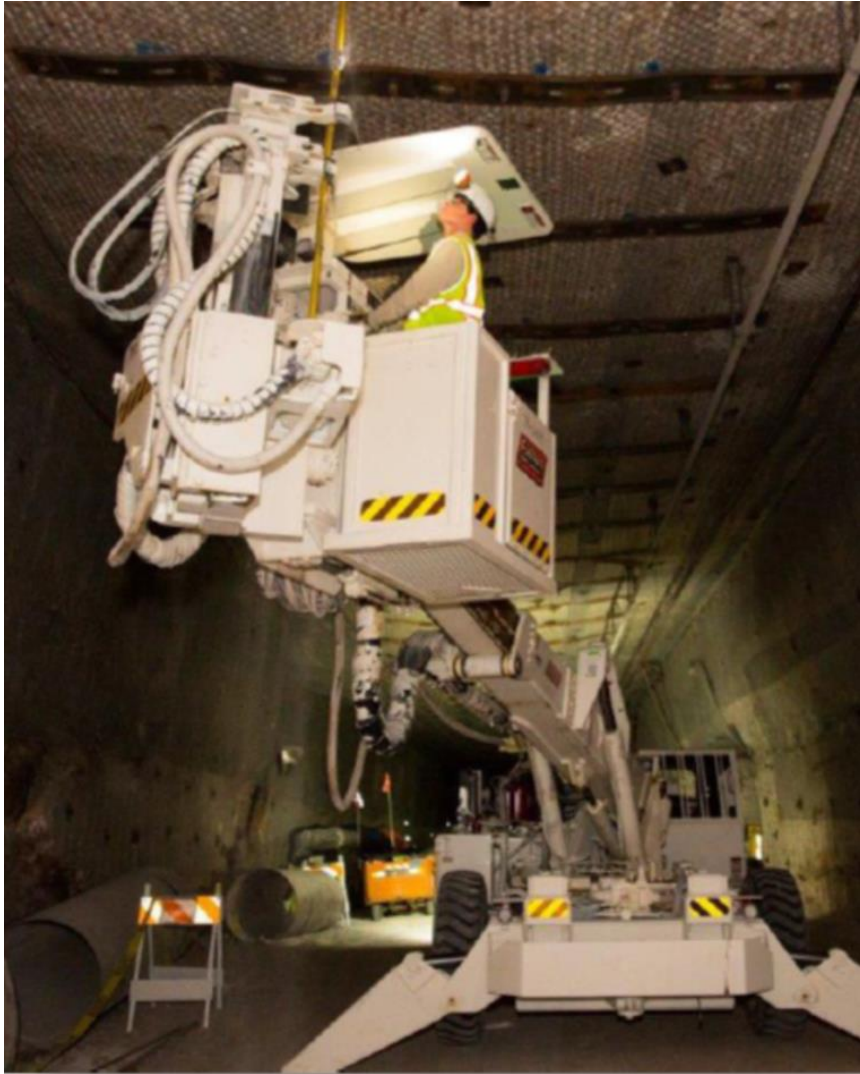
Roof support is installed using diesel or “hybrid” diesel-electric single-boom roof bolting machines. Figure 8 shows that the roof bolt operator is protected by a canopy, but there is no automated temporary roof support (ATRS) like those required on roof bolting machines used in coal mines. The lack of an ATRS means that a roof bolt operator at WIPP has less protection from loose rock. However, an ATRS would be difficult to retrofit because of the greater height

of the drifts at WIPP compared with coal mines. In addition, an ATRS might fracture and destabilize a thin, detached layer if too much pressure was applied. So long as mesh is installed on the roof before fracturing develops, roof bolt operators should be protected from loose rock during subsequent rebolting operations.

FIGURE 8.—A roof bolting machine at WIPP.
