The purpose of this letter is to inform the Environmental Protection Agency that the Carlsbad Area Office (CAO) plans to raise the repository horizon in Panels 3, 4, 5 6, and 9 by approximately two meters so that the roof is at clay seam G. The Waste Isolation Pilot Plant intensively monitors the geomechanical behavior of its underground excavations. Actual monitoring of underground excavations, specific underground studies, and geotechnical modeling (e.g., DOE-WIPP 94-025, Investigation of the Advantages of Removing Highly Fractured Roof Beams), all demonstrate that positioning the roof at clay seam G improves ground conditions in the repository and provide a more stable roof configuration without significantly impacting repository performance. Raising the repository horizon reduces the rate at which ground deteriorates (i.e., slower roof beam deformation rate and slower development of fractures), thus reducing risks during mining and waste handling operations.

DOE-WIPP 94-025

Investigation of the Advantages of Removing Highly Fractured Roof Beams

INVESTIGATION OF THE ADVANTAGES OF REMOVING HIGHLY FRACTURED ROOF BEAMS

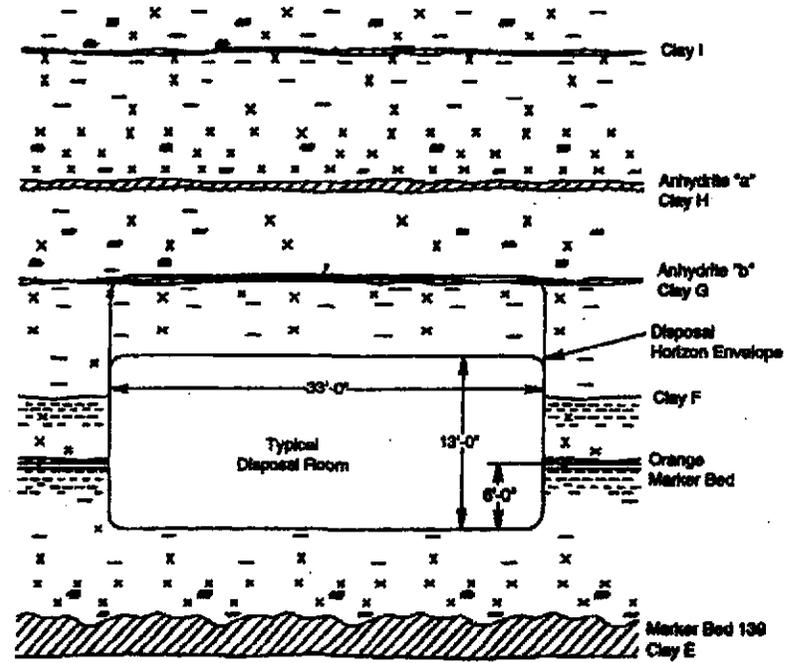
Figure ES-1
Typical Facilities-Typical Disposal Panel
(After Westinghouse, 1995c)

Typical Excavation Sections

Disposal Horizon Stratigraphy

expected to be quite small and may only be observable, if observable at all, in the subsystem performance assessment (PA) computer codes. More importantly, it is expected that there will be an insignificant impact on the location of the Complementary Cumulative Distribution Function (CCDF) curve for the PA that was included in the Compliance Certification Application (CCA) and the Performance Assessment Verification Test. This insignificant impact on the CCDF is expected because of the simplifications and conservative assumptions (e.g., treatment of the disturbed rock zone (DRZ) and panel closure permeability) made in the PA-scale computer models regarding the repository horizon and long-term performance of the disposal system. This change in repository horizon is within the disposal horizon envelope presented in the CCA in Figure ES-1 of Appendix Panel Closure System (PCS) and in Figure 3-6 from Chapter 3.

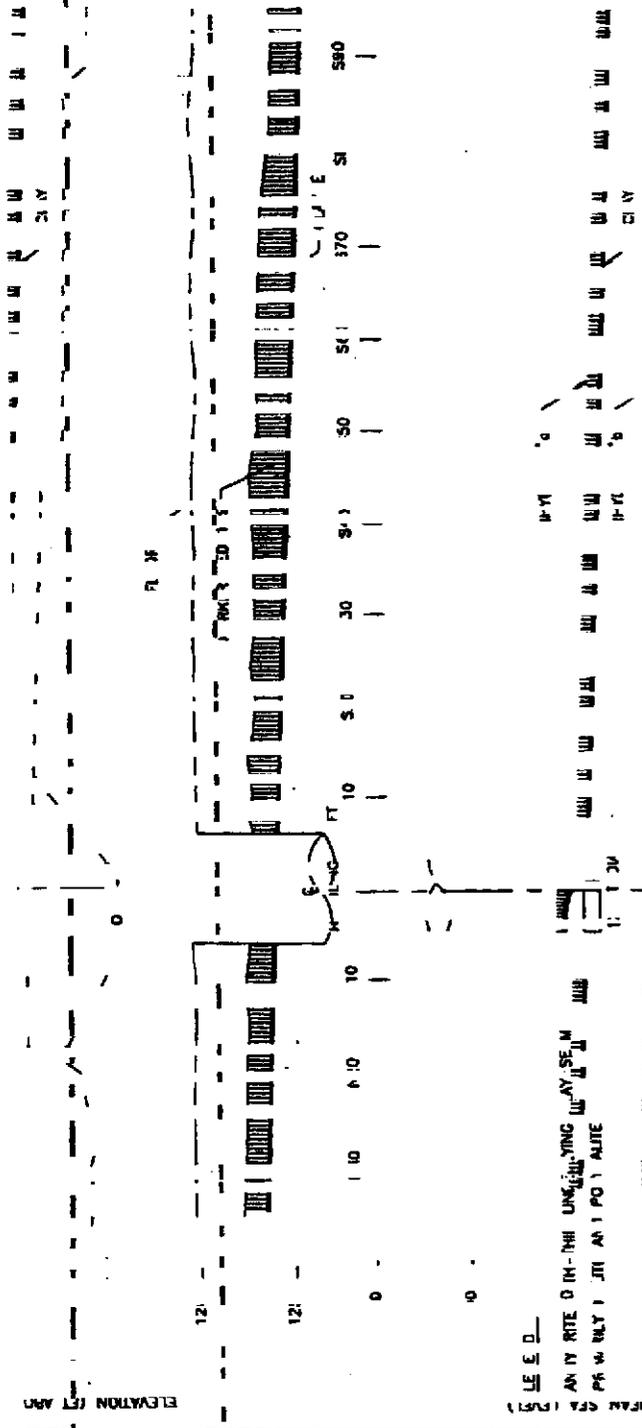
Before Roof Beam Removal

The only excavation at WIPP that has had the roof beam removed up to a clay seam well after initial mining is the Salt Handling Shaft Station. The station was mined (by drill and blast) in 1982 with a 14 to 18 foot high roof (Figure 5). The roof up to Clay G began deteriorating soon after excavation, at least partially because of poor charge control during mining. By 1987, the roof had deteriorated to the point that it was decided to remove the roof beam. The roof beam was removed (Figure 6) between November 1987 and February 1988 using a Tamrock scaler. Because this is a one of a kind excavation for WIPP (in terms of size, shape, and mining method), strong conclusions cannot be drawn from it. However, it must be examined here because its roof beam has been removed.
