SANDIA REPORT

SAND93-1000 • UC-721

Data Report on the Waste Isolation Pilot Plant Small-Scale Seal Performance Test, Series F Grouting Experiment

E. H. Ahrens, T. F. Dale

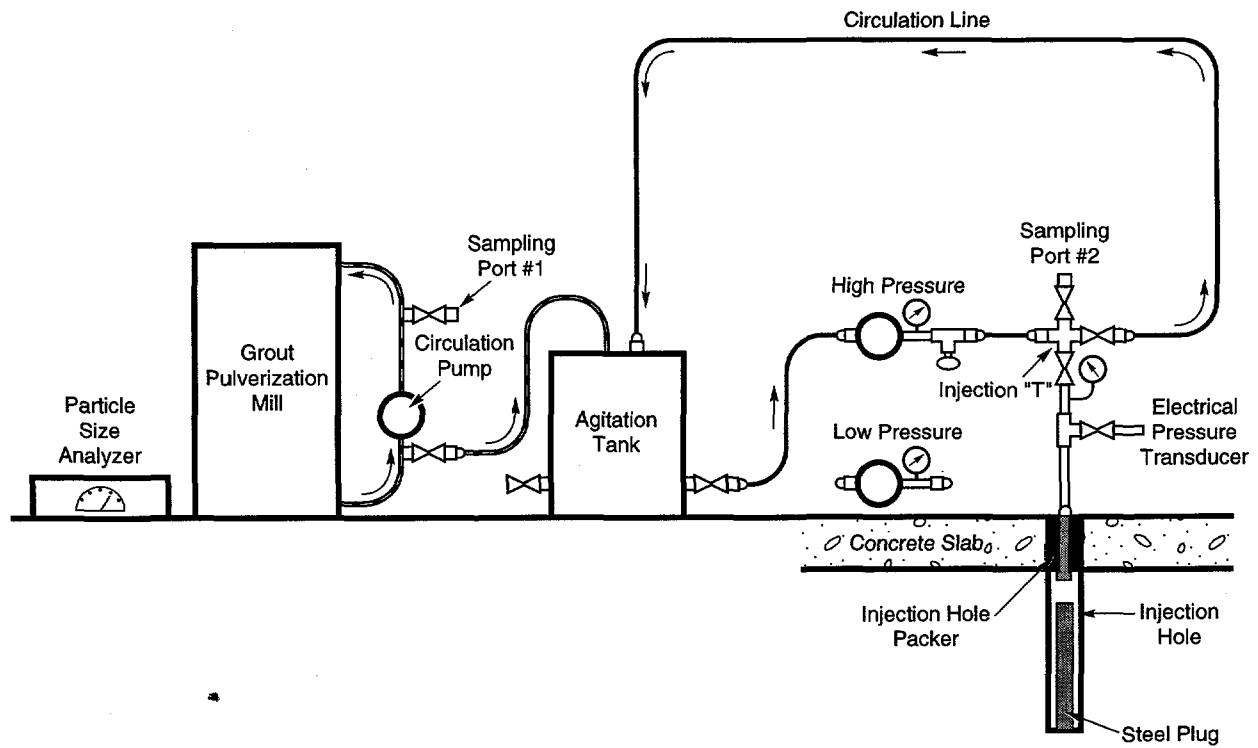
Figure 3-2. Grout pulverization and injection system.

- Inflation pressure in the central injection hole guard packer was checked and adjusted if necessary.
- A hermetically sealed steel plug (shown in Figure 3-2 and described below) was placed in the hole to be grouted. The sliding-end injection packer was positioned above the plug and inflated, and a mechanical restraint was attached to anchor the packer to the slab.

After steady-state flow was achieved in the recirculation loop, the valve to the injection packer was opened and the hole filled by gravity flow (the return valve to the agitation tank remained open during this operation). The hole was considered full when grout extruded from the 6.3-mm stainless steel tube/valve assembly that passed through the packer and out its top.

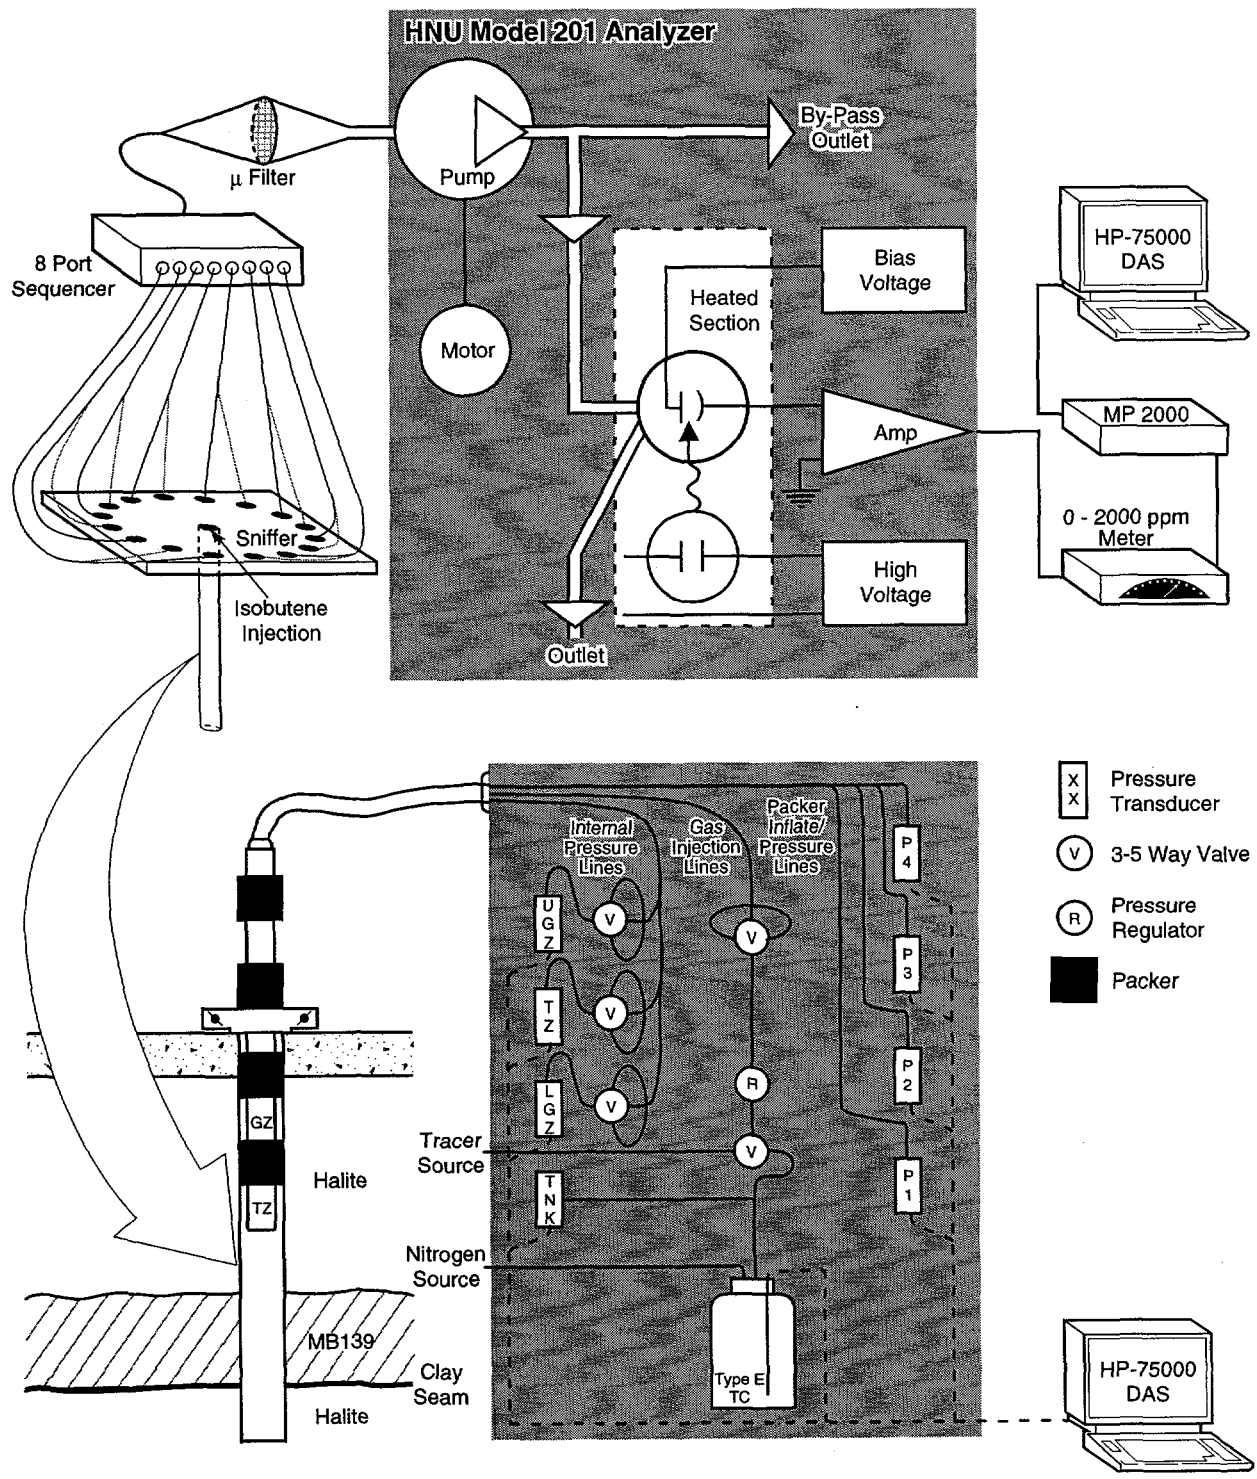
Figure 4-1. Tracer gas injection and sampling equipment.

The gas-injection and sampling equipment configuration is shown in Figure 4-1. This equipment is described in Appendix D. The straddle-packer assembly (also described in Appendix D) was set so that the top of the test zone was approximately 1.37 m below the borehole collar, and a split clamp was placed on the packer tool to maintain that depth throughout the test sequence. Packers P1 and P2 were inflated to 0.69 to 0.86 MPa and allowed to set for a period of 15 to 30 minutes, the noted time of packer compliance for this tool. The digital gas-flow tool (DGFT) was configured to deliver gas from the internal reservoir to the test zone. Prior to testing, the internal reservoir was filled to $7.0 \text{ MPa} \pm 0.07 \text{ MPa}$ and the heat of compression was allowed to dissipate from the reservoir. The panel regulator was set to $0.23 \text{ MPa} \pm 6895 \text{ Pa}$.

The DGFT and packer tool combination used for this series of gas-flow tests had a maximum flow rate of approximately 36 L/min of nitrogen gas at standard pressure and temperature when the panel regulator was set to 0.23 MPa. The test-zone lengths for this series of tests were approximately

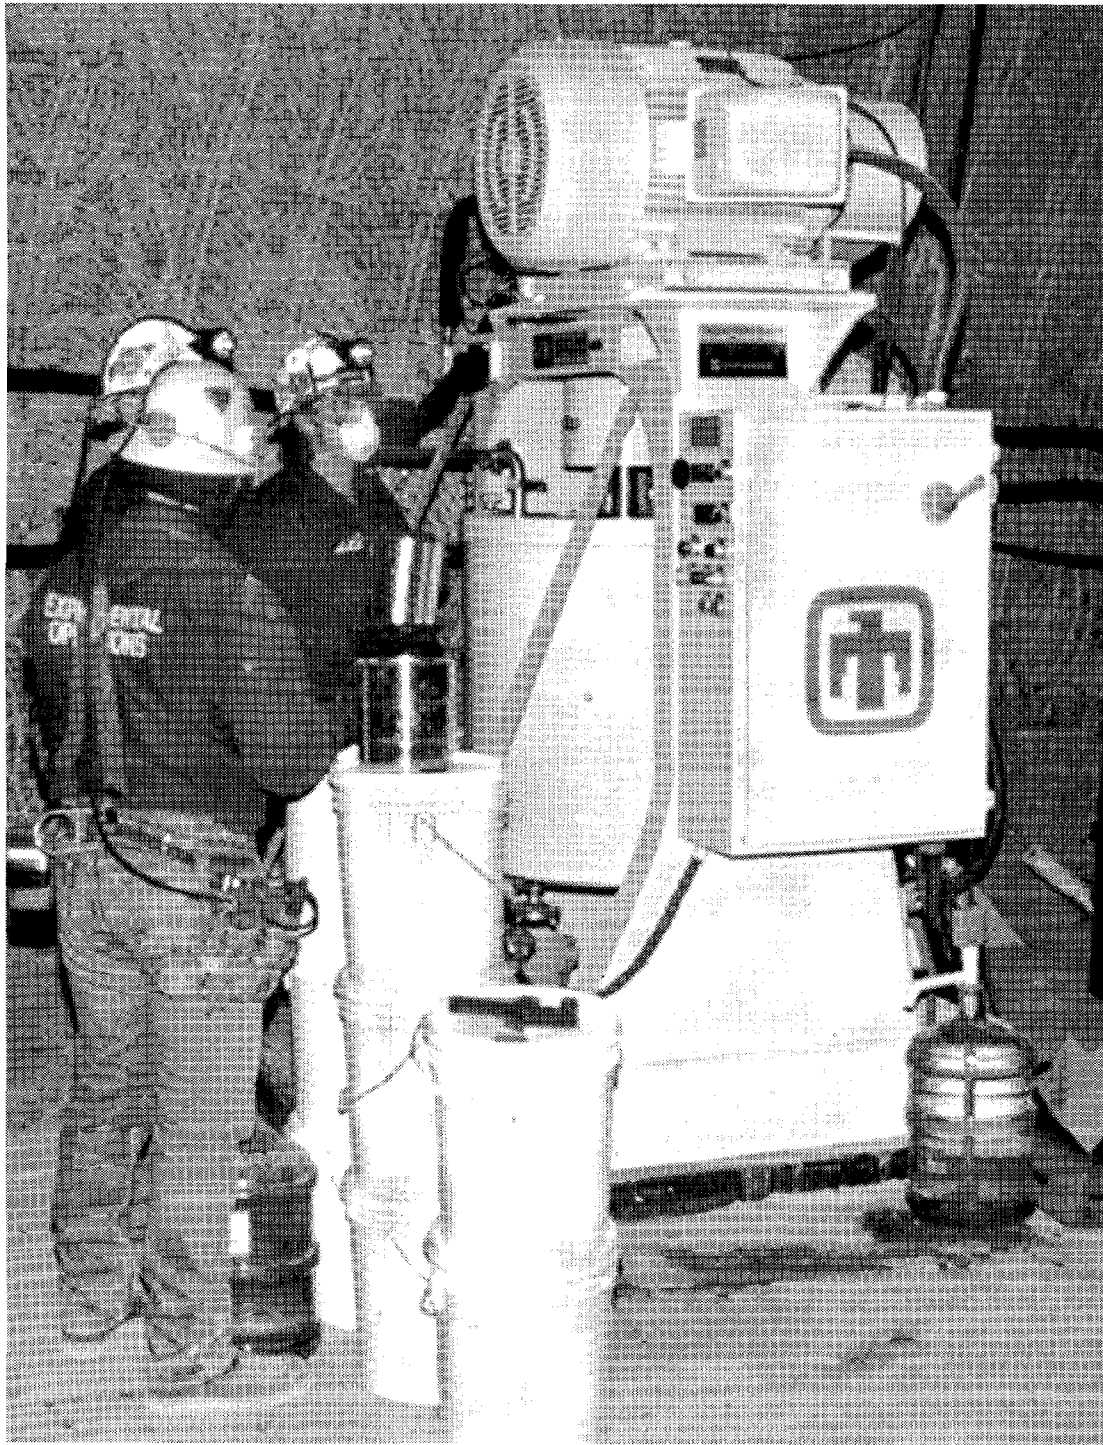
Photo E-1. Szegvari 50S Attritor.

Attritor evaluation began at the Union Process, Inc. laboratory. Preliminary tests were performed in a small Szegvari 1S Batch Attritor with a 3.78 L capacity. Grout particle size and distribution were determined with a MicroTrac laser particle size analyzer. After a series of successful tests at Union Process, a Szegvari 1S was purchased by SNL for grout development and optimization studies to be conducted at Whiteshell Laboratories (operated by Atomic Energy of Canada, Ltd.). The grout development process is described in Appendix A.
