**Waste Isolation Pilot Plant**  
**Geotechnical Analysis**  
**Report**  
**For**  
**July 2006 – June 2007**

**Geotechnical Analysis Report for July 2006 – June 2007**  
**DOE/WIPP-08-3177, Vol. 1**

This report contains an assessment of the geotechnical status of the Waste Isolation Pilot Plant (WIPP). During the excavation of the principal underground access and experimental areas, the status was reported quarterly. Since 1987, when the initial construction phase was completed, reports have been published annually. This report presents and analyzes data collected from July 1, 2006, to June 30, 2007.

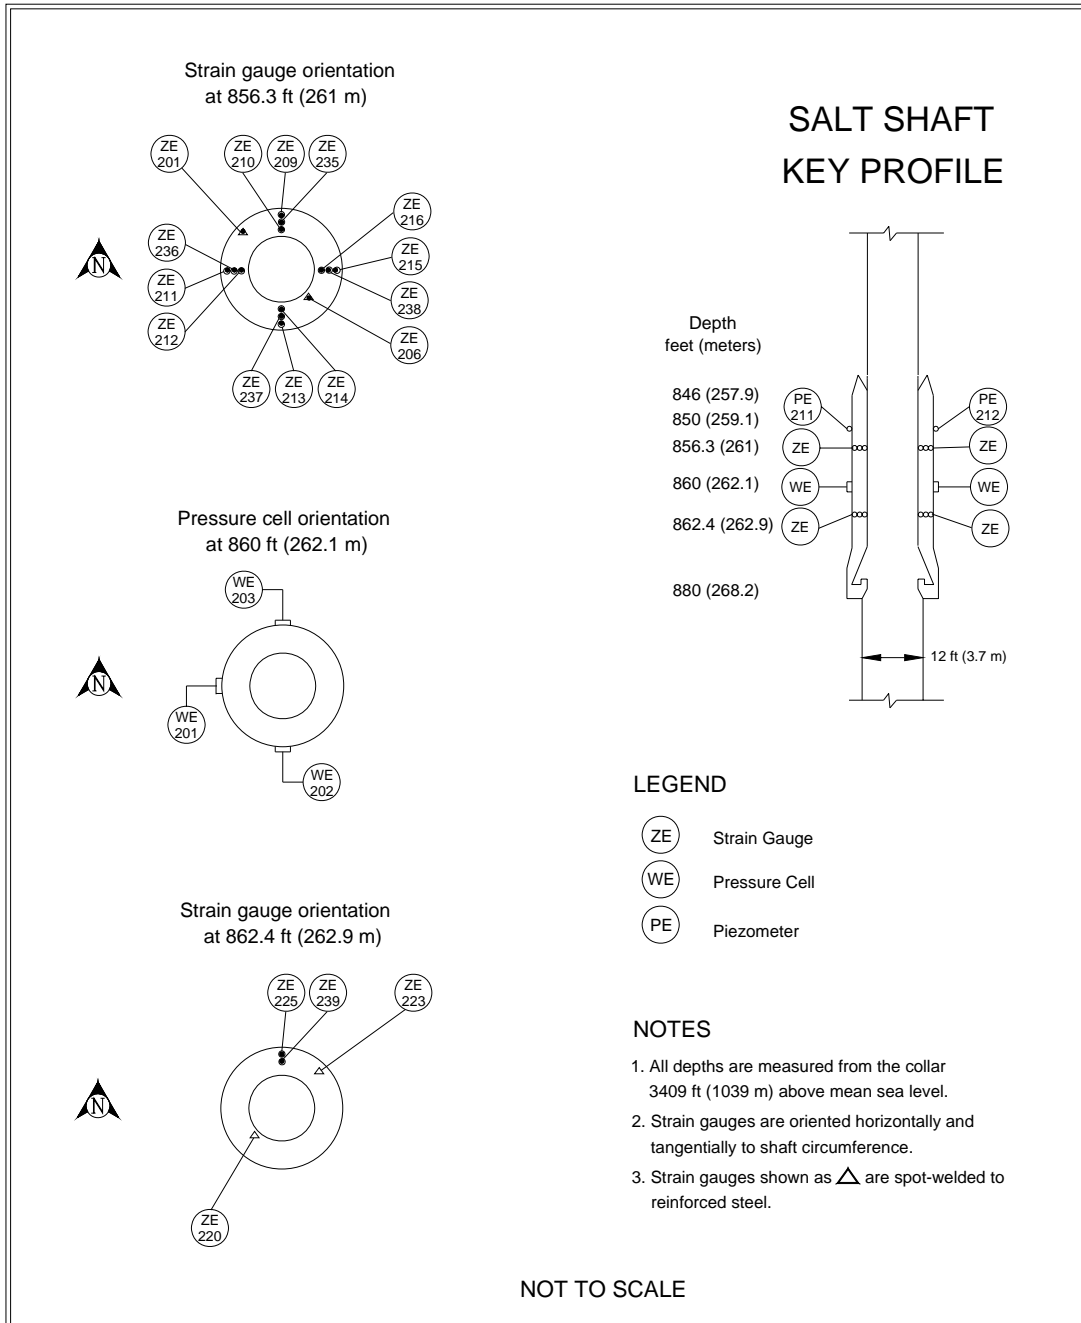
**Figure 3-3 – Salt Shaft Key Instrumentation**

Four earth pressure cells were installed in the key section of the Salt Shaft during concrete emplacement at the 860-ft (262-m) level. These instruments measure the normal stress between the concrete key and the Salado Formation as salt creep loads up the key structure. Three of the four earth pressure cells continue to provide data. These instruments have indicated essentially no contact pressure since their installation (readings resemble instrument drift at a zero pressure). The contact pressures recorded by the instruments for this reporting period ranged from -22 to 5 psi (-152 to 34 kPa).

Sixteen spot-welded and twenty-four embedment strain gauges were installed on and in the shaft key concrete at both the 856.3-ft (261-m) level and at the 862.4-ft (263-m) level. Four spot-welded strain gauges are still functioning at these levels. Maximum strains at the 856.3-ft (261-m) level were 672 and 739 microstrain. Strains at the 862.4-ft (262.9-m) level were 620 and 856 microstrain. The strains from the 12 embedment strain gauges at the 856.3-ft (261-m) level ranged from -826 to 999 microstrain. The strains from the two embedment strain gauges at the 862.4-ft (262.9-m) level were 217 to 358 microstrain. The strains recorded by the spot-welded strain gauges and the embedment strain gauges during this reporting period are very similar to the strains recorded by these instruments at the end of the previous reporting period.

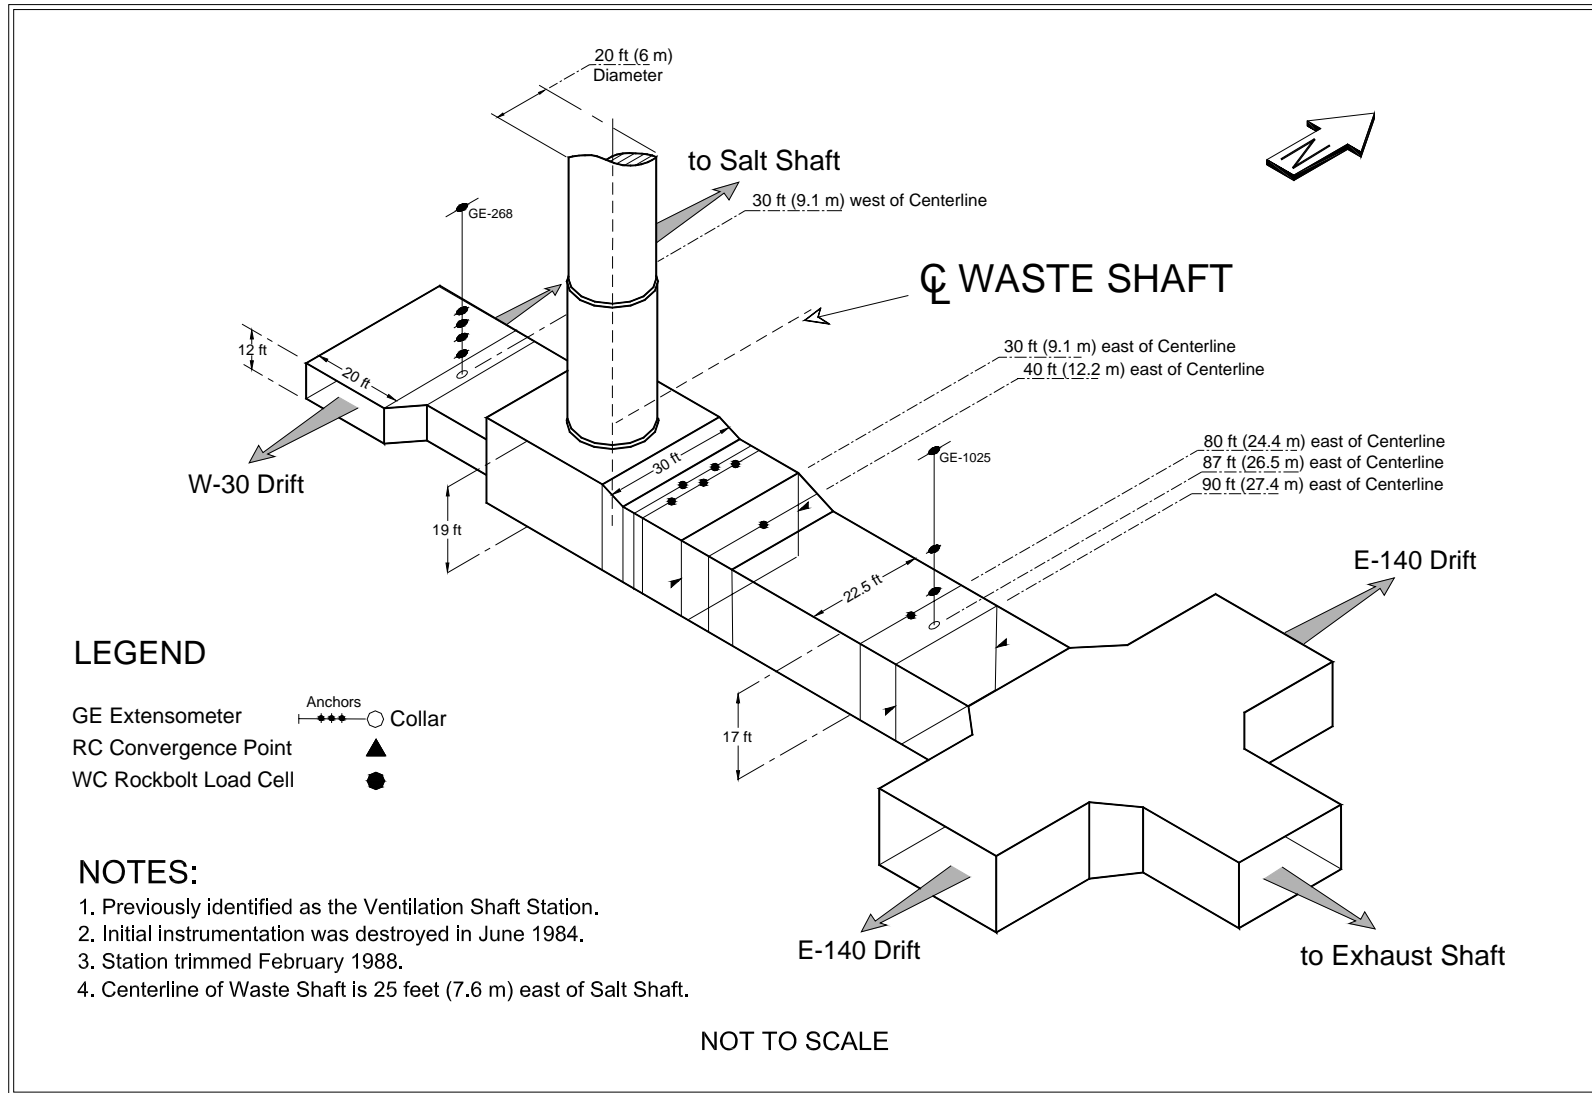
**Figure 4-4 – Waste Shaft Station Instrumentation after Wall Trimming**

Table 4-2 summarizes the recent history of the roof extensometers in the Waste Shaft Station. Extensometer 51X-GE-00268 (W-30) is installed in a borehole drilled into the roof of the station. Extensometers 51X-GE-00356 and 51X-GE-00357 monitor fracture dilation along the shaft wall above the east brow.

Bolt tails were trimmed, and some cable shoe anchors were replaced to provide additional operating clearance for waste handling operations.
